Brooklyn Hill Cycling Improvements

90% Design Stage Safe System Audit

Prepared for:
Wellington City Council

Prepared by:
Stantec

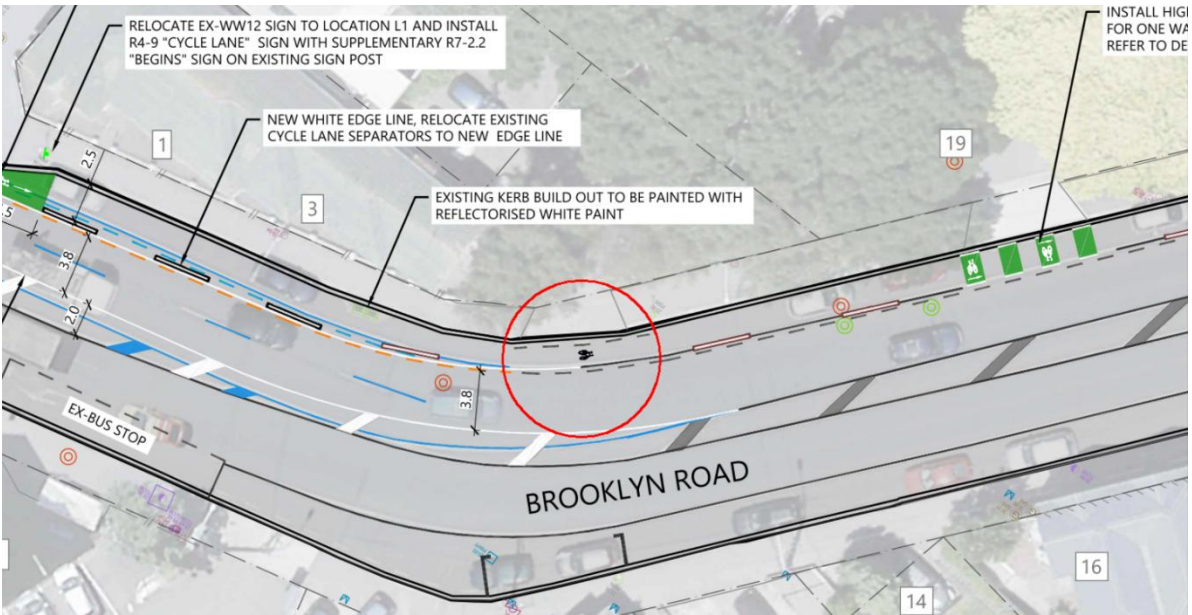
Figure 2: Drawing Sheet C301 - Cycle Way Marking

On drawing sheet C301, at the T-intersection between Nairn Street and Brooklyn Street, there is a green-painted cyclist symbol marking the start of the cycle lane. However, further along the same lane, another cyclist symbol appears at a driveway without the green background (shown in **Figure 2**^{Error! Reference source not found.}). This inconsistency can confuse both drivers and cyclists, reducing the visibility, presence and continuity of the cycle lane.

The severity is based on a cyclist missing the visual guidance into the separated cycle lane due to inconsistent symbol markings, resulting in potential exposure to vehicle conflict in the adjacent traffic lane.

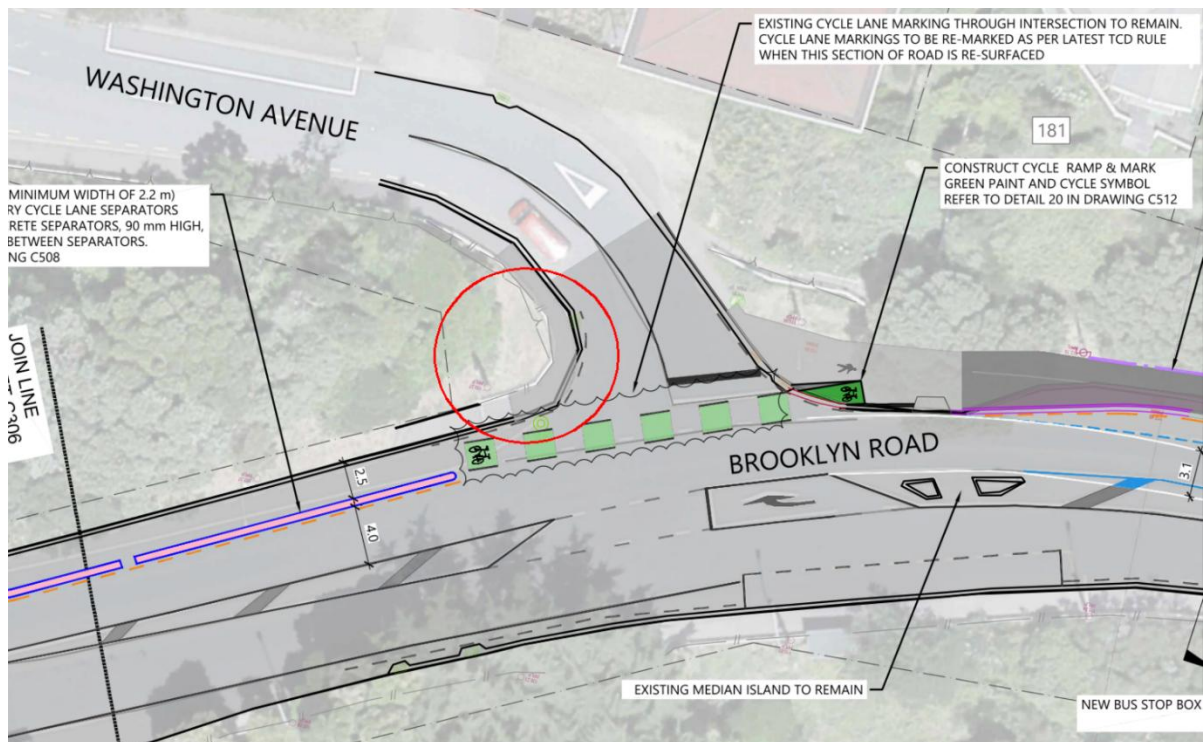
Figure 3: Drawing Sheet C307 - Pedestrian Facilities at Brooklyn Road & Washington Avenue Intersection

Drivers will be preparing for the pedestrian crossing with the median build-out and may not expect pedestrians to cross immediately. If pedestrians cross prematurely at undesignated points, it may result in slower driver reactions and increase the risk of conflict.

1. Remove dropped kerb to encourage pedestrians to cross at the designated point.
2. Remove the footpath at this location to discourage unsafe crossings and guide pedestrians to safer, designated crossing points on Washington Avenue

| Client decision | <p>Drop kerb to remain for access to Central Park by PSR maintenance vehicles and for cyclists. T&I minor works programme to consider a dedicated pedestrian crossing adjacent to the cycle lane crossing at the intersection. Follow up on minor works programme to occur.</p> |

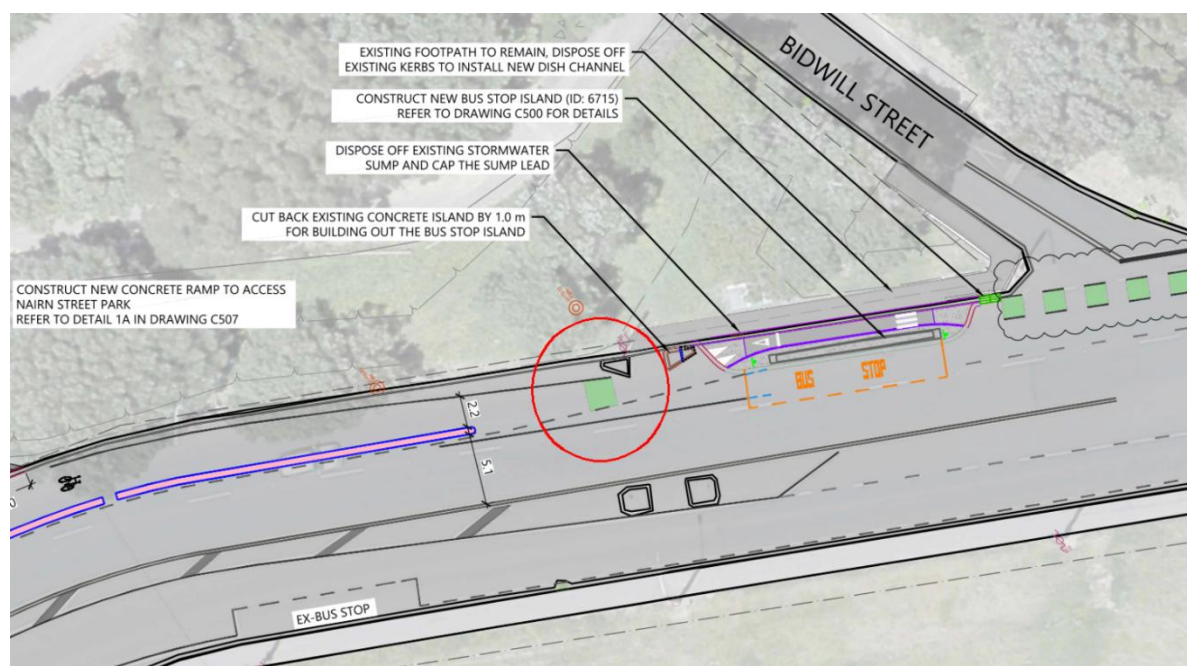
Figure 4: Drawing Sheet C305 - Missing Cycle Signage

On drawing sheet C305, on Brooklyn Road just before the intersection with Bidwill Street, green surfacing is shown to indicate the presence of a cycle way. However, the absence of a cycle symbol on the green surfacing (as shown in **Figure 4**) may create ambiguity for both cyclist and bus drivers, particularly as it is located just before the bus stop, where buses begin to merge left to reach the designated stopping area.

| Design team response | Agreed, A cycle symbol can be added over the existing green paint, and an additional green treatment with a directional arrow can be applied just before the cycle ramp on the bus stop island (see snip below). This will help reinforce the intended travel direction for cyclists and improve overall legibility of the facility. |

| Client decision | Designer to update the drawings with a cycle symbol over the existing green paint, and additional green treatment with a directional arrow just before the cycle ramp on the bus stop island (see snip above). |

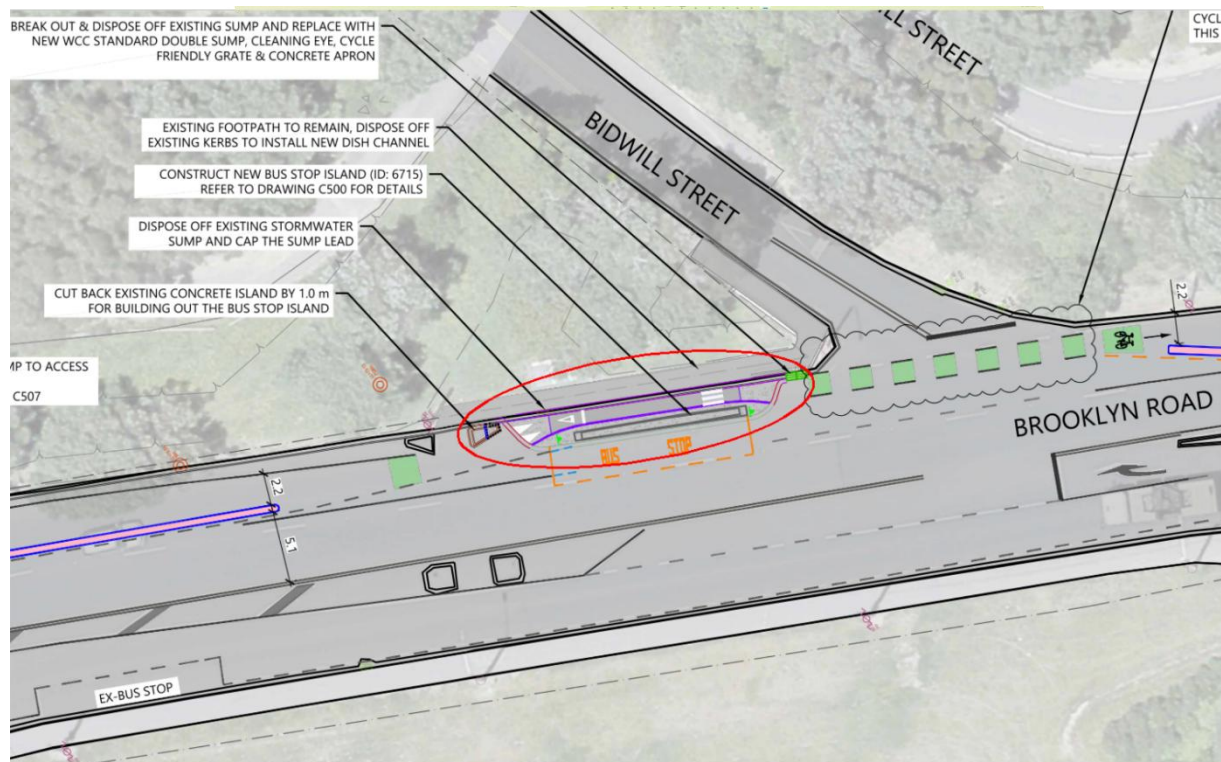
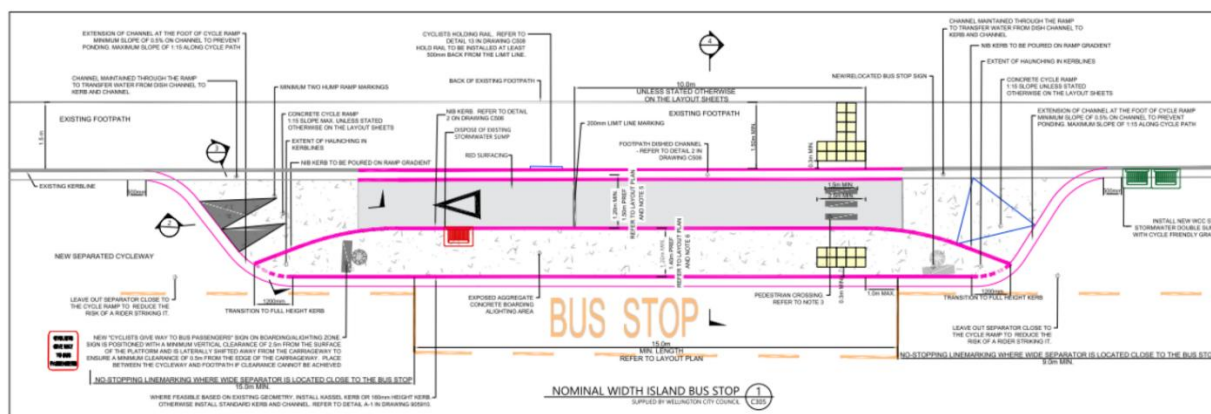
Figure 5: Drawing Sheet C305 – Shared Path by The Bus Stop

Figure 6: Drawing Sheet 500 - Shared Path by The Bus Stop

1. Introduce red surfacing on the cycle path adjacent to the bus stop to warn cyclists of pedestrian activity and ensure the white crossing line is flush with the surface to prevent trip hazards.

| Design team response | The red surfacing on the cycle path is already shown on the drawing C500 (Refer below snip) |
| Client decision | Current NZTA guidance to be applied, designer to retain the red marking already shown on the drawing |

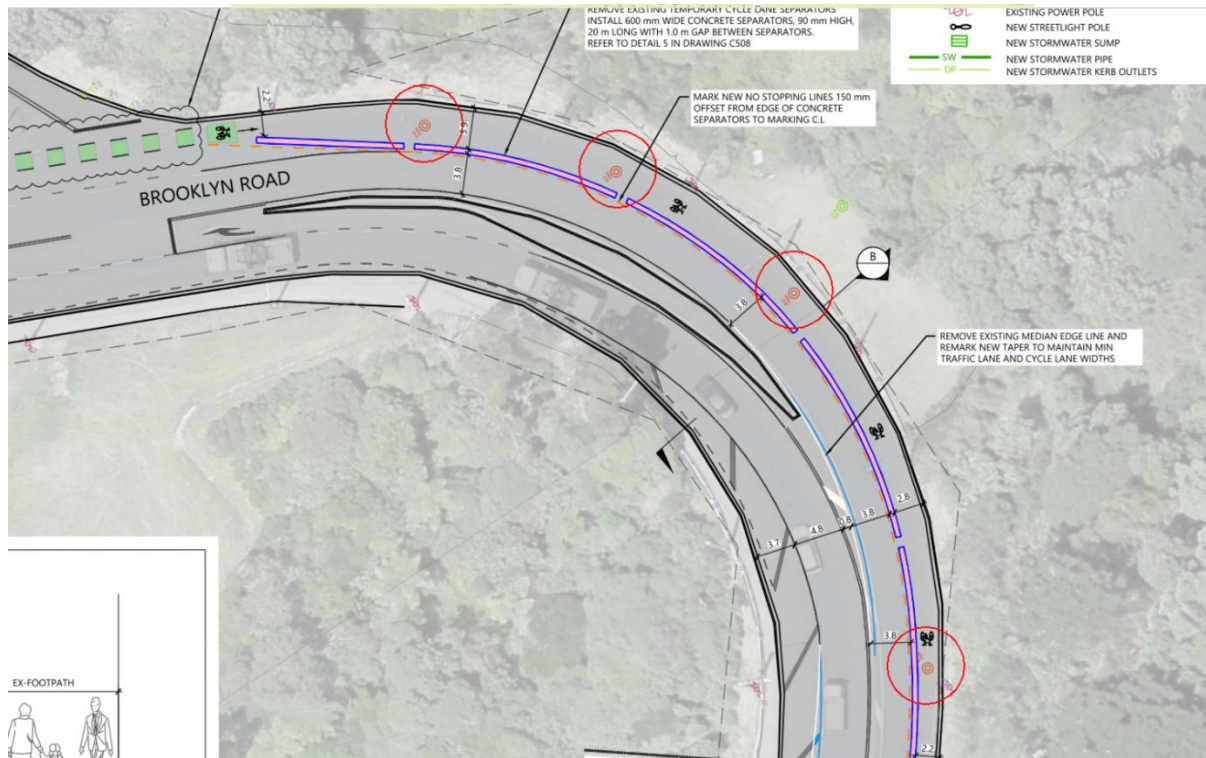
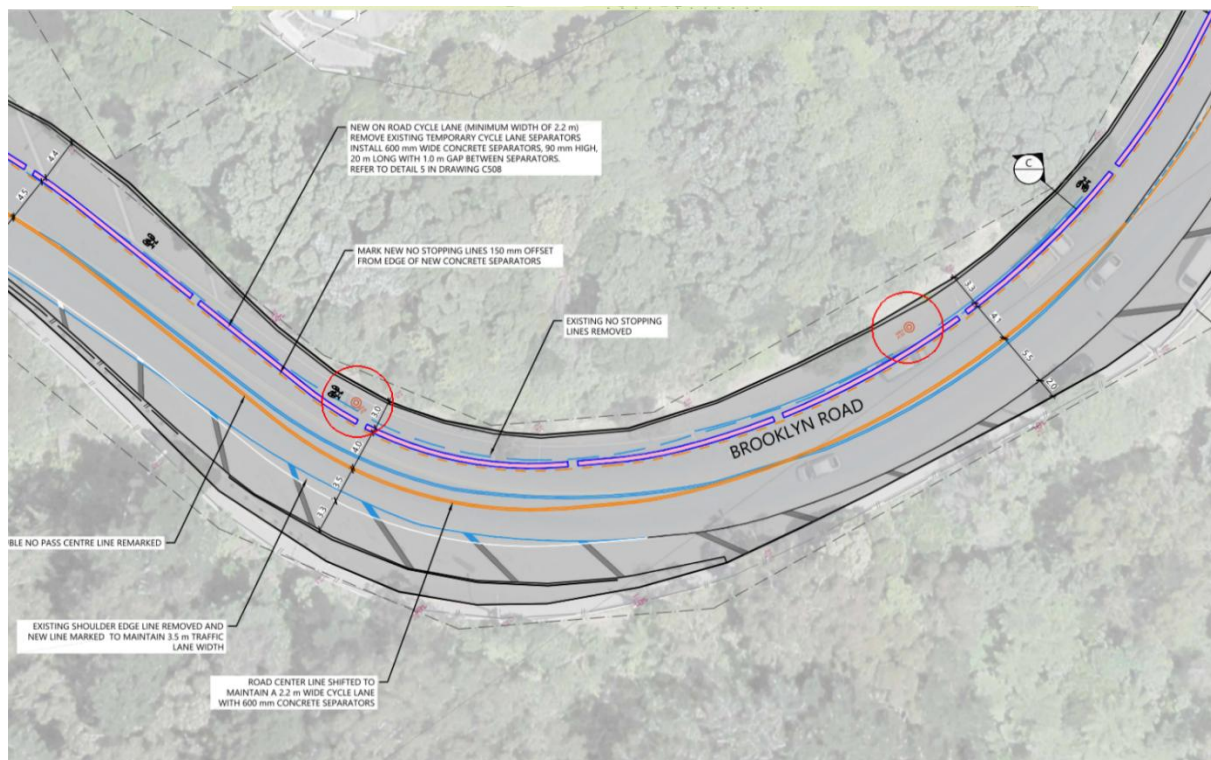
On Drawing sheet C305 and C306, several manholes are located along the cycle way (as shown in **Figure 7** and **Figure 8**). These surfaces can become slippery, particularly in wet conditions, posing a safety risk for cyclists. The reduced traction may lead to loss of control or falls, especially when cyclists are required to navigate over or around these features.

Figure 7: Drawing Sheet C305 - Multiple Manholes on Cycle Way

Figure 8: Drawing Sheet C306 - Multiple Manholes on Cycle Way

The severity is based on cyclists losing control due to slippery manhole surfaces along the cycle way, especially in wet conditions, increasing the risk of falls and injury.

1. Use non-slip surfacing treatments on the manholes to ensure safe passage for cyclists in all weather conditions.

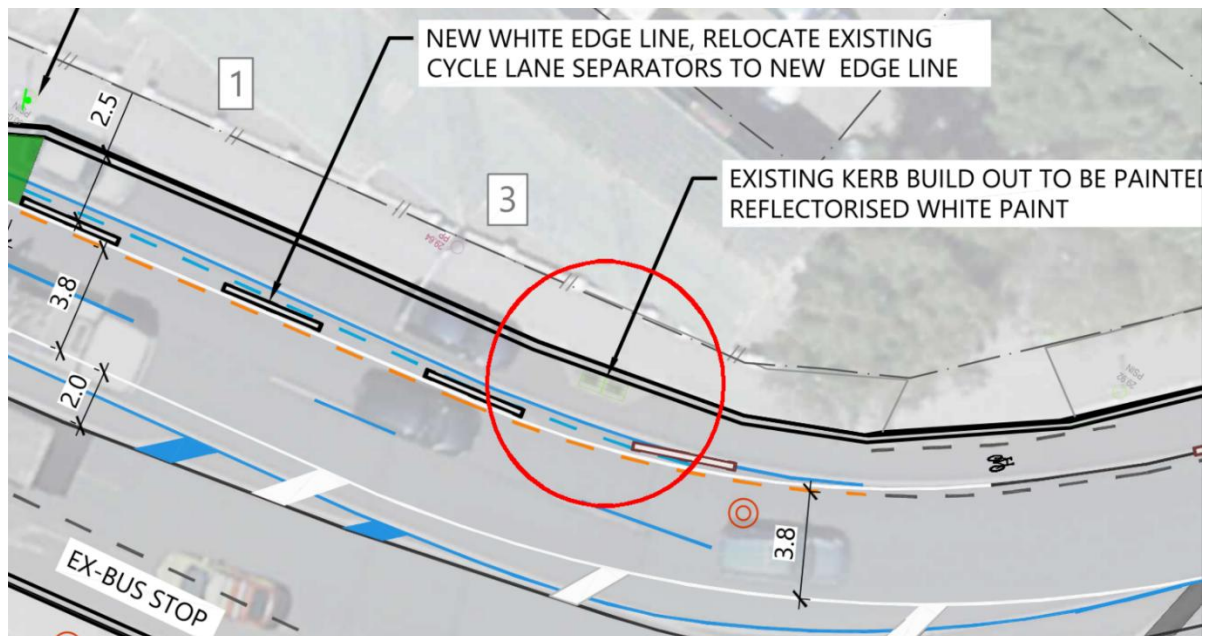
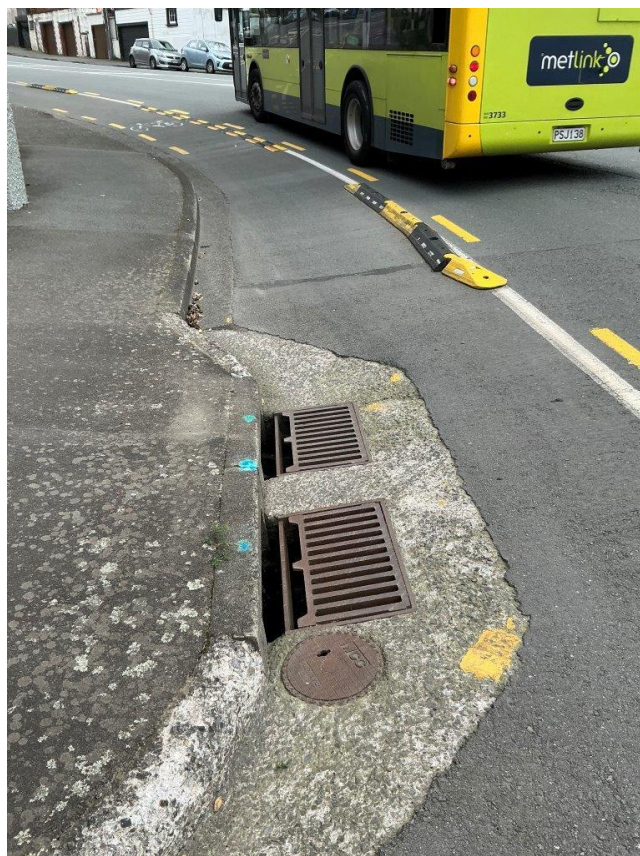
On drawing sheet C301, a stormwater sump is shown within the cycle way (as shown in **Figure 9**). During the site visit, the audit team assessed the remaining usable width and found that the sump's placement presents multiple concerns. In addition to potential safety risks from uneven or slippery surfaces, the sump significantly reduces the effective width of the cycle path. This narrowing may restrict safe passing and manoeuvring for cyclists, particularly in areas with higher cyclist volumes or limited space.

Figure 9: Drawing Sheet 301 - Stormwater sump on Cycle Way

Figure 10: Stormwater Sump on Cycle Way – On-site

The severity is based on reduced cycle path width and surface hazards from the sump, increasing the risk of cyclist instability.

| Design team response | Agreed, The stormwater sump can be replaced with a cycle-friendly, non-slip grate that is flush with the surrounding surface to improve safety and comfort for cyclists. |
| Client decision | Recommendation number 1 - Designer to update the drawings to reflect the stormwater sump to be replaced with a cycle-friendly non-slip grate that is flush with the surrounding surface. Recommendation number 2 – Altering the sump location will be a costly change, which is out of scope for this project |

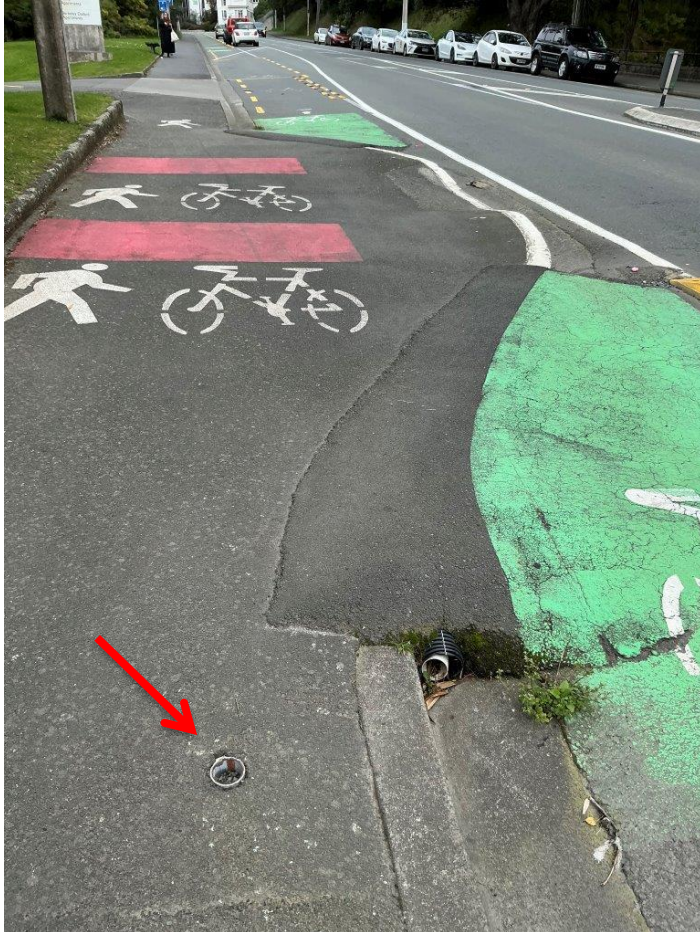
Figure 11: Exposed Sign Post Hole

While on-site, the audit team identified an exposed hole in the pedestrian footpath where a sign post had previously been removed (as shown in **Figure 11**). This presents a clear trip hazard, particularly for vulnerable users such as elderly pedestrians, children, and individuals with mobility impairments.

1. Fill and seal the hole promptly to eliminate the trip hazard and restore the integrity of the walking surface.

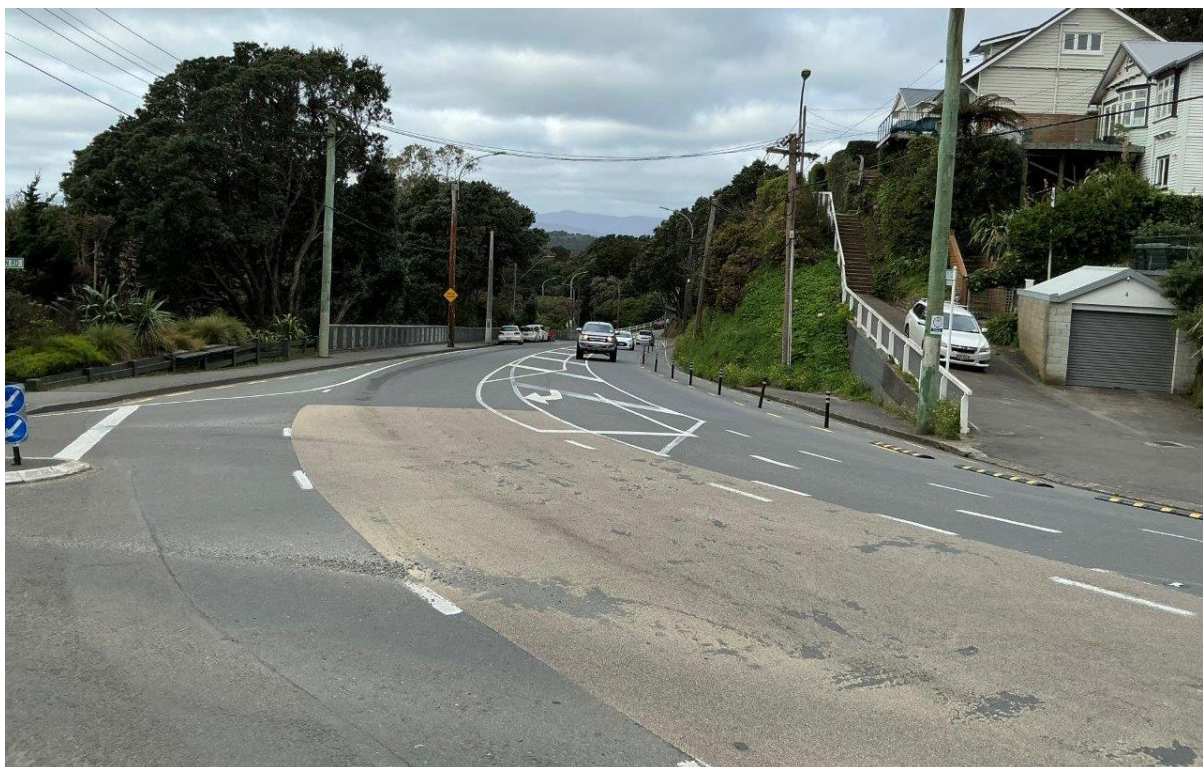
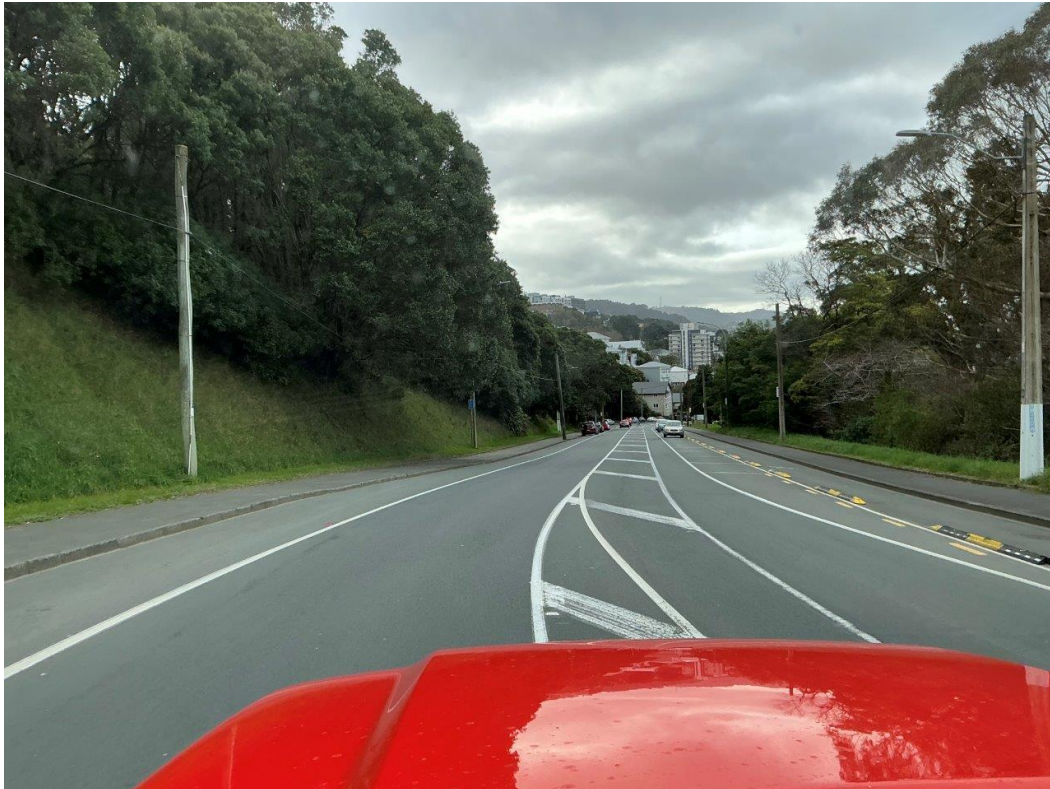
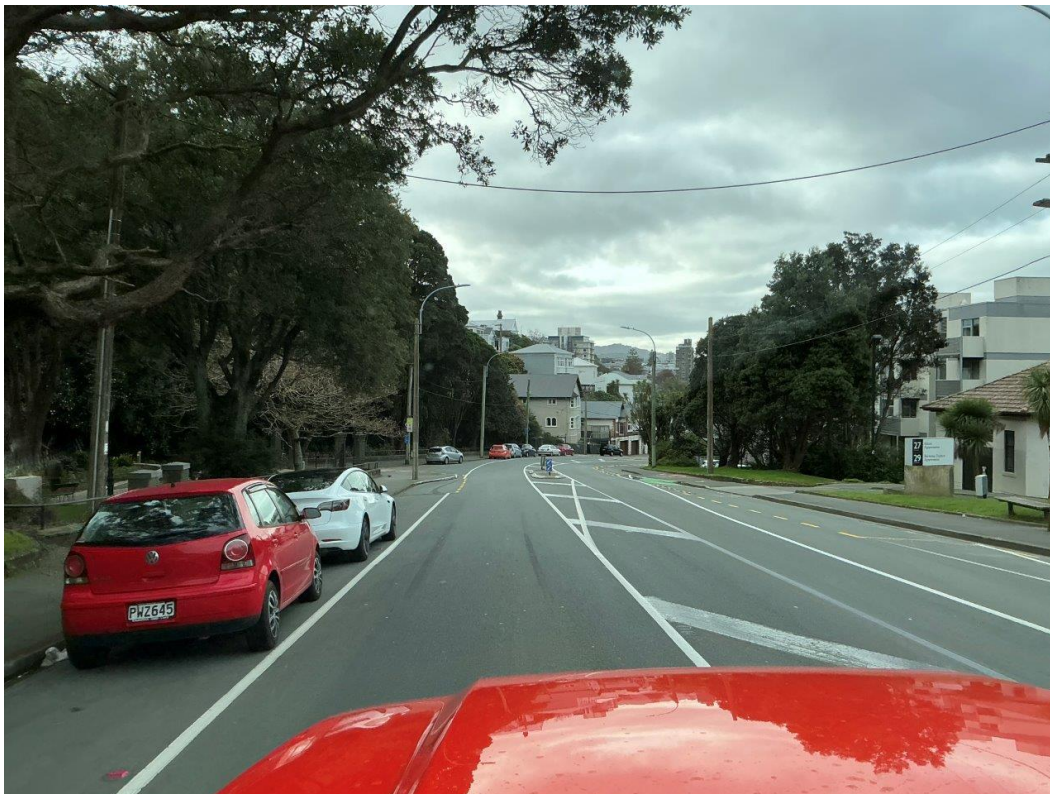
While on-site, the audit team identified several instances of ghost markings, both faded or partially removed, that remain visible on the pavement. These remnants can cause confusion for both drivers and cyclists, especially when they appear near intersections, lane transitions, or cycle paths. Ghost markings may lead to misinterpretation of lane guidance or right-of-way, potentially increasing the risk of unsafe manoeuvres. This is of particular concern during wet / dark conditions.

Figure 12: Ghost Marking on Pavement - Part 1

Figure 13: Ghost Marking on Pavement - Part 2

Figure 14: Ghost Marking on Pavement - Part 3

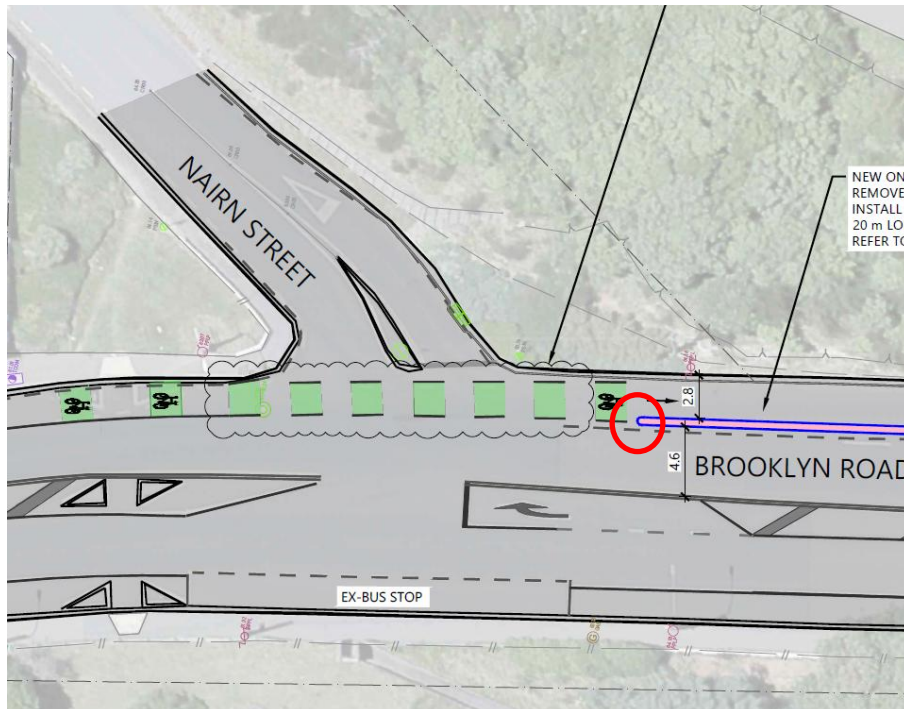
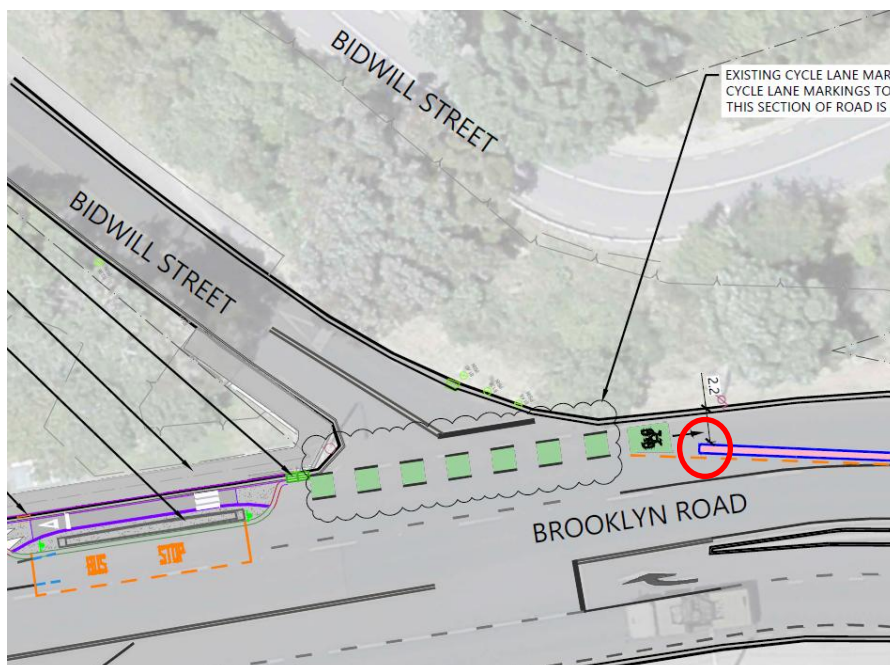
the side street while looking right to filter into a gap while not noticing the proximity of the cycle lane separator.

Figure 15: Lack of vertical indicators at Nairn Street

Figure 16: Lack of vertical indicators at Bidwill Street

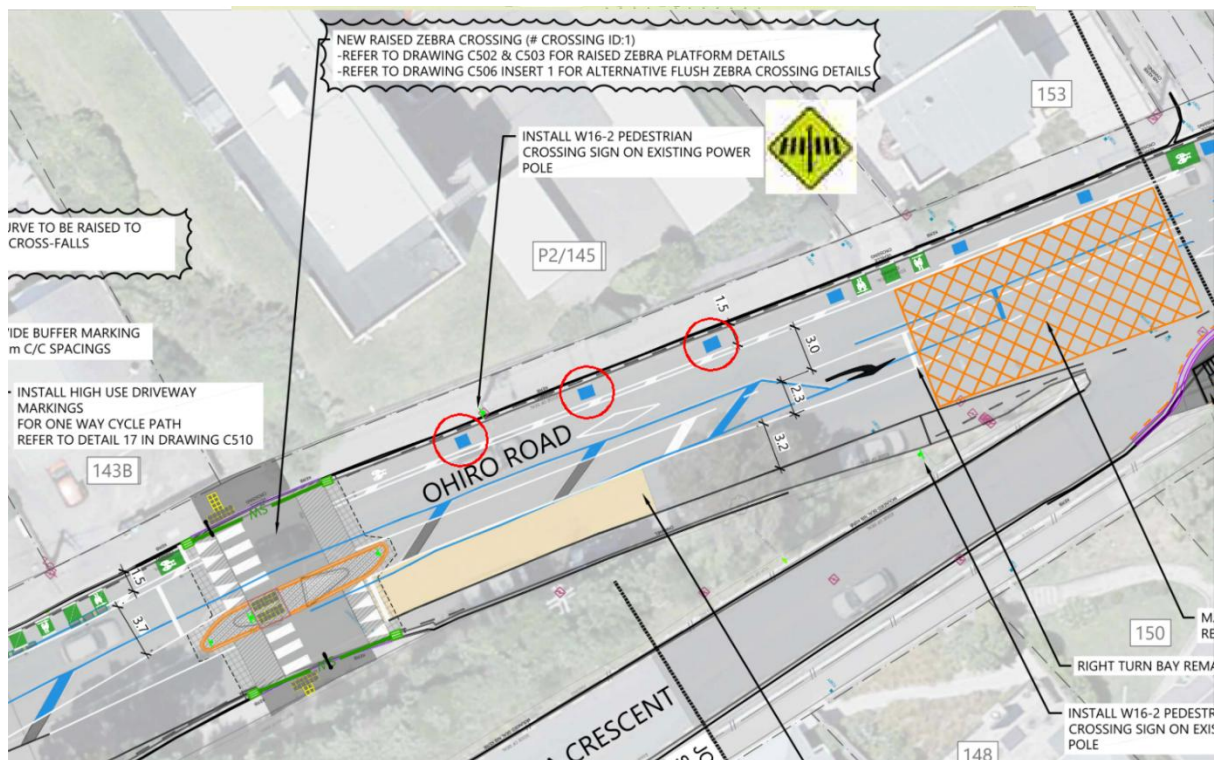
Figure 17: Drawing Sheet C308 - Removal of Green Surfacing on Cycle Way

Drawing sheet C308 indicates that some green surfacing on cycle way will be removed (as shown in **Figure 17**). This could lead to confusion for drivers, who may inadvertently merge into the cycle lane, and reduce visibility for cyclists.

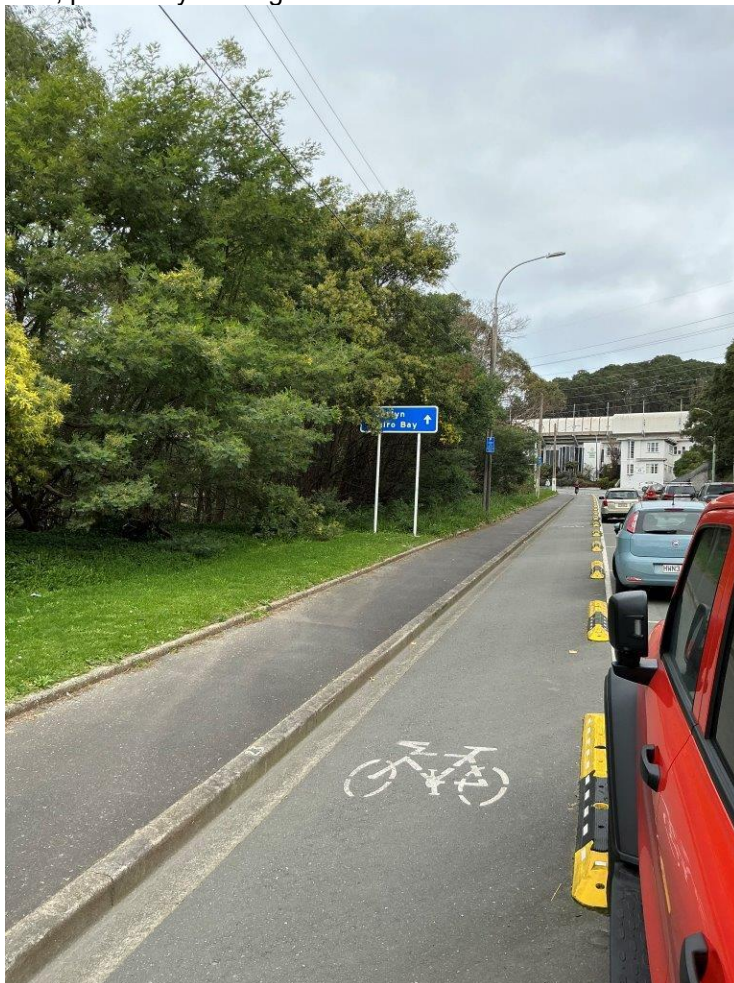
Figure 18: Signage Encroachment

During the site visit, the audit team observed that overgrown vegetation is obstructing the visibility of road signage (as shown in **Figure 18**). This can prevent drivers from seeing important information in time, potentially leading to unsafe decisions or missed instructions.

| Client decision | This recommendation to be passed to Vegetation Maintenance Team |
