Thorndon Quay Cycleway Safe System Audit Report

Safe System Audit Post Construction

14-Aug-2025

Client: Wellington City Council

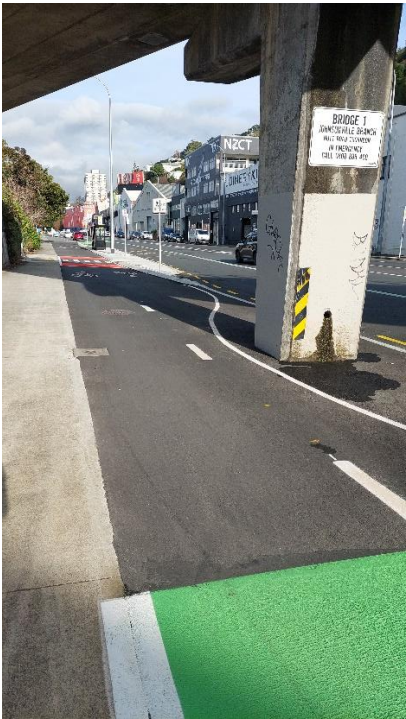
Figure 3. Centre line marking around bridge column

Minor

A centreline and edge lines have been added to the cycle path under the rail overbridge near Gun City. The edge line moves from the back of the kerb around the column for the bridge and then back to the kerb line. The centreline starts out in the centre of the path and stays at the same offset from the kerb line resulting in a cycle lane that is so narrow it cannot be ridden in.

Remove the centreline marking.

Probability Rating:		Severity Outcome Rating:	
Crashes are likely to be Very Unlikely		Death or serious injury is Minor	
Design Team Response: <i>Agree with SAT</i>			
Safety Engineer:		Agree with SAT and Designer response.	
Client Decision:		Agree with safety engineer.	
Action Taken:		Designer to review centre line and make recommendations on corrective action.

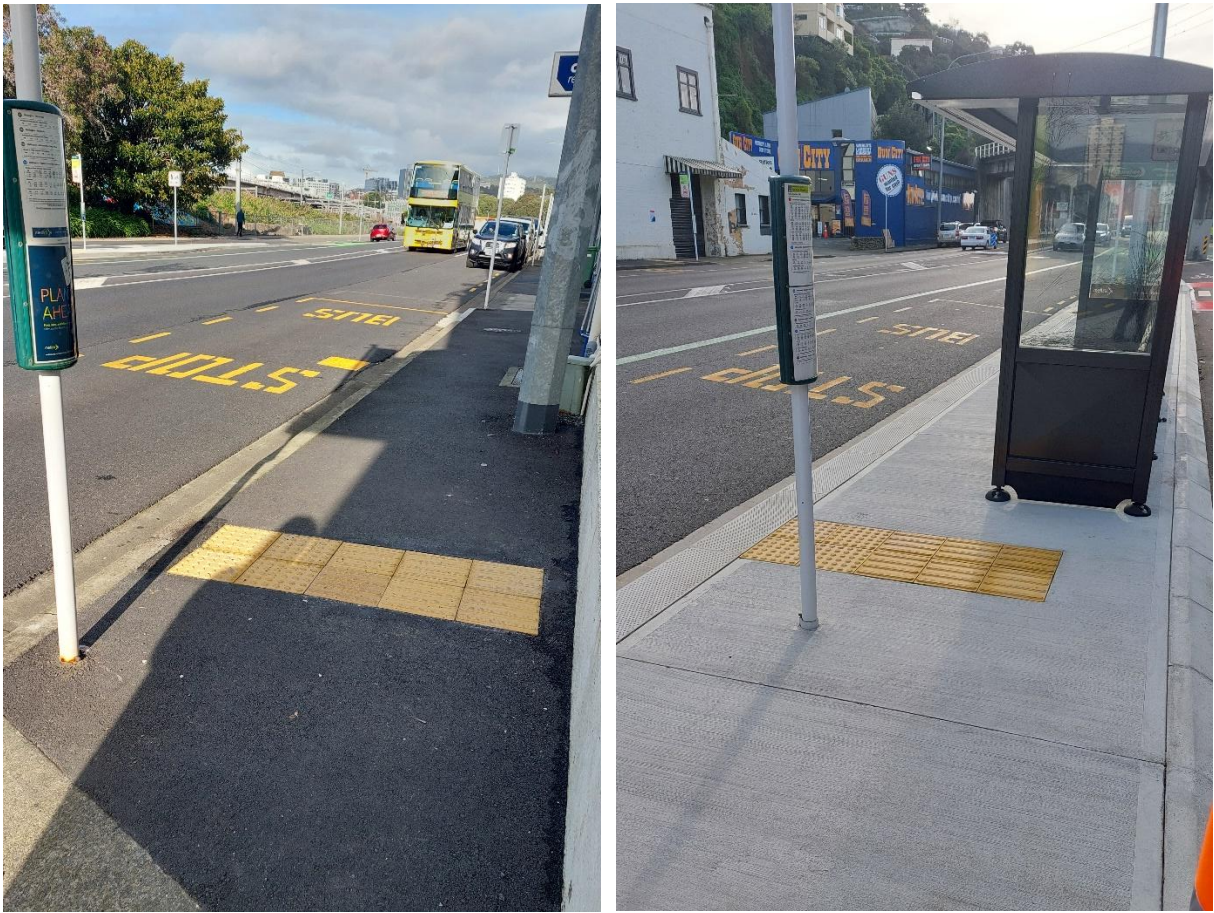
Figure 4. Tactile pavers at Omega Car Rentals Bus Stop

Significant

Tactile pavers at bus stops should be located approximately 450mm back from the kerb face. This ensures visually impaired people are located a safe distance back from the kerb line and therefore any approaching buses. The tactiles at the bus stops on both sides of the road at Omega Car Rentals appear to be too close to the kerb line.

Review position of tactile pavers at the Omega Car Rentals bus stops.

Probability Rating:		Severity Outcome Rating:	
Crashes are likely to be Very Unlikely		Death or serious injury is Serious	
Design Team Response: <i>RTS14 recommends the tactile stop 300mm behind the kerb face. Tactiles have been checked against this. No Change proposed.</i>			
Safety Engineer:		Agree with Designer response. .	
Client Decision:		Agree with Safety Engineer.	
Action Taken:		No further action required.

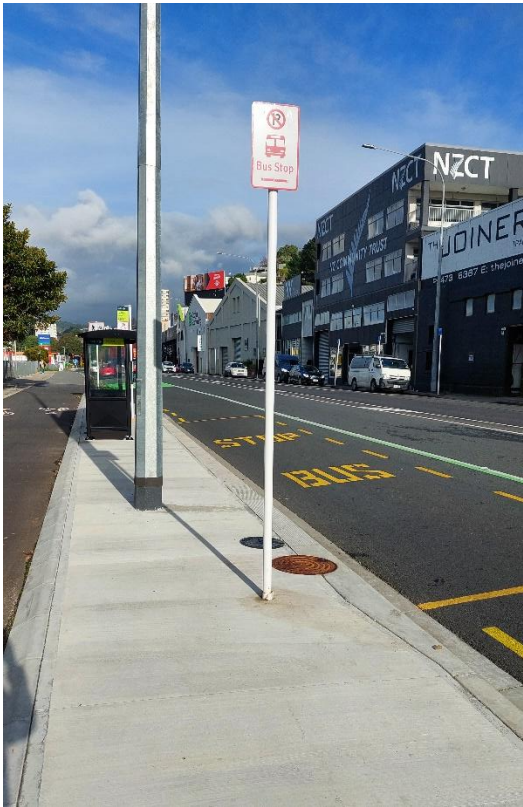
Figure 5. Sign and streetlight at bus stop

Significant

The bus stop on the city bound side of Hutt Road at Omega Car Rentals has a streetlight column and a bus stop sign located in the bus stop island. The SSAT are unsure that someone in a wheelchair would be able to manoeuvre around the sign and light column to get to the bus stop. With the bus stop sitting on a raised island this creates a risk that the wheelchair user would fall off the island as they attempt to manoeuvre through the gap which could result in serious injuries.

Review the position of the street light column and bus stop sign to confirm wheelchair users can access the bus stop.

Probability Rating:		Severity Outcome Rating:	
Crashes are likely to be	Unlikely	Death or serious injury is	Serious
Design Team Response: To be reviewed.			
Safety Engineer:		Comment pending Design Team response.	
Client Decision:		Comment pending design team response.	
Action Taken:		Pole location to be reviewed by Designer and recommendation to resolve the issue.

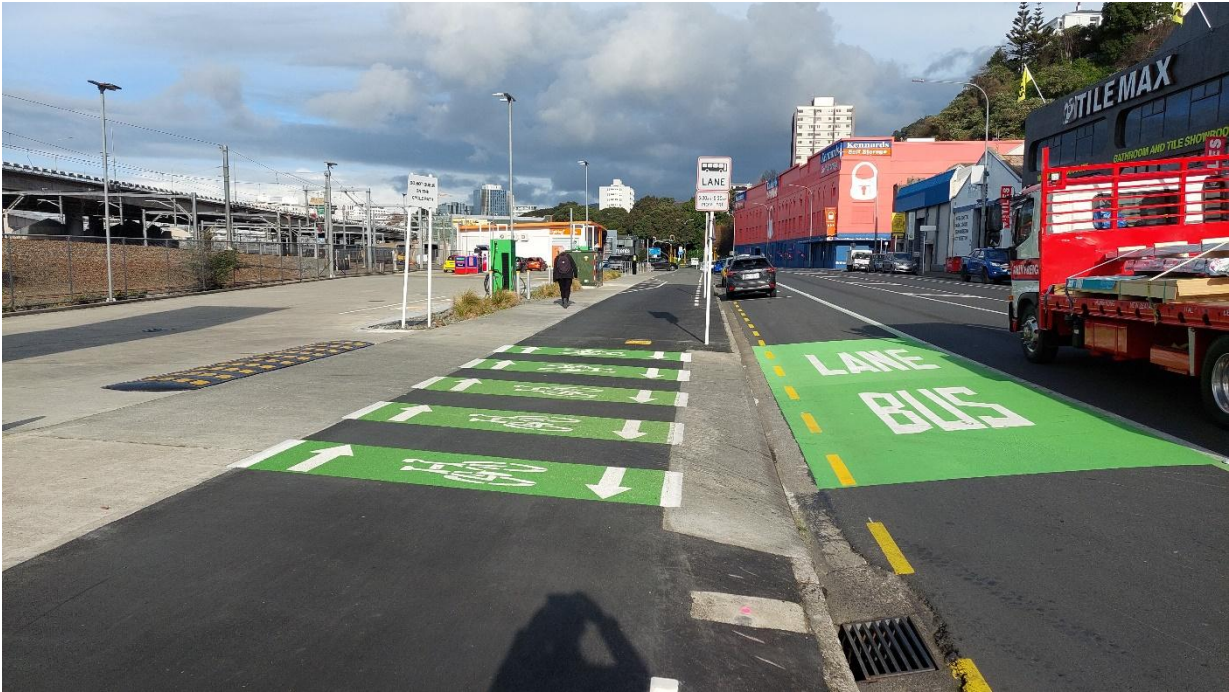
Figure 6. Waitomo petrol station entry

Serious

The entry to Waitomo petrol station has a speed hump located at the back of the footpath. Some drivers entering the accessway are doing so at speeds that are too high for conflicts with pedestrians and cyclists. These drivers then slow rapidly as they cross the cycleway/ footpath before hitting the speed hump. In order to reduce speeds at the conflict point the speed hump should be located on the approach side of the petrol station entry.

Provide a speed hump on the approach side of the entry to the petrol station.

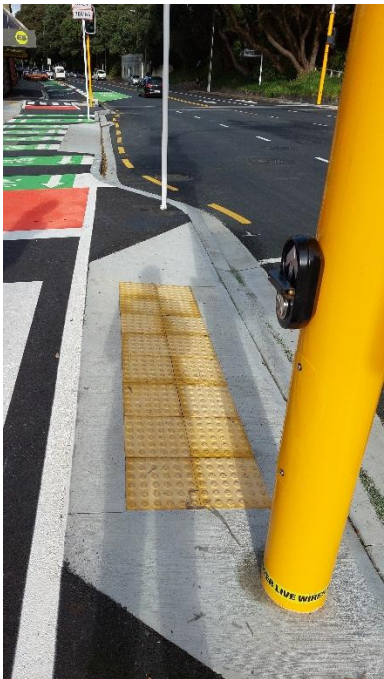
Figure 7. Thorndon Quay pedestrian crossing at Tinakori Road

The SSAT acknowledge that there is limited space in this area and despite this concern when onsite the SSAT received positive feedback on the crossing from a member of the public.

The operation of this crossing point and others where there is limited space should be monitored to ensure that these spaces operate safely especially if cycle speeds are high in the area.

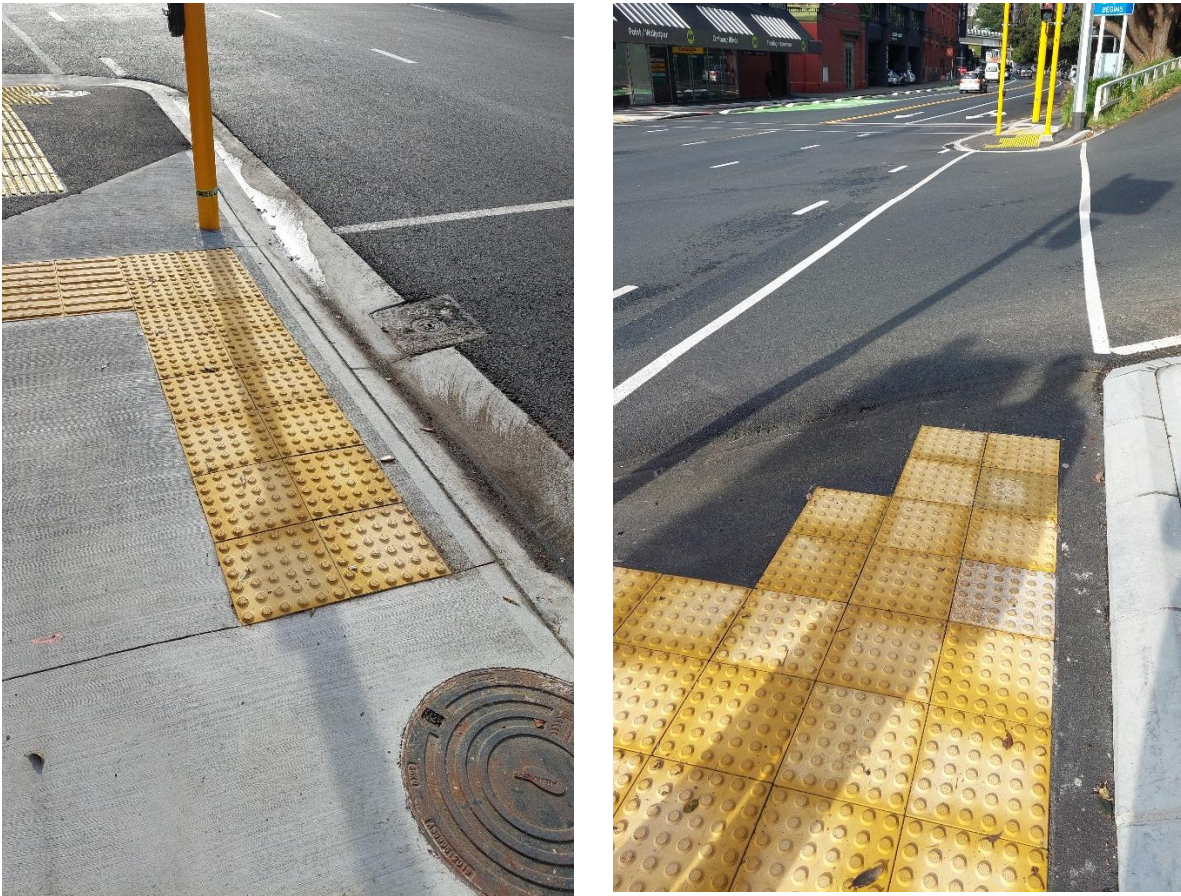
Figure 8. Tactile pavers at Tinakori Road

Significant

Tactile pavers at some of the crossing points at the Tinakori Road/ Thorndon Quay intersection are located too close to the traffic lane. The hazard warning pavers should be set back a minimum of 300mm from the kerb line.

Probability Rating:		Severity Outcome Rating:	
Crashes are likely to be	Unlikely	Death or serious injury is	Serious
Design Team Response: Agree with Audit team. Check compliance and consider repair. Designer to review issued design files to confirm compliance.			
Safety Engineer:		Agree with SSA. Ensure that the 300mm offset is achieved.	
Client Decision:		Agree with safety engineer.	
Action Taken:		Designer to review the compliance of the tactile pavers and provide recommendations

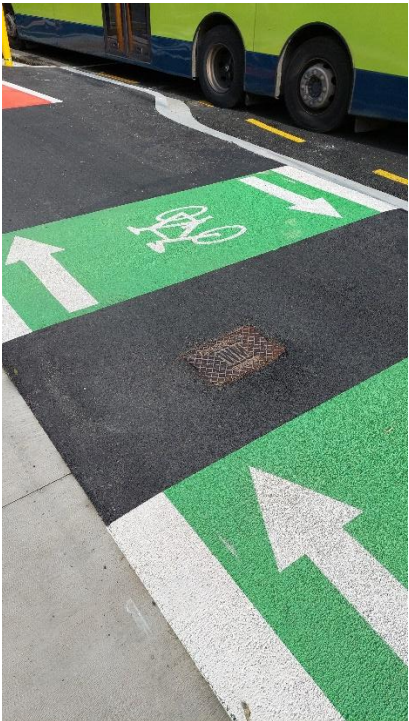
Figure 9. Service cover at Guthrie Bowron that is not flush

Minor

The cycleway is used by cyclists and by scooter riders. Some of the service covers are not flush with the pavement which can lead to instability for people on scooters due to their small wheels. While outside of the SSA scope, there are some service covers in the area of road that has been resurfaced that have similar issues. Again, these can be a hazard for small motorbikes using the road.

Probability Rating:		Severity Outcome Rating:	
Crashes are likely to be	Likely	Death or serious injury is	Minor
Design Team Response: No Design response.			
Safety Engineer:	Agree with SSAT.		
Client Decision:	Agree with safety engineer.		
Action Taken:	Design Team to review the level of the service covers and provide recommendation.

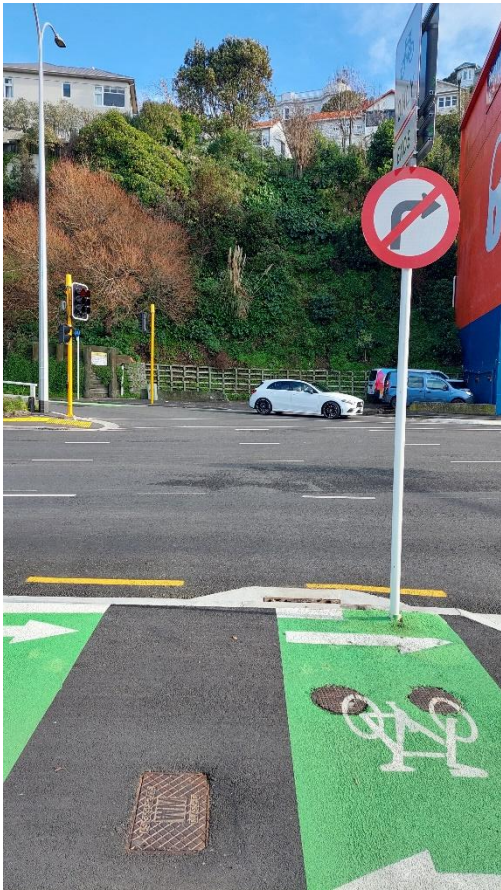
Figure 10. Vehicle using the intersection as a give way .

While on site the SSAT noticed several instances of drivers either not complying with signals at Tinakori Road and still driving as if the intersection is a give way, or, stopping forward of the limit line in the advance stop box. Despite the above comment the behaviours didn't necessarily result in an unsafe situation that would require changes to the construction of the project. Changes in how intersections operate can take time to settle in and the operation of the intersection should be monitored to ensure that it does settle down over time and does not result in unsafe behaviours.

Monitor the intersection to check for unsafe behaviours

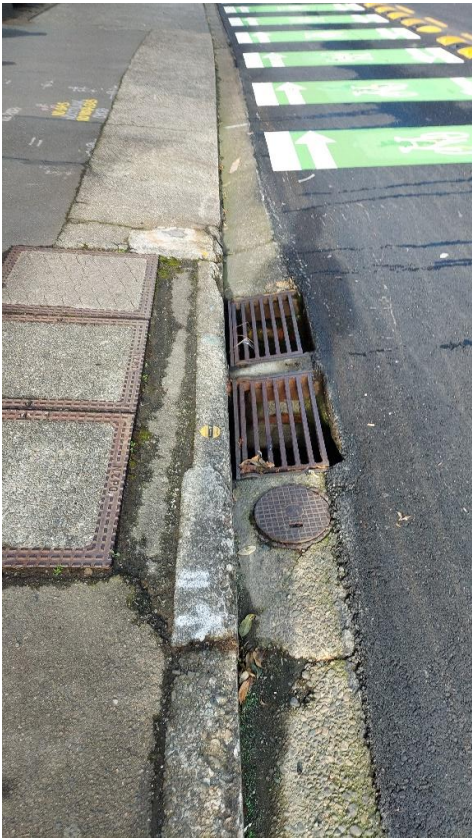
Figure 11. Sump grate at Guthrie Bowron

Serious

Outside Guthrie Bowron and the exit from Capital Gateway are sump grates that are not cycle friendly. This is a hazard for riders with narrow wheels on their bikes. While the grates are up against the kerb line, when cyclists pass each other or have interactions with pedestrians on the cycle path or illegally parked vehicles on the cycle path, cyclists can end up riding over these grates.

Probability Rating:		Severity Outcome Rating:	
Crashes are likely to be	Likely	Death or serious injury is	Serious
Design Team Response: Agree with SAT. These should be replaced.			
Safety Engineer:		Agree with SSAT and Designer response.	
Client Decision:		Sumps to be upgraded to cycle safe sump grates.	
Action Taken:		Sumps to be upgraded to cycle safe grates.

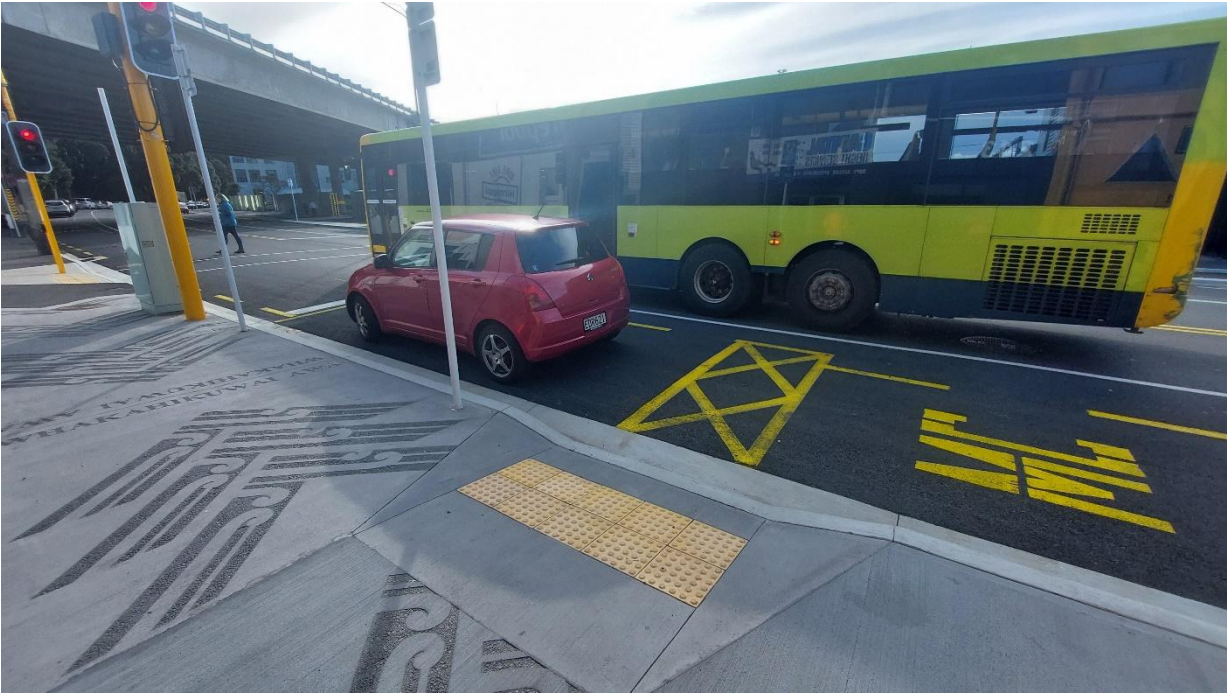
Figure 12. Tactile pavers at mobility carpark.

The mobility carpark near Hirepool has a pram crossing point with tactile pavers. This may indicate to a visually impaired person that this is a crossing point rather than the adjacent signalised crossing. It is unlikely that a mobility impaired person, who is also visually impaired, would be using this kerb drop by

themselves. While the likelihood of an event occurring is very unlikely, crossing the road at this point could lead to serious injuries particularly when drivers are accelerating to avoid stopping at the signals, something the SSAT observed when on site.

Probability Rating: Crashes are likely to be Very Unlikely		Severity Outcome Rating: Death or serious injury is Serious	
Design Team Response: We understand this is a correct interpretation of RTS14. The tactiles indicate a hazard, not a crossing.			
Safety Engineer:		Agree with SSAT. These tactiles should be removed.	
Client Decision:		Tactile pavers to be removed.	
Action Taken:		Tactile pavers to be removed.

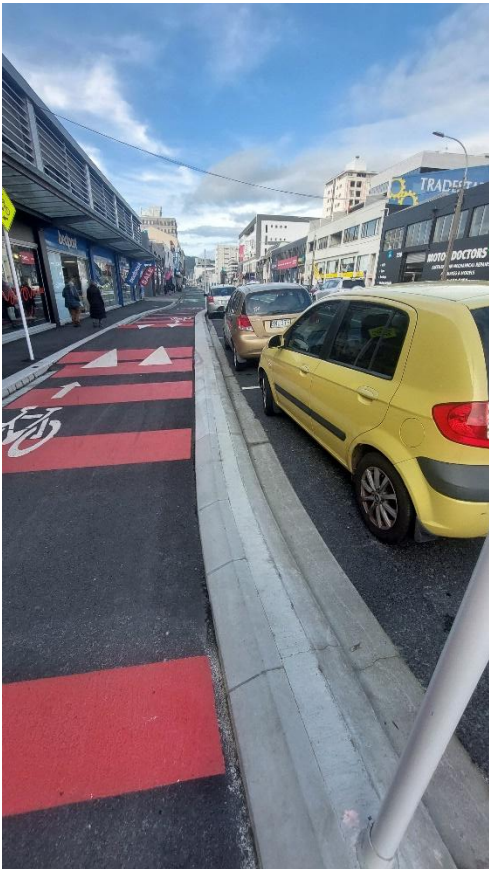
Figure 13. Kerb between parking and cycle lane.

Minor

The kerb between car parks and the cycle lane at iRide is narrower than throughout the rest of the project. When passengers open their door, they will be doing so into the cycle lane which will cause cyclists to move right, and into conflict with cyclists approaching from the other direction. In addition to this risk, the narrow island between the car park and the cycle lane is difficult to stand on and may result in people slipping off the kerb. In a previous SSA the audit team noted that islands between car parking and the cycle lane should be at least 800mm wide.

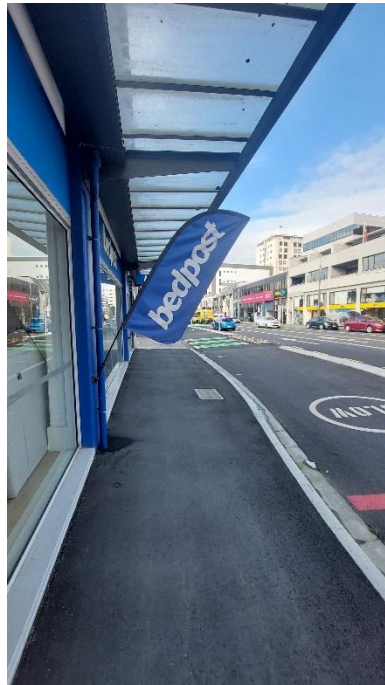
Figure 14. Flags hanging over footpath

Moderate

Bedpost has installed flags on the side of their building that obstruct the footpath past the store. Because of the way the flags are constructed, it is not possible to walk under most of the flag which effectively half's the width of the footpath. This could result in pedestrians stepping out onto the cycle path and being hit by a cyclist. As volumes on the path increase with the opening of Te Ara Tupua the likelihood of this crash type occurring will increase.

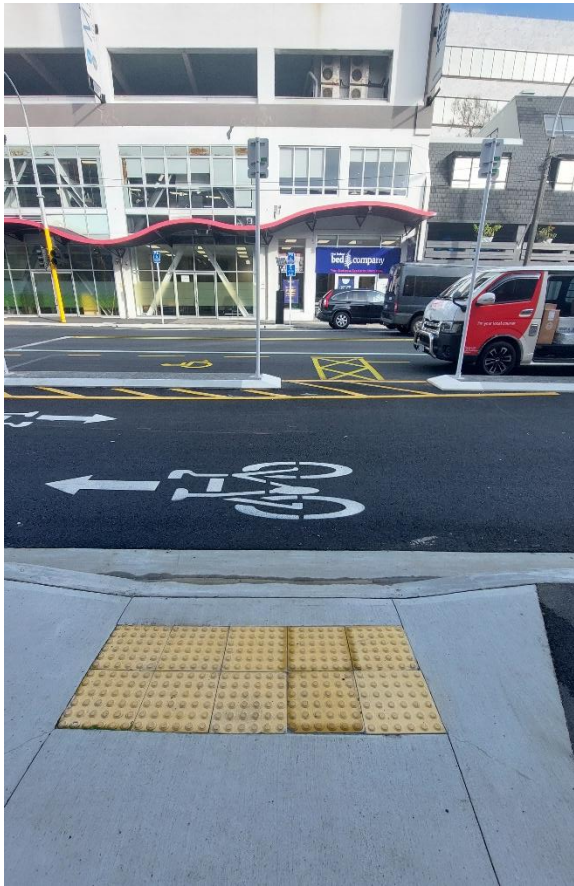
Figure 15. Mobility carpark access

The pram crossing for the mobility carpark at MacKenzie and Willis is not aligned with the mobility carpark. These should be aligned to allow a straight path to be taken across the cycleway to the carpark.

As previously noted, there are tactile pavers at the pram crossing which may be misleading to a visually impaired person.

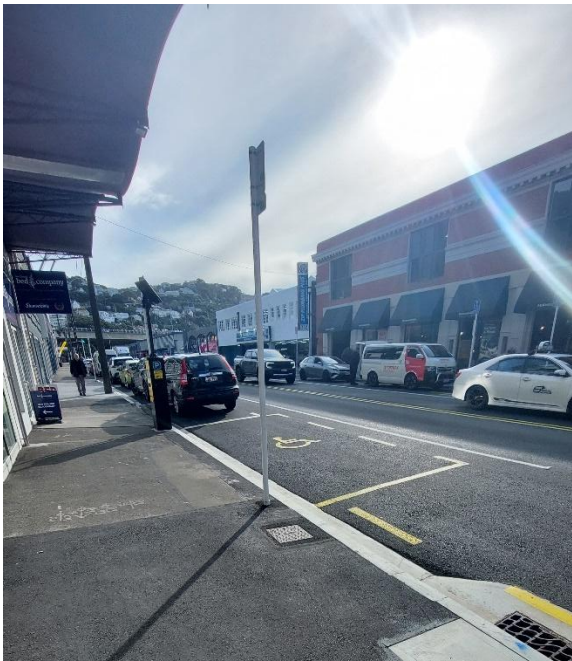
Figure 16. Mobility carpark at the Bed Company

Minor

The mobility carpark at the Bed Company does not have a pram crossing to allow access to the carpark.

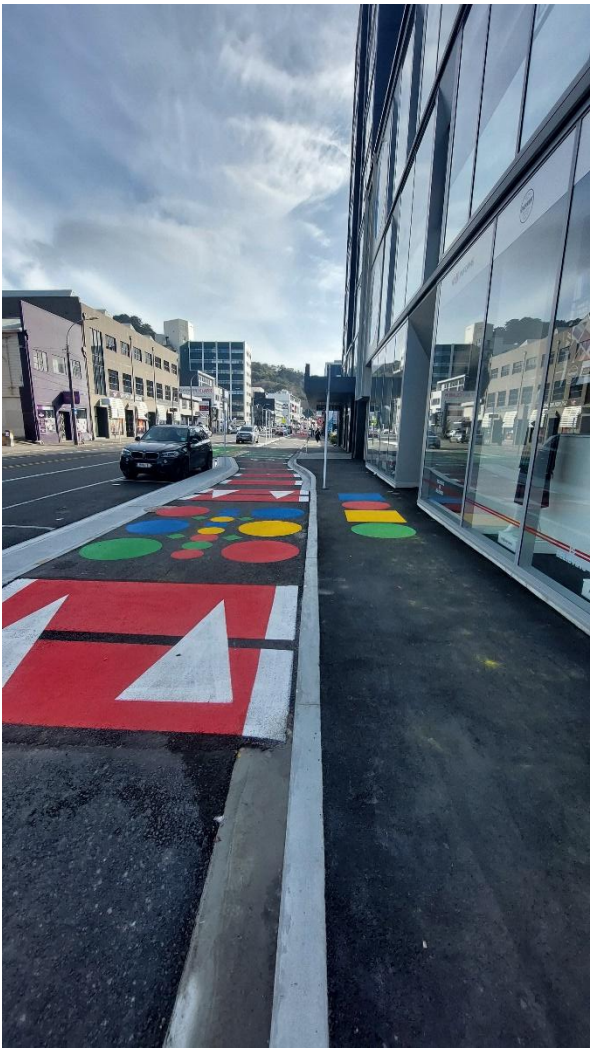
Figure 17. Pedestrian crossing of the cycle path

At formal crossings, cyclists are not always slowing or stopping to allow pedestrians to cross the cycle path. Consideration should be given to adding permanent warning signage on the cycle path for the zebra crossing with a subplate or separate sign for cyclists to give way to pedestrians.

In locations where crossings are informal, it may not be clear to pedestrians that they need to give way to cyclists. To avoid this, consideration should be given to making informal crossing points zebra crossings. This will provide the same type of treatment along the corridor and provide clarity on who gives way.

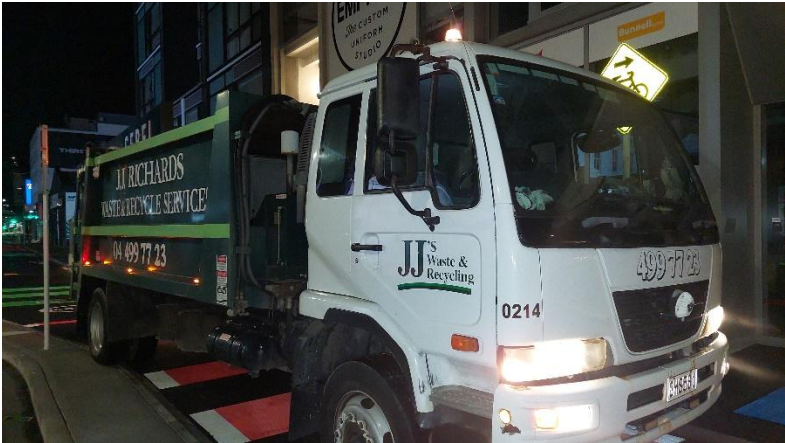
Figure 18. Rubbish truck parked in cycleway

Serious

Some vehicles, in particular rubbish trucks, are parking in the cycleway to access businesses located along the path. This puts cyclists either in conflict with vehicles using the road when they need to use the road to go around the parked vehicle or, results in a conflict between these trucks and cyclists on the path. These vehicles manoeuvre into, along and out of the cycle path in ways that aren't necessarily predictable, such as backing out of the cycleway. Over a number of years there have been several collisions between rubbish trucks and vulnerable road users as they have manoeuvred, that have resulted in the death or serious injury of the vulnerable road user. It is because of this the Severity Outcome rating is ranked as Fatal.

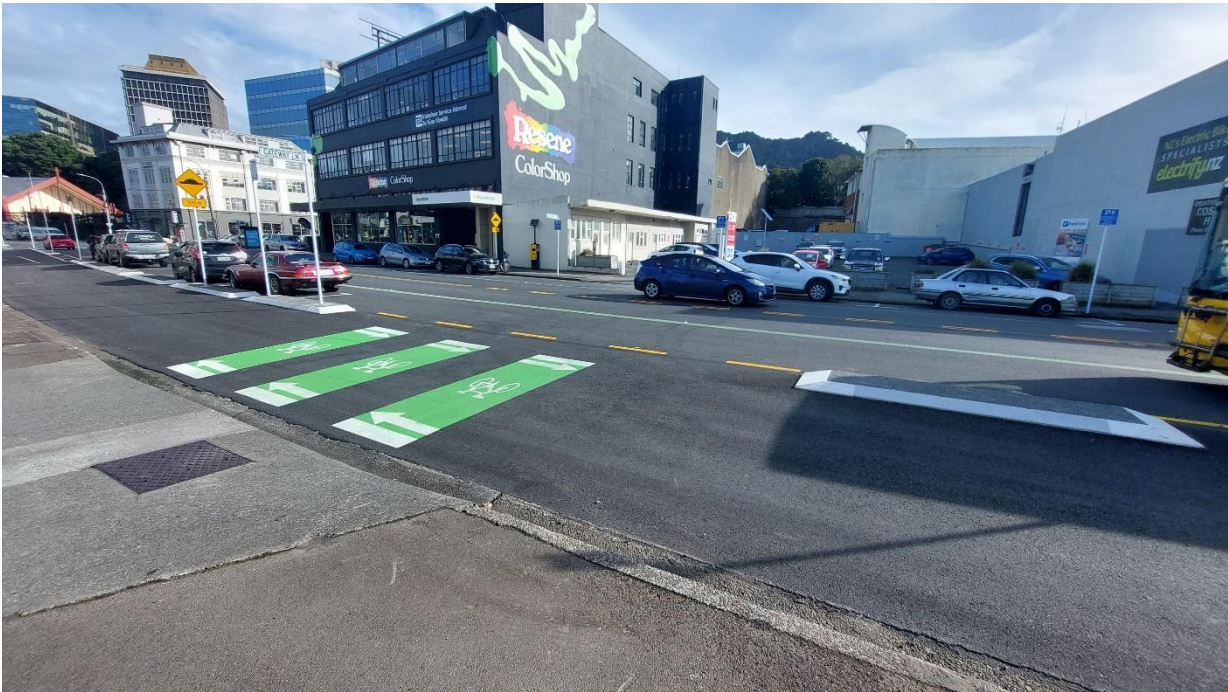
Figure 19. Entrance to Capital Gateway

Serious

Several of the accessways along the corridor do not have speed humps across the accessway. These include the entry to VTNZ and Capital Gateway. The SSAT observed a four-wheel drive turn right into Capital Gateway, at speed, and an approaching cyclist needed to take evasive action/ breaking to avoid a collision.

Probability Rating: Crashes are likely to be Very Likely	Severity Outcome Rating: Death or serious injury is Serious
<i>Design Team Response: Speed humps have been left off ‘intersection’ type crossovers like this one and applied to Driveway crossovers. Comfortable to add them based on the observations of the SAT, but recommend they be left off the exit driveways for Capital gateway.</i>	
<i>Safety Engineer:</i>	<i>Agree with SSAT and Designer response. Add the Capital Gateway exit driveway to the Monitoring Plan.</i>
<i>Client Decision:</i>	Agree with the Safety Engineer.
<i>Action Taken:</i>	<i>Item to be added to the monitoring plan.</i>

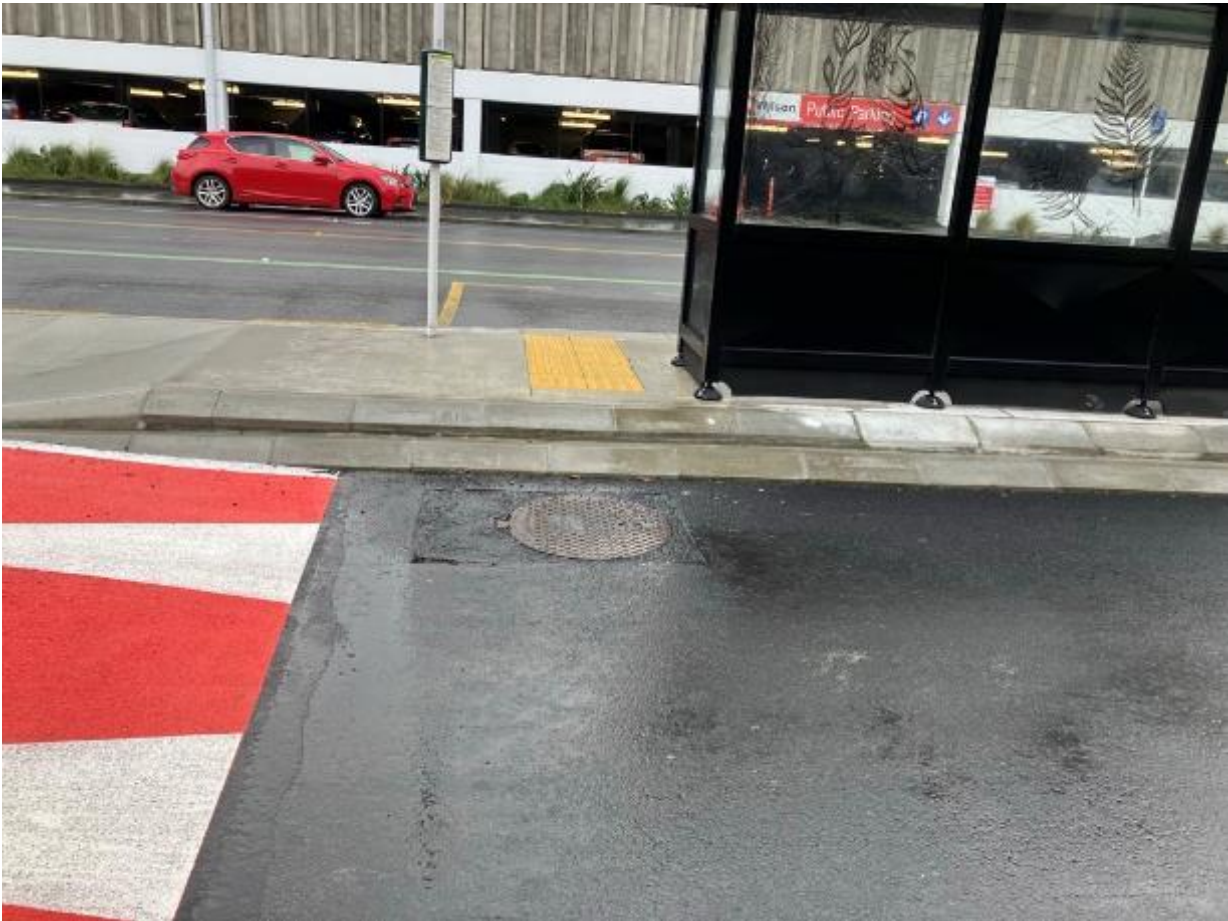
Figure 20. Drop onto the cycle path

Moderate

Several of the bus stop islands are constructed with two mountable kerbs on top of each other. This creates a relatively large height difference between the top of the island and the cycle path. As the islands are relatively narrow and there can be a number of people getting on and off the bus at the same time, there is a risk that someone could fall off the island onto the cycle path.

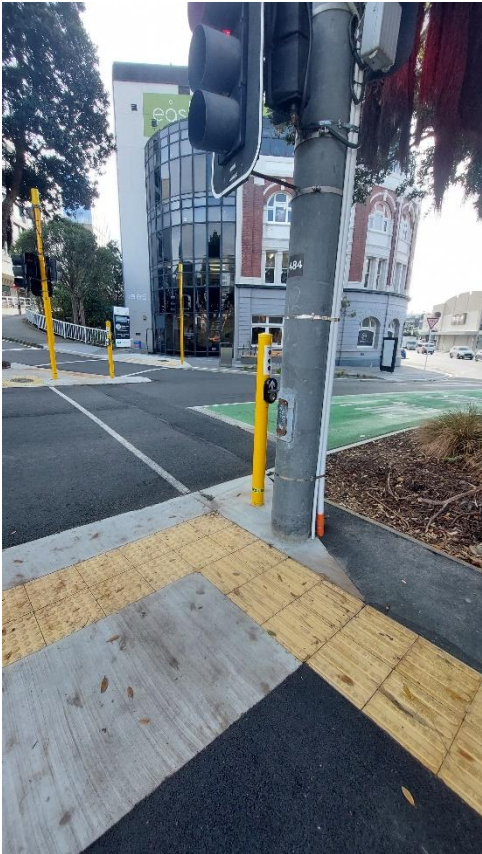
Figure 21. Call button behind signal pole.

The signal call button for pedestrians crossing the bus lane at Mulgrave Street is behind the traffic signal pole. This may make it difficult for a visually impaired person to locate the call button.
