# Preliminary Slope Hazard Assessment

## Shelly Bay Road Upgrades

Prepared for  
Wellington City Council

Prepared by  
Tonkin & Taylor Ltd

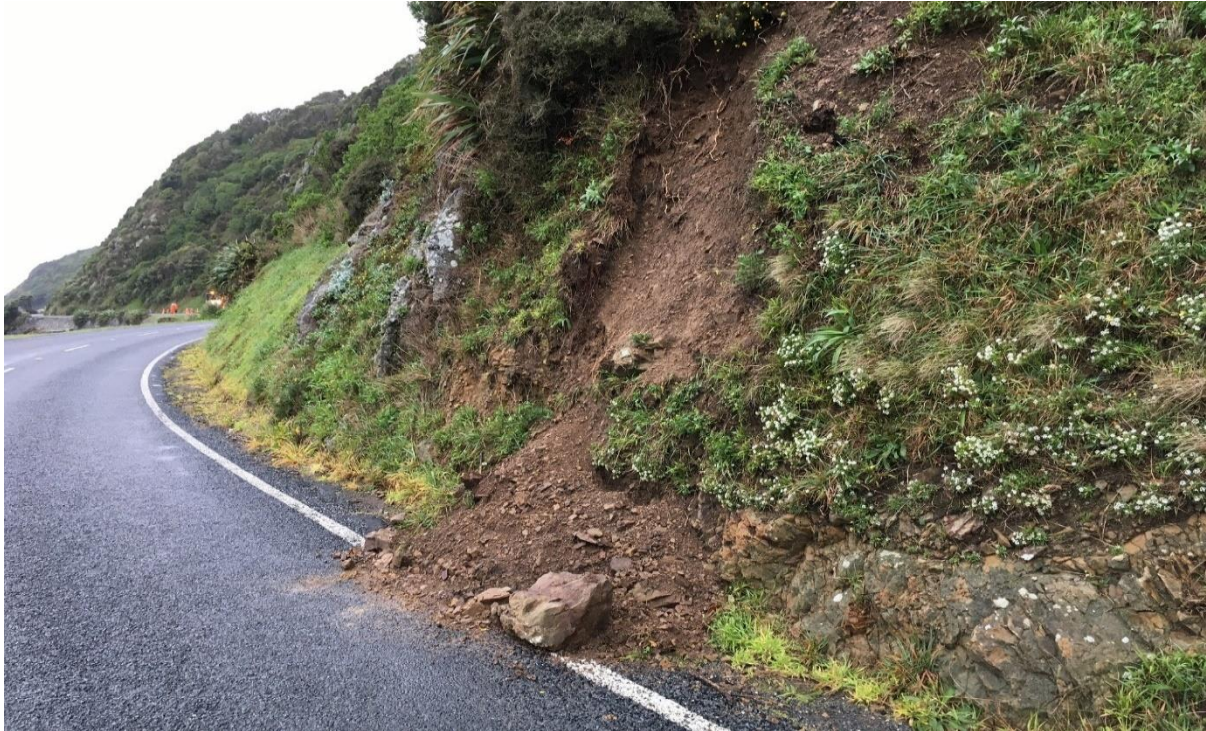
Such small-scale slope instability is expected to occur occasionally under normal rainfall conditions (<1 to 5-year return interval (0.2 to 1.0 annual probability of occurrence)).

Debris (in the order of  $1.0 \text{ m}^3$  or less) may accumulate locally on the road shoulder and part of a single lane requiring removal, but the road will remain usable. Some or all the debris may be captured by vegetation and not inundate the shoulder or road.

Several small-scale landslides were observed during the T+T site walkover, as shown in **Figure 5**.

*Figure 5: Shallow slide of loose surficial soils and rock observed on 19 June 2020. Approximately  $1 \text{ m}^3$  debris inundating road shoulder*

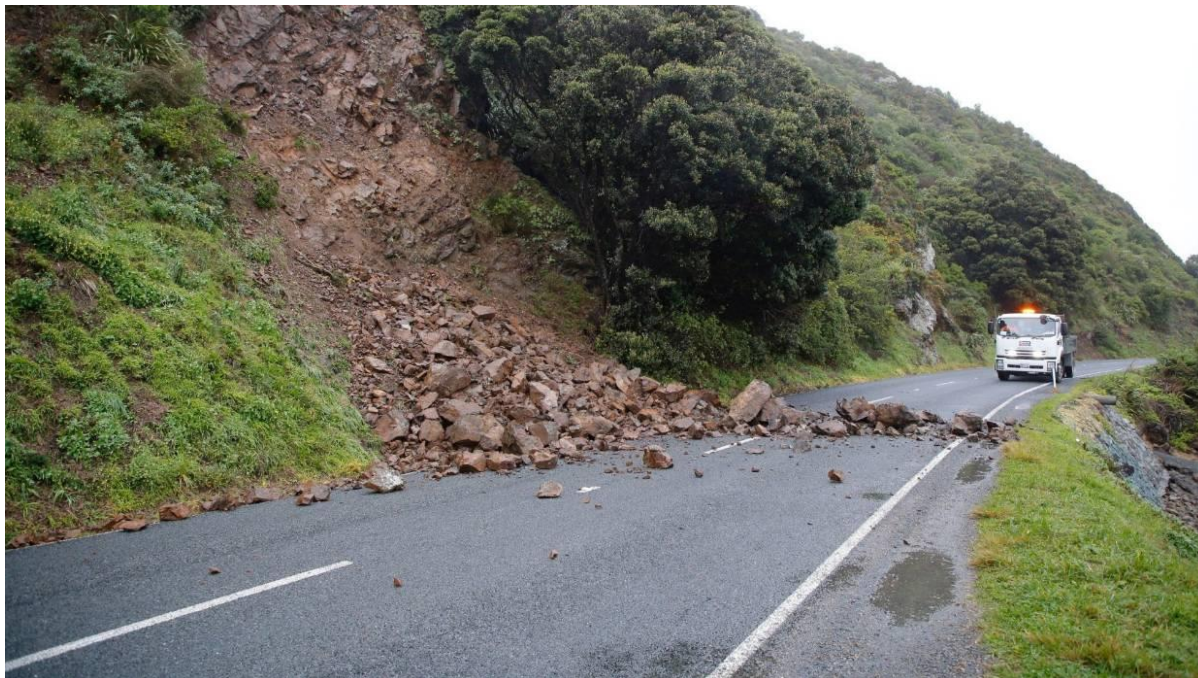
Such intermediate-scale slope instability is expected to occur under normal to adverse conditions (2 to 100-year return interval (0.01 to 0.5 annual probability of occurrence)) due to heavy rainfall and/or earthquake.

Figure 6: Rockmass slide at CH 1100 m on 19 June 2020 blocking the road (photograph sourced from [stuff.co.nz](https://stuff.co.nz))
