Thorndon connections cycleway audit - safety and accessibility

90% design audit

Paneke Pōneke
Bike network plan

January 2023

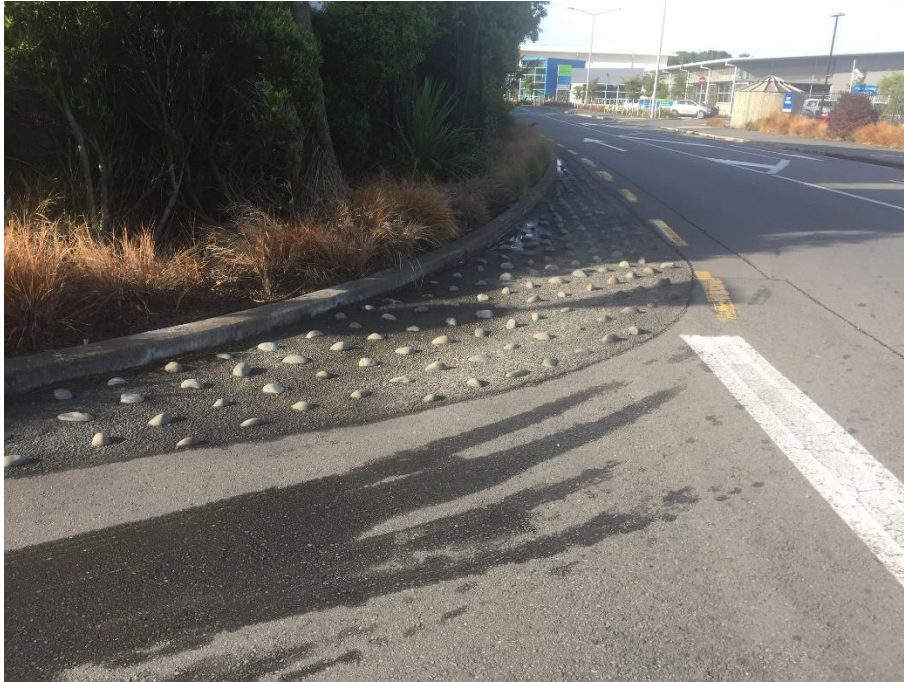
Figure 4-1: River stones on Sisson Drive

The safety issue is the potential high-speed turns between Hill Street and Tinakori Road which could lead to conflict with pedestrians. The proposed changes to this approach are unlikely to slow vehicles.

The risk factors include: the width of Hill Street – i.e. increased pedestrian crossing distance; and the side road angle, which allows for faster right turns in and left turns out of Hill Street.

Crashes are expected to be very unlikely (one every 7+ years), but those that do occur would likely result in serious injury, due to the vehicle speeds involved.

Probability of crash occurring		Unlikely
Expected crash severity		Serious injury
Primary treatment recommendations:		
4.1.1	<p>Rather than a painted edge line, the area could be filled with river stones set in concrete (similar to the Northlands Mall approach to Sisson Drive in Christchurch – see Figure 4-1). This would be traversable by heavy trucks, but avoided by car drivers.</p> <p>Consider whether the area of the river stone island can be increased above that of the painted edge line currently proposed (based on light vehicle tracking).</p> <p>Ensure a flat pedestrian path through the stony area is included.</p>	
Supporting treatment recommendations:		
4.1.2	N/A

Responses:	
Designer	Agree that the Hill St pedestrian crossing distance is longer than desired and that a traversable kerb buildout could be of use to slow left turning vehicles. However, the use of riverstone material is not in keeping with a transitional approach as this feature cannot be easily changed once installed. The use of low rubber speed humps for buildout would be preferred.
Safety Engineer	Agree with Designer - preference for low rubber speed humps in buildout area.
Proposed action	Agree with above low rubber speed hump treatment more applicable and raised pedestrian crossing and reduced speed limits will reduce risk here also.
Client decision	Agree with Proposed Action
Action taken	Add low rubber speed hump to design.

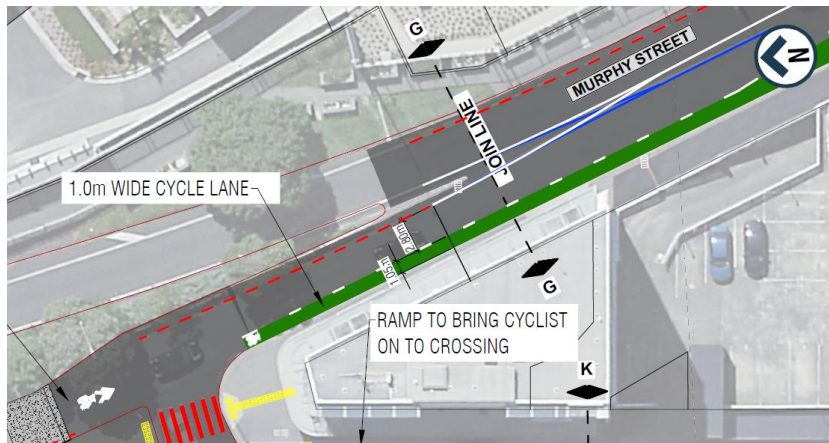
Figure 4-3: narrow cycle lane on Murphy Street

The safety issue is the cycle lane on Murphy Street after the pedestrian crossing (see Figure 4-3) is too narrow.

The crash type expected is cyclist vs motorist.

The risk factors include cyclists and motorists having a false sense of security thinking they each have their own spaces when there is not enough width for this form of provision and the carriageway constraints between the solid median island and the footpath kerb.

The relevant standards are outlined in the CNG section on [cycle lanes](#), which specifies an absolute minimum cycle lane width of 1.4 m (adjacent to a kerb, in low speed environments, for short sections).
