# Hutt Road Sustainable Transport Study

**Final Report**

Opus International Consultants Ltd Wellington Civil

17/12/2015

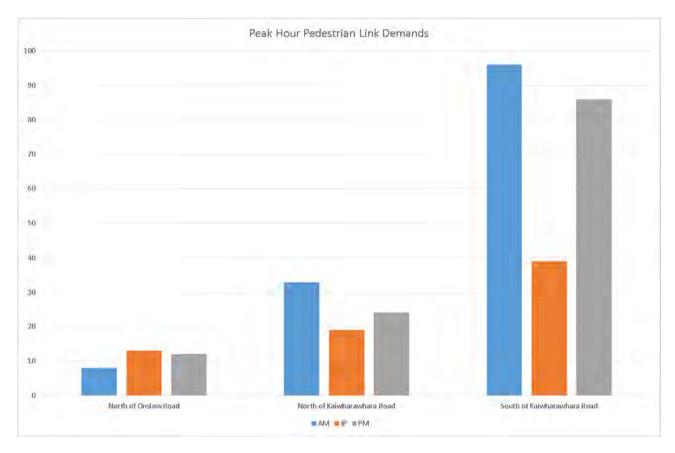
Figure 2: Pedestrian Link Demands (2015 count data)

The two-way peak hour pedestrian link demands are shown in Figure 2 below.

There is a low demand on Hutt Road north of Kaiwharawhara Road, the demand increases by around 200% south of Kaiwharawhara Road.

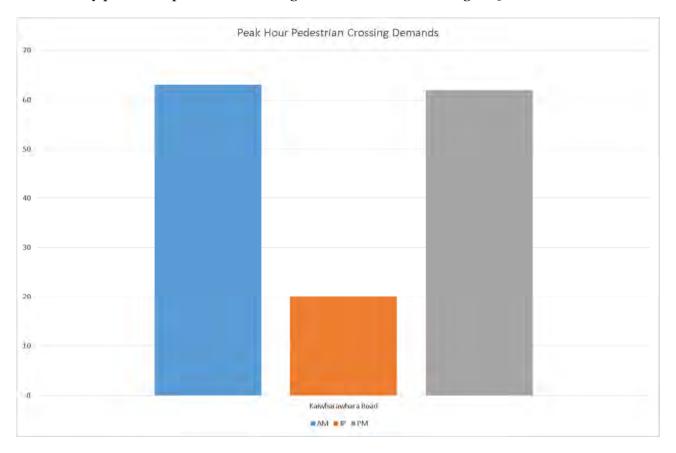
Figure 3: Peak Hour Pedestrian Crossing Demands (2015 count data)

The two-way peak hour pedestrian crossing demands are shown in Figure 3 below.

The crossing of Hutt Road at Kaiwharawhara Road is a key link for the residential catchment west of Hutt Road in this area.

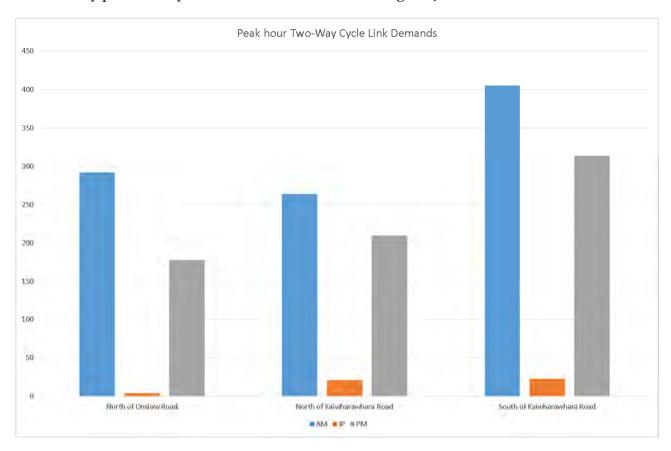
Figure 4: Cycle Link Demands (2015 count data)

The two-way peak hour cycle link demands are shown in Figure 4 below.

The cycle link demand is consistently high in the commuter peaks and low at other times. As expected the demands increase from north to south as more catchments connect with the route, the most significant change is south of Kaiwharawhara Road which is reflected in the turning demands below.

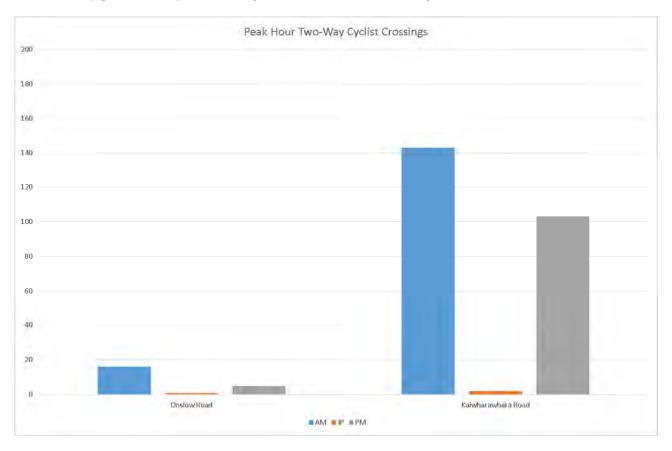
Figure 5: Peak Hour Cyclist Crossing Demands (2015 count data)

The two-way peak hour cycle crossing demands are shown in Figure 5 below.

The numbers above also include cyclists turning into and out of Kaiwharawhara Road from Hutt Road from the road as well as crossing from the shared path.

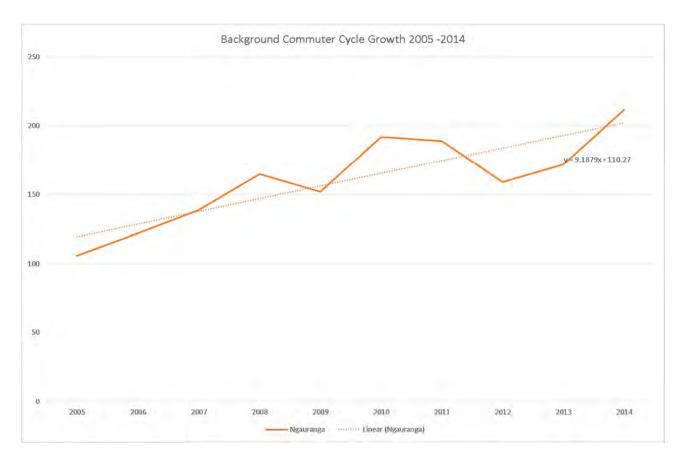
Figure 6: Background Peak Hour Commuter Cycle Growth 2005-2014 (sourced from TDG annual surveys)

The background growth in commuter cyclists over the past 10 years is shown in Figure 6 below (counted at Ngauranga Gorge). The trend lines indicate that growth is increasing at an average per annum rate of 8.3%.

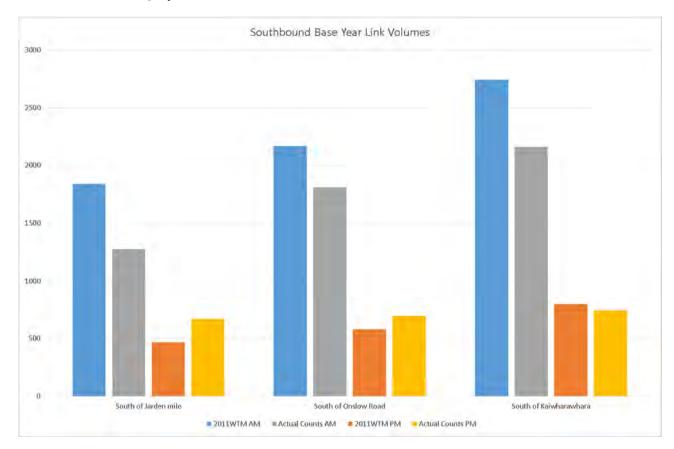
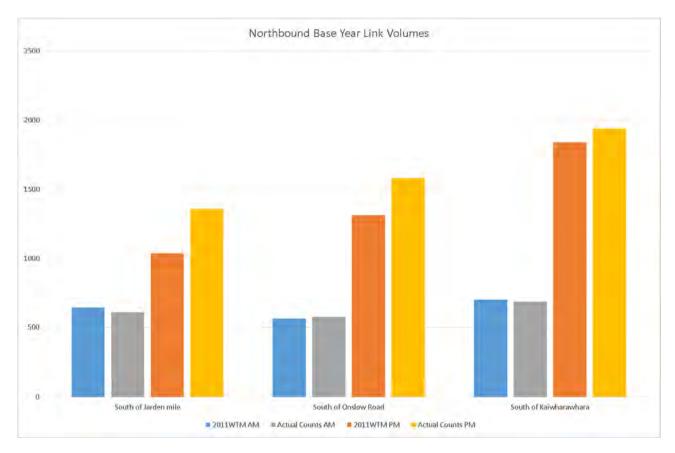
Figure 7 and Figure 8 show the following:

- Reasonable correlation between the WTM and actual counts in the off peak direction;
- An over-prediction of southbound AM peak demand and an under-prediction of northbound PM peak demand by the WTM compared with actual counts; and
- Demand over the threshold for a dual lane link (1600-1800vph) for southbound traffic and between Aotea Quay and Onslow Road for northbound traffic.

Figure 7: Southbound Base Year Link Volumes Comparison

Figure 8: Northbound Base Year Link Volumes Comparison

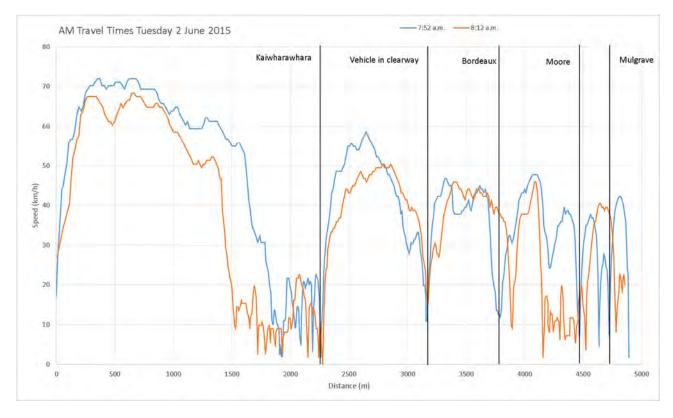
Figure 9: Southbound AM Travel Times

The overall travel times for the two journeys are 12 minutes, 43 seconds and 15 minutes, 15 seconds respectively. This equates to average travel speeds over the 4.9km section of 24 and 19 km/h respectively.

It should be noted that the sample size here is not enough to be representative, however, it correlates well with typical conditions expected along the corridor and the bus travel times presented in section 7.1.3 below.

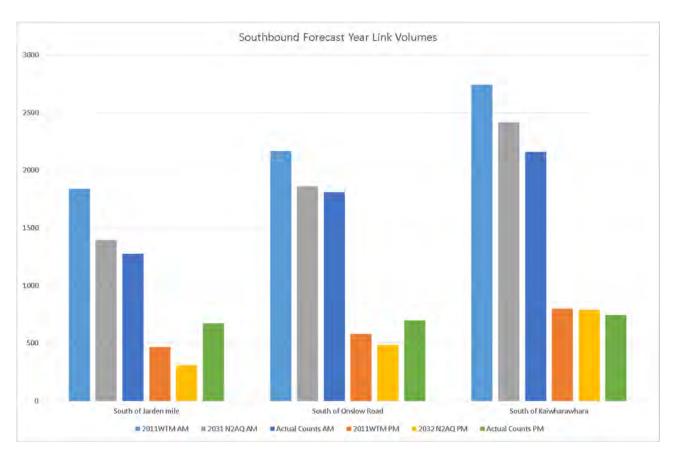
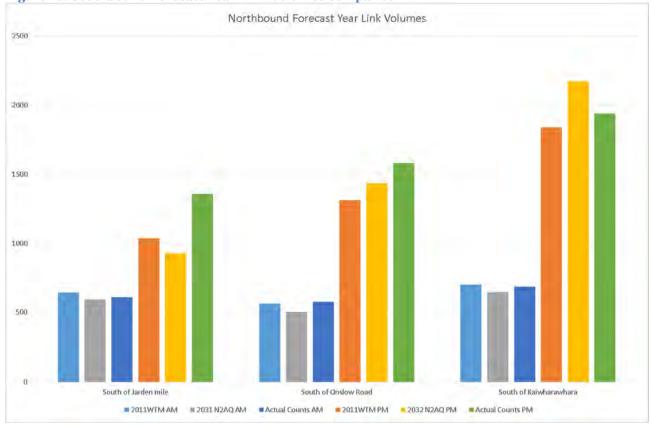
- In the southbound direction in the AM peak the 2031 scenario results in reduced flows along the entire corridor when compared with the 2011 base model. Between Jarden Mile and Aotea Quay the 2031 scenario shows good correlation with the existing actual counts.
- In the northbound direction in the PM peak the 2031 scenario correlates well with both the actual counts and 2011 base model flows between Onslow Road and Aotea Quay. North of Onslow Road both modelled flows are significantly lower than the actual counts.
- Demand greater than the threshold for a single lane link (1600-1800vph) north of Aotea Quay for southbound traffic and between Aotea Quay and Onslow Road for northbound traffic.

In summary, the 2031 scenario will result in little change in traffic flows when compared with the actual counts.

Figure 10: Southbound Forecast Year Link Volumes Comparison

Figure 11: Northbound Forecast Year Link Volumes Comparison

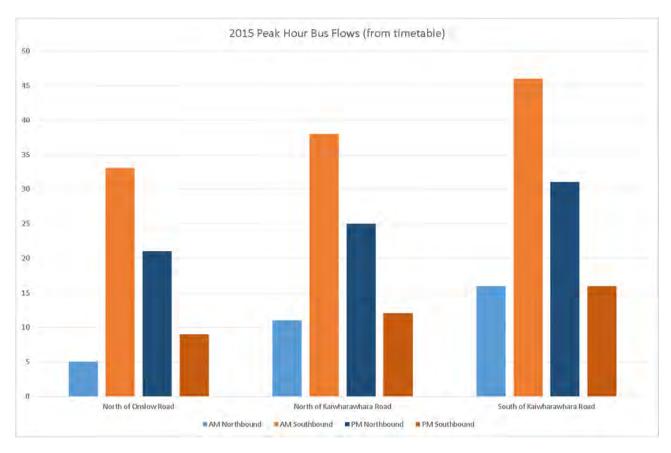
Figure 14: Peak Hour Bus Flows

The peak hour bus flows at the key intersections are shown in Appendix F and Figure 14 below.

In the AM peak hour there are 46 buses travelling southbound south of Kaiwharawhara Road and 16 buses travelling northbound. In the PM peak hour there are 16 buses travelling southbound south of Kaiwharawhara Road and 31 buses travelling northbound.

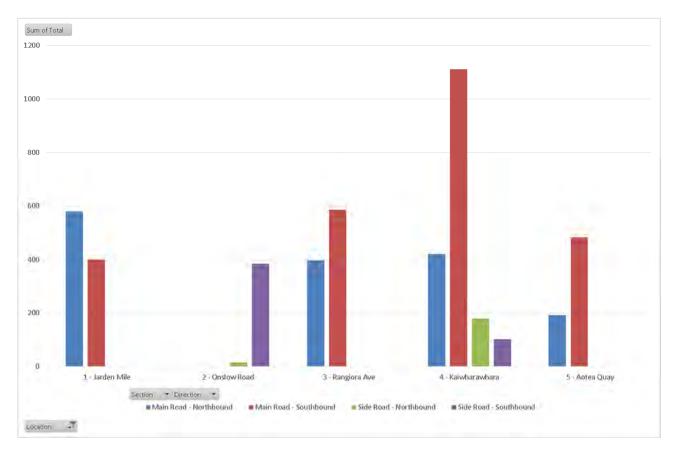
Figure 15: Bus Stop Boarding Data (weekdays in March 2013)

The following trends can be observed:

- In the southbound direction, boarding demands are relatively consistent with a notable peak at Kaiwharawhara Road.
- The boarding demand on Kaiwharawhara Road is relatively low, with a strong demand southbound on Onslow Road.

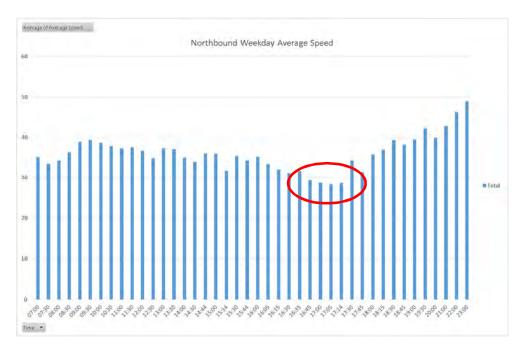
Figure 16: Northbound Weekday Average Bus Speed

The following two graphs show the average speeds over the Hutt Road / Thorndon Quay corridor based on the No. 54 route (Wellington to Churton Park).

In the northbound direction the slowest speeds occur in the PM peak (as expected).

- On the main route heading northbound there does not appear to be any significant pinch points. The average speed in the PM peak period is around 5km/h slower than average speeds throughout the rest of the day.
- In the AM peak delays of around one minute are experienced around the Kaiwharawhara Road intersection for routes travelling both through and left.
- In the PM peak delays of around one minute are incurred turning left into Onslow Road, this may be caused by turning traffic getting caught in the queued through traffic.

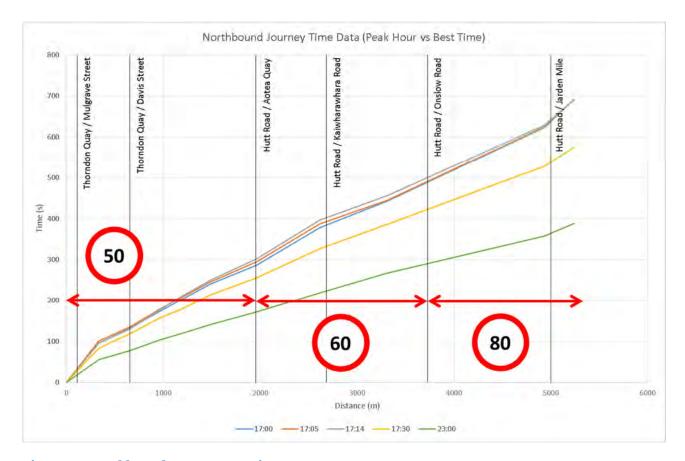
Figure 20: Northbound Bus Journey Time Data

The following two graphs show the average journey times against distance for four peak hour period runs along with an evening run along the entire Hutt Road / Thorndon Quay corridor.

In the northbound direction the slowest section of the journey is the first one which is leaving the bus-terminus and joining Thorndon Quay. This is expected to be due to high boarding numbers at the bus terminus, congestion associated with other buses and intersection delays at the Mulgrave Street intersection.

The remainder of the journey is at a relatively constant speed with noticeable slow points around the Kaiwharawhara Road intersection and the Jarden Mile Intersection.

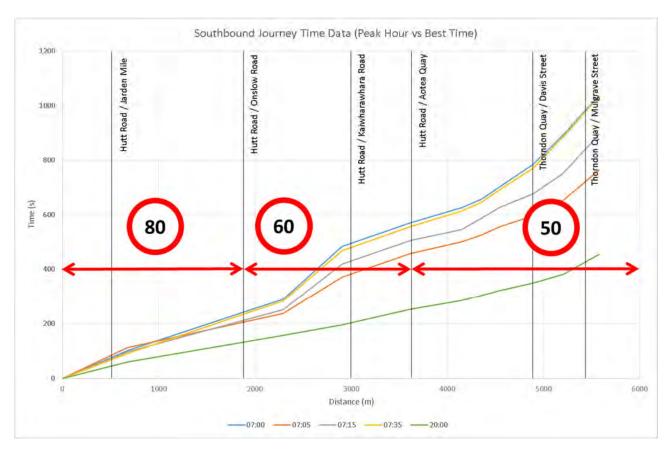
Figure 21: Southbound Bus Journey Time Data

In the southbound direction the slowest section of the journey is around the Kaiwharawhara Road intersection (approximately two and a half minutes additional delay when comparing the average worst peak trip against the average best trip). The Thorndon Quay section of the route is also noticeably slower than the remainder of the route.

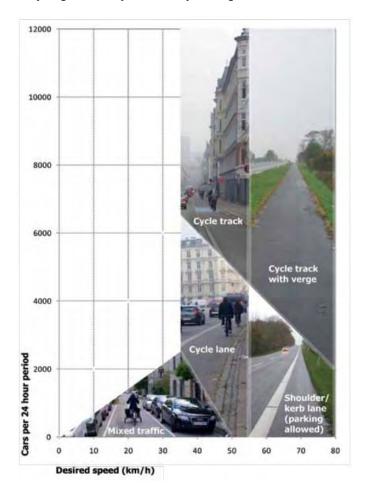
Figure 24: Cycle Facilities for Different Traffic Conditions (Collection of Cycle Concepts, 2012,)

Figure 24 below shows some guidance on facility types for different traffic conditions (speed versus volumes) prepared by the Cycling Embassy of Denmark.

The traffic volumes on Hutt Road conditions are off the chart shown below which indicates that a fully separated cycle facility is required.

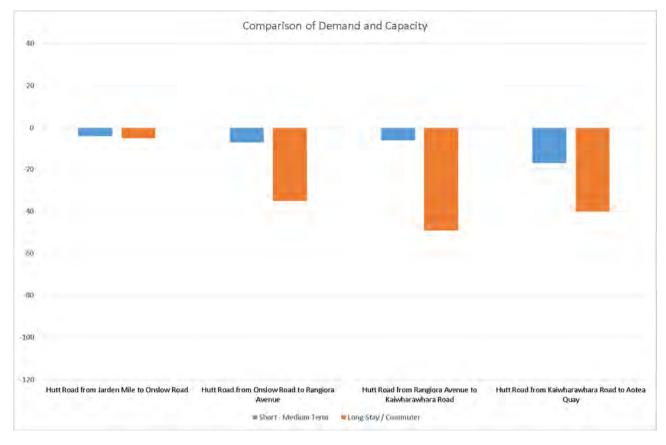
Figure 28: Comparison of Demand and Capacity for Option A

Figure 28 compares Table 32 above with Table 33 below (worst case demand for the different parking duration types against the capacity provided for that type). It shows a shortfall in long term / commuter parking capacity along the entire corridor with significant shortfalls (> 35 parks) on Hutt Road between Onslow Road and Aotea Quay.

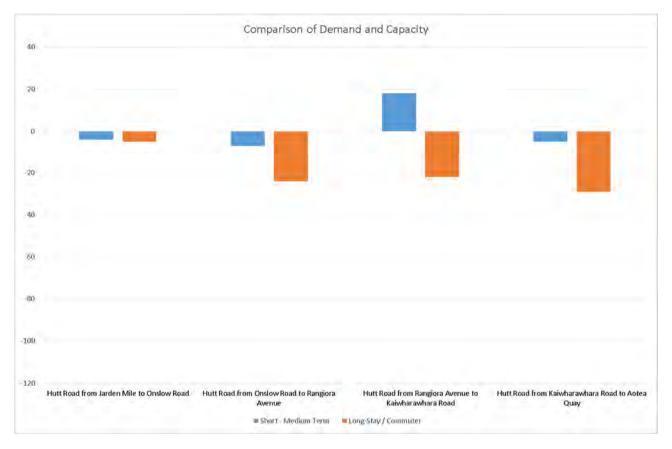
Figure 29: Comparison of Demand and Capacity for Option B

Figure 29 compares Table 32 above with Table 34 below (worst case demand for the different parking duration types against the capacity provided for that type). It shows:

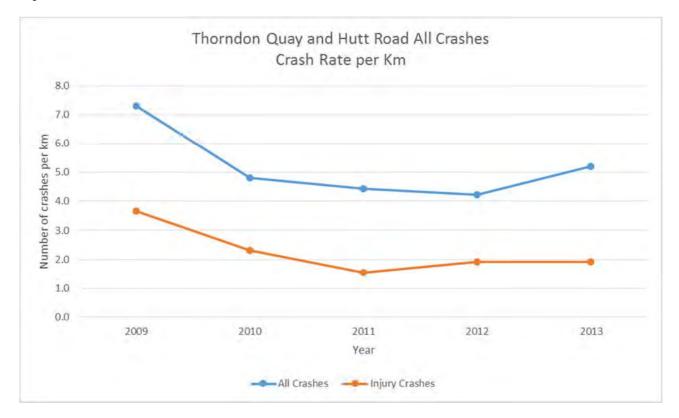
Figure 2: Corridor Summary: Crash Rate per km

The crash rate for all crashes as shown in Figure 2 below does not take into account traffic volumes along the route. There are only limited traffic counts along the corridor and the volumes vary significantly along the corridor. Analysis of the traffic counts at the Ngauranga Interchange shows there has been no growth in traffic volumes over the five year period so the crash rate shown is representative of the trends.

Figure 2 above shows the overall crash rate for all reported crashes including non-injury crashes. The overall crash rate declined significantly between 2009 and 2010 after which the crash rate has stayed relatively static at between four and five crashes per km, before then experiencing a slight increase in 2013. There has been a steady decrease in the injury crash rate from 2009 to 2011, with a slight increase in the crash rate in 2012 but has stayed below two crashes per km. The overall crash trend is decreasing throughout the five year period.

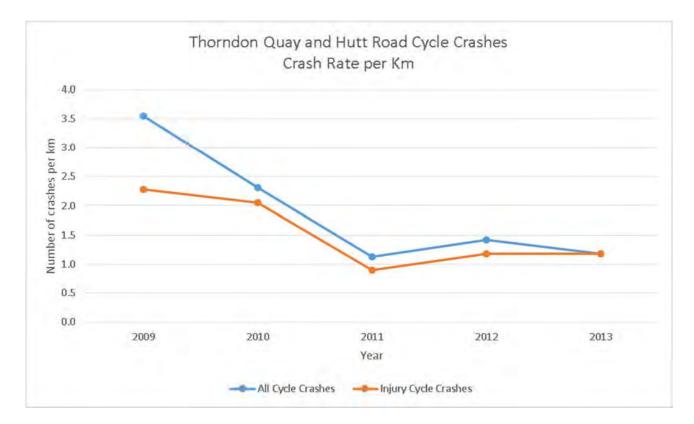
Figure 3: Corridor Summary: Cycle Crash Rate per km

Figure 3 above shows the crash rates for cycle crashes. The crash rates per km have been adjusted proportionally using the annual AM peak cycle surveys to account for the growth in cycle demands over the five year period. Indicative assessments of the corridor against the predicted crash frequency from the Economic Evaluation Model (EEM) show that the crash rate is significantly higher than would typically be expected.

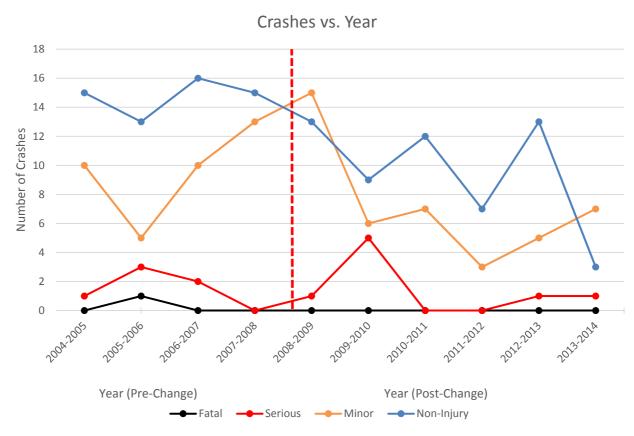
Figure 6: Hutt Road: Injury and Non-Injury crashes per year

Figure 6 shows all injury and non-injury causing crashes before and after the speed limit reduction, with the red dashed line denoting the period between the changes.

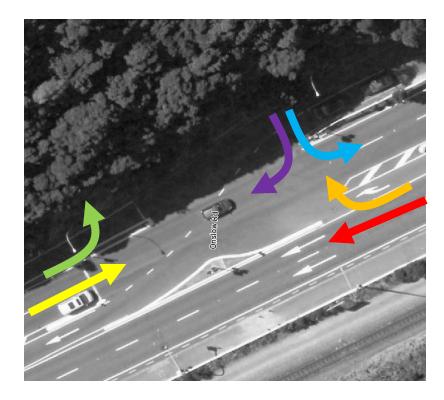
#### Onslow Road / Hutt Road

I hour peak based on peak period for all movements

Movement	AM 1 hour	AM 2 hour	IP 1 hour	IP 2 hour	PM 1 hour	PM 2 hour
	7	14	4	10	1	2
	0	1	0	0	0	1
	1	3	9	14	11	18
	0	0	1	1	0	1
	0	0	0	0	0	0
	2	6	0	0	0	0
Total	10	24	14	25	12	22

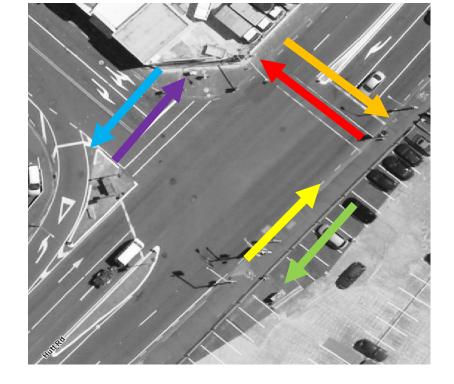
Kaiwharawhara Road / Hutt Road

I hour peak based on peak period for all movements Yellow includes red movements, green excludes orange movements

Movement	AM 1 hour	AM 2 hour	IP 1 hour	IP 2 hour	PM 1 hour	PM 2 hour
	5	19	7	9	48	70
	58	84	13	18	14	24
	5	15	11	13	61	82
	33	50	15	19	11	18
	1	5	5	5	2	5
	4	14	5	8	3	11
Total	106	187	56	72	139	210

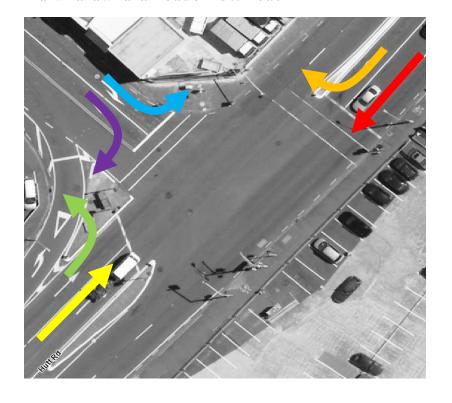
# Kaiwharawhara Road / Hutt Road

1 hour peak based on peak period for all movements

Movement	AM 1 hour	AM 2 hour	IP 1 hour	IP 2 hour	PM 1 hour	PM 2 hour
	240	409	7	12	20	42
	0	0	0	0	1	3
	23	34	14	15	188	336
	5	5	0	0	101	172
	1	3	0	0	1	2
	137	218	2	5	5	7
Total	406	669	23	32	316	562

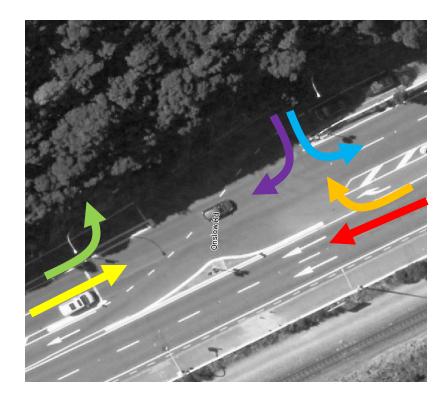
#### Onslow Road / Hutt Road

# 1 hour peak based on peak period for all movements

Movement	AM 1 hour	HCV%	IP 1 hour	HCV%	PM 1 hour	HCV%
	1218	9%	509	11%	538	4%
	58	9%	58	3%	131	0%
	432	8%	542	14%	1306	3%
	83	14%	128	3%	275	1%
	177	2%	55	5%	50	0%
	565	1%	127	4%	145	2%
Total	2533		1419		2445

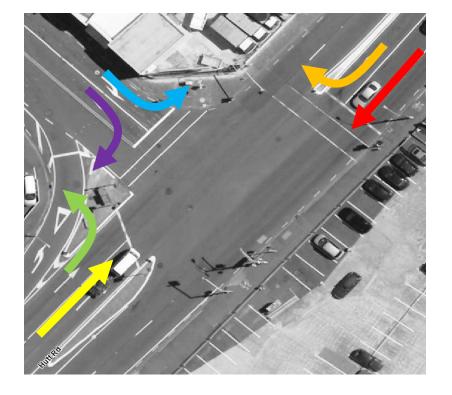
# Kaiwharawhara Road / Hutt Road

Movement	AM 1 hour	HCV%	IP 1 hour	HCV%	PM 1 hour	HCV%
	1659	3%	511	4%	490	2%
	148	9%	92	1%	204	1%
	429	7%	566	4%	1405	1%
	237	3%	309	2%	776	0%
	145	1%	143	3%	174	1%
	1033	2%	299	2%	335	0%
Total	3651		1920		3384

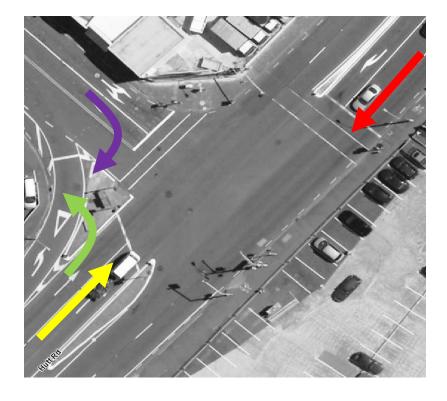
# Kaiwharawhara Road / Hutt Road

Movement	AM 1 hour	AM 2 hour	IP 1 hour	IP 2 hour	PM 1 hour	PM 2 hour
	38	62	9	18	12	21
	11	18	7	14	27	45
	5	10	1	2	6	12
	8	15	1	2	4	8
NB	16	28	8	16	33	57
SB	46	77	10	20	16	29

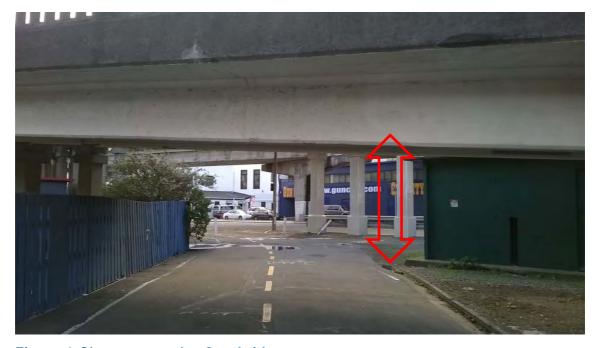
Figure 1 Clearance under Overbridge

Clearance to the underside of the bridge on the western side of the path was approximated to be 2m. Austroads AGRD Part 6a: Pedestrian and Cyclist Paths recommends a vertical clearance of 2.2m for cyclists.

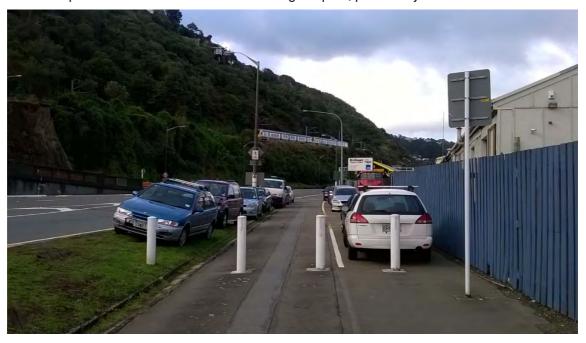
It is noted that even though many businesses have their own parking, presently vehicles still choose to park for short durations on the existing footpath, particularly at the childcare centre.

Consider making some of the new on street parking short term at key locations to provide a safer alternative to the current practice of short term parking on the footpath.

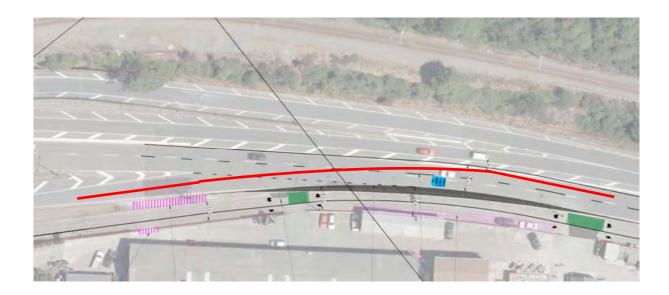
Single occupancy vehicles turning onto Aotea Quay may have to make sudden lane changes across the proposed T2 lane.

Review the appropriateness of the T2 lane east of the Aotea Off-ramp.

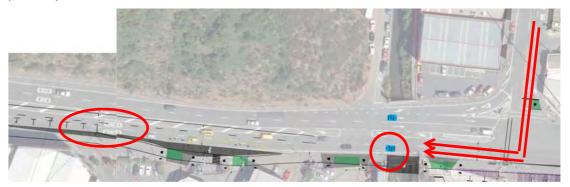
The kerbside lane of the existing double right turn from Kaiwharawhara road leads directly into the T2 lane. This may result in unfamiliar drivers making sudden merge manoeuvres in close proximity to an intersection.

Review T2 lane markings and signs in vicinity of the intersection. Consider installing temporary advanced warning of the T2 lane on Kaiwharawhara Road.

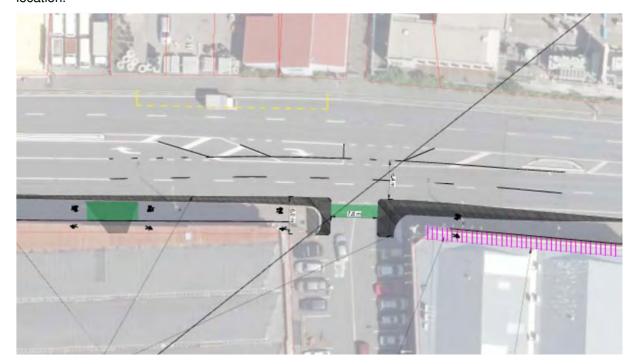
The green surfacing across Westminster Street encourages cyclist priority through the intersection. It is not clear from the design whether cyclists are intended to have priority at this location.

Check swept paths for turning vehicles.

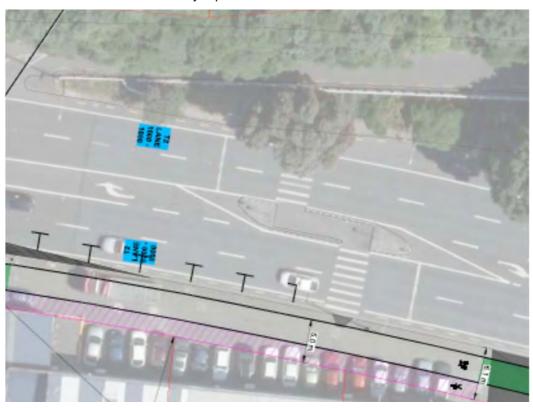
As all the pedestrian crossings in the rest of the study area are being signalised, consideration should be given to signalise the pedestrian crossing at Rangiora Avenue. The existing crossing is located in an area with a 60km/h speed limit, and a higher speed environment. The existing crossing crosses multiple lanes in the same direction and queued vehicles can obscure visibility, as was noted in the crash history report.

Consider expanding the project scope to include signalisation/conversion to a vehicle priority refuge type crossing, of the staggered pedestrian crossing near Rangiora Avenue.

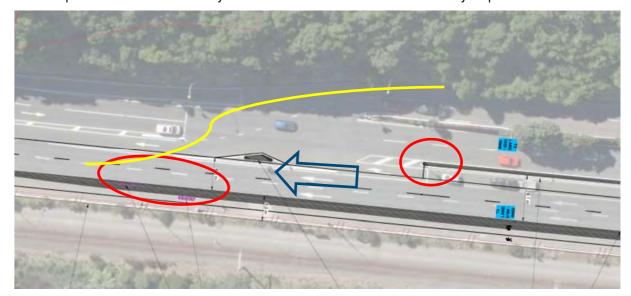
Due to the seagull signal, when cyclists turn right out of Onslow Road they are expected to execute a right hand merge with southbound through vehicles. In addition, there are no crossing facilities provided for northbound cyclists to access Onslow Road from the cycle path.

Consider improving cycle access between Onslow Road and the cycle path.

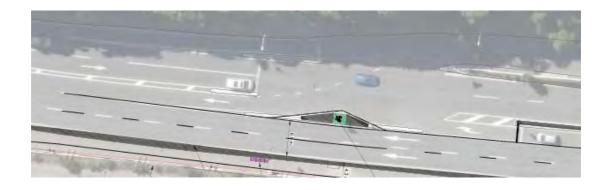
Design updated to provide cycle refuge in island as shown below.

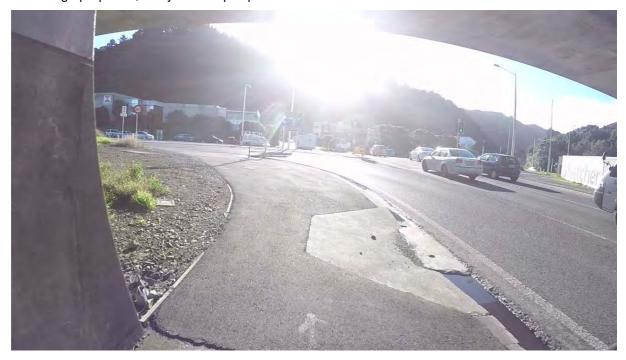
No change proposed, as cyclist ramp is provided.

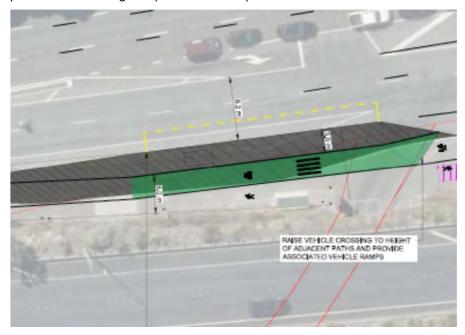
At some locations, such as adjacent to the Ngauranga signals, below, it appears that the pedestrian crossing point to access the pedestrian waiting areas are at grade, ie no kerbs to get on/off. This differs slightly from the above comments where there are kerbs for pedestrians and will make the crossing points clearer. Where there is no kerb, such as this location, it is considered that pedestrians may not use them as there is no physical barrier (kerb) to encourage them to cross at the crossing point. Again, if zebra lines are used here, then full pedestrian crossing components are required.

Consider the appropriateness of pedestrian crossings across the cycle path and appropriateness of forming a legal crossing point.

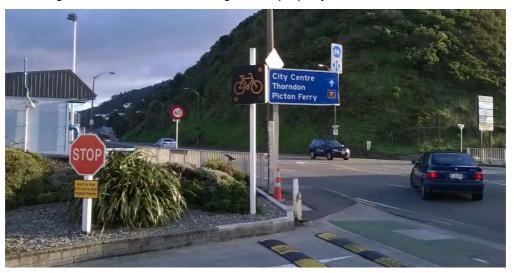
For example, an activated sign has been placed within the spotlight carpark, the sign is high (above the drivers view shaft for within a carpark) and is on the left, while drivers are looking right. Drivers pulling out of the driveway are likely to wait on the cycle path for a gap in oncoming traffic, and will not see a sign in the property.

Consider improvements at each vehicle crossing on a case by case basis. Ensure warning signage is within driver field of vision. Consider raised profile treatments and reduced angle entries to lower turning vehicle speeds. Consider signage on driveways to supplement proposed green surfacing treatment for increasing driver awareness of the cycle path.
