Karori 90% cycleway audit - safety and accessibility

90% design audit

Paneke Pōneke
Bike network plan

July 2023

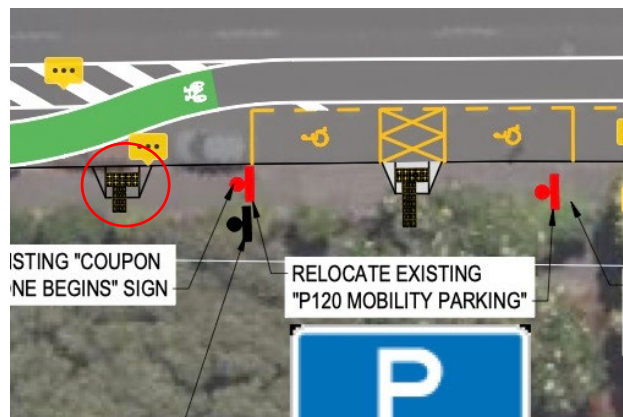
Figure 5-1: pram crossing with unknown purpose (in red circle)

Opposite property number 30 Glenmore Road, the signage plan set indicates a new kerb ramp aka pram crossing (shown in red circle in screen snip below) that does not lead anywhere. There is another kerb ramp proposed to serve the mobility parking which appears appropriate. Because this kerb ramp is not shown in the main plan set, it is assumed to be a draughting error. If left in the plans and constructed, it could be a significant safety issue for vision impaired pedestrians.

Probability of crash occurring	Very unlikely
Expected crash severity	Serious injury
Primary treatment recommendations:	
5.1.1	Remove the unnecessary proposed kerb ramp and tactiles.
Supporting treatment recommendations:	
5.1.2	N/A

Designer	Noted, kerb ramp and tactiles will be removed.
Safety Engineer	Agree with CAT and Designer's response.
Client decision	Remove kerb ramp.
Action taken	Kerb ramp removed.

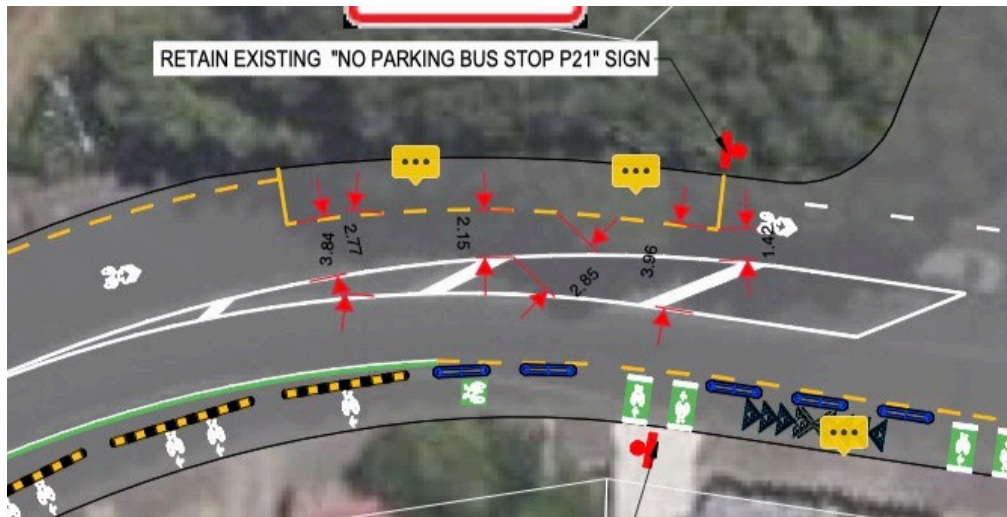
Figure 5-2: Bus stop 4316 is judged to not be a safety issue

The CAT has assessed the lane widths and potential for a pinch point for downhill cyclists at bus stop 4316 The Rigi.

While a 1.42 m pinch point between a stopped bus and the flush median does develop, it is not anticipated that any motor traffic will be stopped in that flush median. This bus stop arrangement is judged to be not a safety issue. This assessment is included in the event a reader questions whether an assessment has been undertaken.

Probability of crash occurring	N/A
Expected crash severity	N/A
Primary treatment recommendations:	
5.2.1	N/A
Supporting treatment recommendations:	
5.2.2	N/A

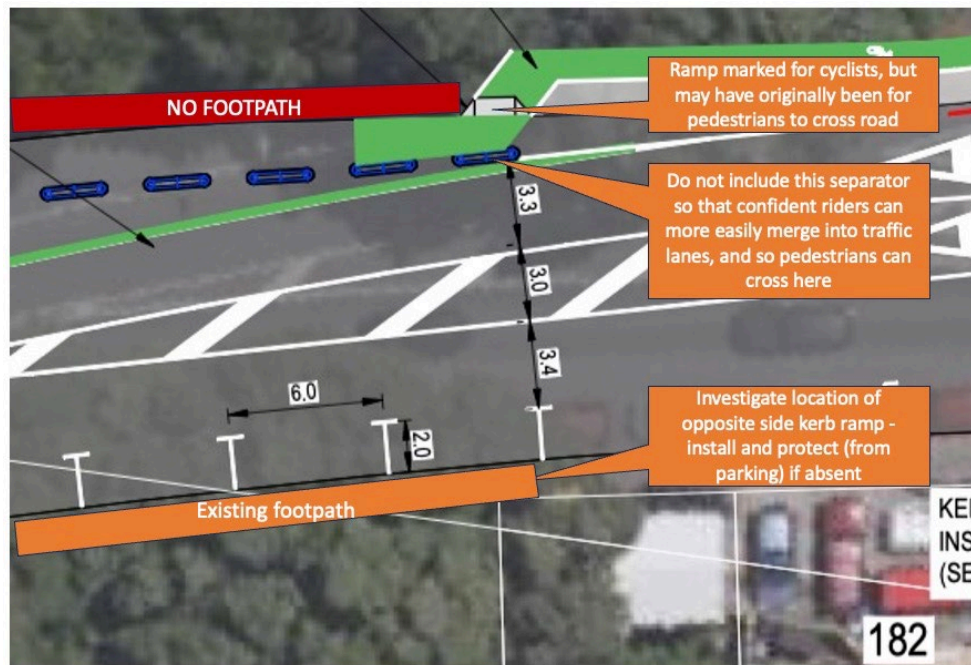
Figure 5-3: kerb ramp and separator layout opposite property 182

- cycle lanes should terminate 30 m before a roundabout as per the CNG and TCD Manual Part 4 section 5.4.5
- there should be a kerb ramp on each side of the road when footpaths end and restart on the other side of the road as per PNG [kerb crossings](#)

Probability of crash occurring		Very unlikely
Expected crash severity		Serious injury
Primary treatment recommendations:		
5.3.1	Maintain crossing pedestrian access to kerb ramp on inside of curve by omitting last separator	
5.3.2	Ensure that there is an accessible kerb ramp not blocked by carparking on the opposite side (the service station side)	
Supporting treatment recommendations:		
5.3.3	N/A

Responses:	
Designer	5.3.1. Last separator to be omitted. 5.3.2. Client has noted that a kerb ramp on the service station side will not be included as part of the Transitional Cycleway project but may be included later as part of the Transformational cycleway Programme.
Safety Engineer	Agree with Designer's response. The Project Manager should ensure that this information on the outstanding missing ramp is retained and accessible for the future transformational team.
Client decision	Agree. Remove separator and inform transformation team on future kerb ramp.
Action taken	Separator removed from designs. Report for Transformational team begun.

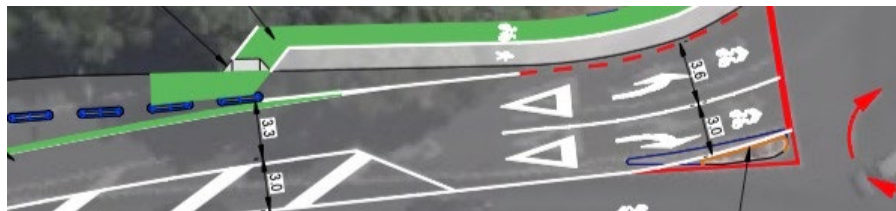
Figure 5-4: confident riders are unsupported in making transition to mixed traffic

The crash type/s expected is sideswipe.

The risk factors are volumes of confident and/or right turning cyclists and motorists.

Probability of crash occurring	Very unlikely
Expected crash severity	Minor injury
Primary treatment recommendations:	
5.4.1	N/A
Supporting treatment recommendations:	
5.4.2	Provide additional green backed sharrow(s) between the end of the cycleway and the sharrow at the limit line.
5.4.3	Develop a consistent marking plan – some sharrows are green backed and some are not.

Responses:	
Designer	5.4.2. Noted, additional sharrows to be included. 5.4.3. No design response. WCC preference for sharrows with green back to be included only at transitions non-green back throughout as typically used.
Safety Engineer	Agree with CAT and Designer’s response.
Client decision	Agree with designer and safety engineer.
Action taken	Designs change to include additional sharrows.

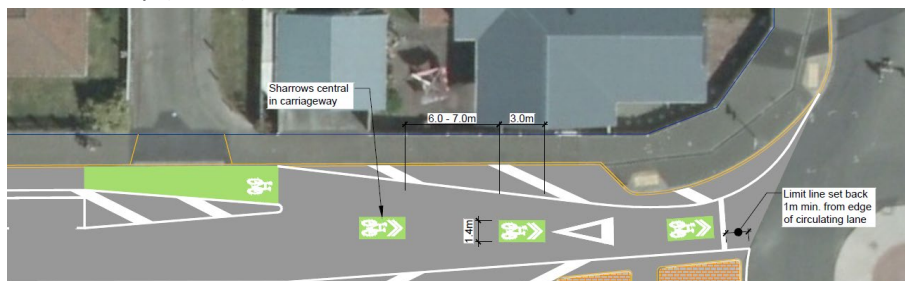
Figure 5-5 shows the current thinking on best practise for a kerbside cycle transition on the approach to a roundabout, with sharrows in green boxes as agreed by the Active Modes Infrastructure Group (AMIG).

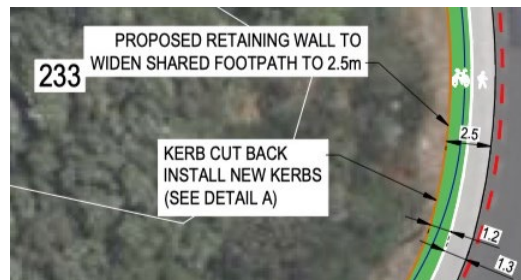
Figure 5-6: proposed segregated path on inside of curve near Upland Road

The designer has proposed a retaining wall to widen the existing footpath to a 2.5 m wide shared path with paint segregation. Some comments:

- The paint separation is not likely to work in practice
- It is understood that the paint separation is intended as a minor aid for people with vision impairment, and therefore it is not seen as a safety issue or harm to include, although the cost/benefit ratio for paint separation is likely to be low
- The widening is worthwhile for the interested but concerned cyclist who would not want to ride on the carriageway
- The number of pedestrians using this segment is expected to be very low so a 2.5 m shared path without paint separation should be adequate
- The plan callouts jumble terminology e.g. “shared footpath”

Probability of crash occurring	N/A
Expected crash severity	N/A
Primary treatment recommendations:	
5.5.1	N/A
Supporting treatment recommendations:	
5.5.2	For clarity, the designer should update the callouts to reference the existing footpath and the proposed shared path

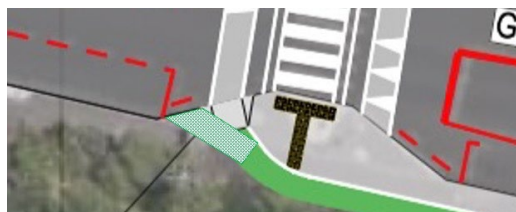
Figure 5-7: proper alignment of return to carriageway minimises turning angle shown with stippled green polygon

The risk factors are the volumes of motorists and cyclists. Wet weather and darkness will increase the likelihood of a collision.

The relevant guidance is TCD Manual Part 4, although no specific angle of re-entry ramp is listed in New Zealand documents. Our experience is that the angle should be 70 degrees.

Probability of crash occurring		Very unlikely
Expected crash severity		Serious injury
Primary treatment recommendations:		
5.6.1	Eliminate the conflict point by realigning the kerb ramp as illustrated	
Supporting treatment recommendations:		
5.6.2	N/A

Responses:	
Designer	Noted. Kerb ramp to be realigned.
Safety Engineer	Agree with CAT and Designer’s response.
Client decision	Agree with all.
Action taken	Angle of kerb ramp realigned in the latest design.

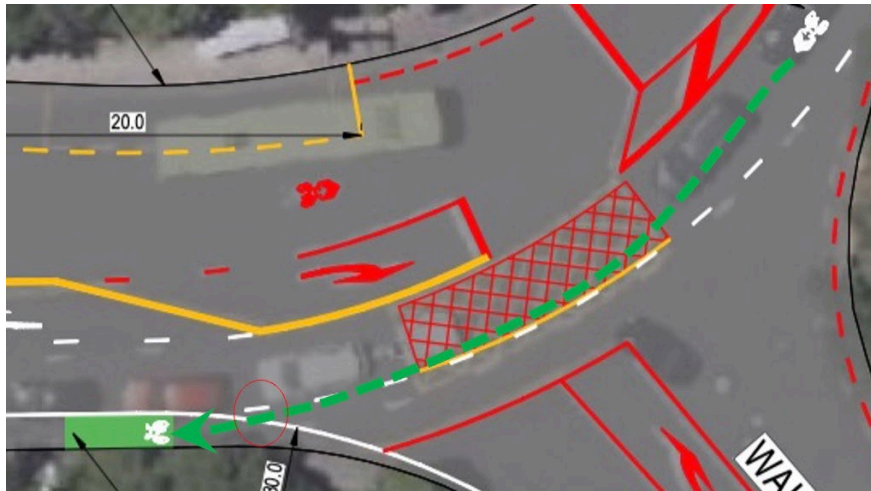
Figure 5-10: clip from design plan; green dashed line shows cyclist trajectory

The edgeline is shown as a continuous white line. Road users are not intended to cross solid white lines. For legibility, the edgeline should be omitted and linemarking designed as per TCD Manual Figure 4-22 (although NZ guidance is not very clear on this point).

Probability of crash occurring	Choose probability
Expected crash severity	Choose severity
Primary treatment recommendations:	
5.7.1	N/A
Supporting treatment recommendations:	
5.7.2	Omit white edgeline at Waiapu Rd

Designer	Noted. Amendment to be made.
Safety Engineer	Agree with CAT and Designer's response.
Client decision	Agree with all.
Action taken	Design updated to eliminate kerb line.

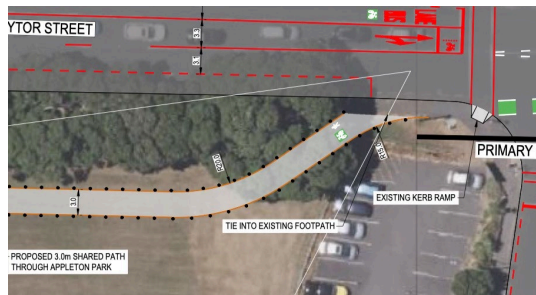
Figure 5-11: the 90% design plan offers no details on the shared path at the Chaytor / Birdwood intersection

The safety issue is that there are multiple physical hazards at the proposed shared path entrance point to Appleton Park and none seem to be acknowledged or mitigated in a 90%

Probability of crash occurring	Very unlikely
Expected crash severity	Minor injury
Primary treatment recommendations:	
5.8.1	Detail how the shared path will be safely integrated with the existing infrastructure in Appleton Park
Supporting treatment recommendations:	
5.8.2	Include wayfinding signage, possibly in lieu of the rather unnecessary cyclists use ramp sign.

Responses:	
Designer	5.8.1. Noted, will be amended to reflect transition to Appleton park shared path. 5.8.2. Noted, will be amended to include wayfinding signage indicating direction through park.
Safety Engineer	Agree with CAT and Designer’s responses.
Client decision	Agree with the above responses.
Action taken	A widened kerb, green paint and wayfinding added to the designs.

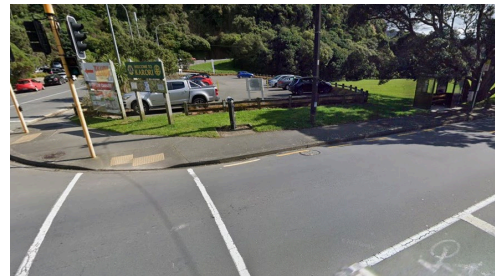
Figure 5-12: there is a multitude of constraints from poles to bus shelters that will create conflicts

The risk factors are volumes of path users and darkness.

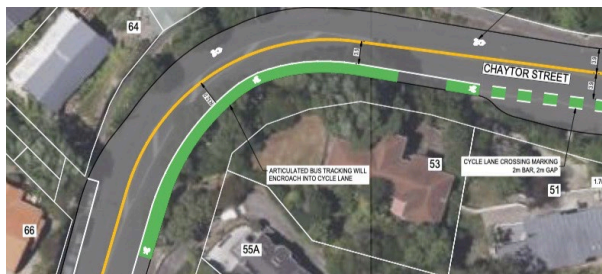
Figure 5-13: xxx

Opposite property number 64 Chaytor Street there is a proposed cycle lane on the inside of a tight curve. Motorists are likely to encroach on the cycle lane, both wearing the surface colour

The crash type is rear end collision between motor vehicle and cyclist. The risk factors are darkness and traffic volumes.

Articulated buses will need to track into the cycle lane. Therefore the best mitigation may be audio tactile profiled markings (ATPMs) to keep the majority of traffic within their lane. Raised reflectorised pavement markings may be effective but not as durable.

Probability of crash occurring	Very unlikely
Expected crash severity	Serious injury
Primary treatment recommendations:	
5.9.1	N/A
Supporting treatment recommendations:	
5.9.2	Consider ATPMs to reduce incidence of motor vehicle intrusion in cycle lane.

Designer	Noted, ATPMs will be included in this section.
Safety Engineer	Agree with CAT and Designer's response.
Client decision	Agree with all.
Action taken	ATP added to the curve.

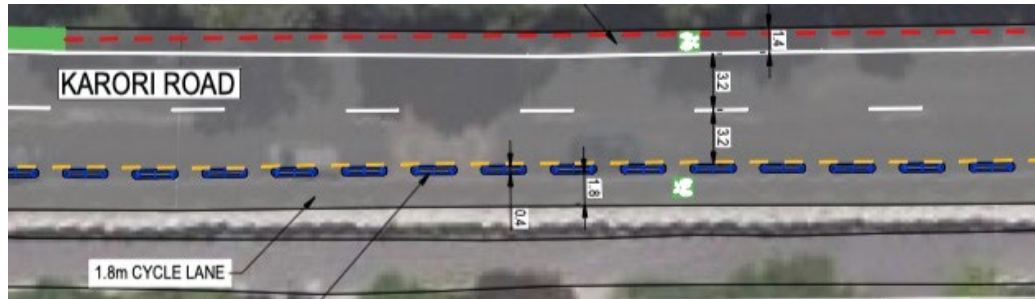
Figure 5-14: clip from Karori Rd part 2 at property number 128

The citybound kerbside cycle lane is proposed to be 1.4 m with two 3.2 m traffic lanes. This is a lane with that is below minimum as per CNG and TCD Manual and will not likely achieve the project objectives (i.e., people will feel unsafe). The 3.2 m traffic lanes are acknowledged to be for the purposes of the design vehicles.

A preferable layout is 3.1 m traffic lanes and 1.6 m cycle lane. Heavy vehicles can encroach when required as there is only paint between the lanes. A narrower traffic lane will also perceptually encourage lower traffic speeds.

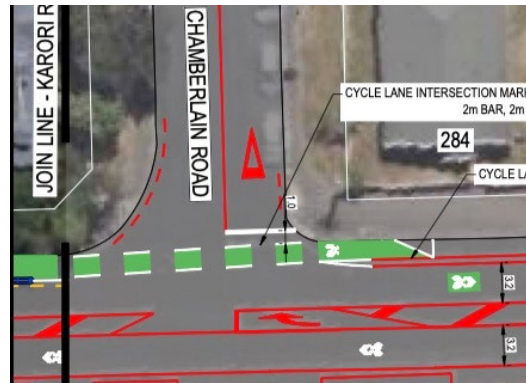
Figure 5-16: abrupt transition for people on bikes

Probability of crash occurring	Very unlikely
Expected crash severity	Serious injury
Primary treatment recommendations:

5.12.1	N/A
Supporting treatment recommendations:	
5.12.2	Consider a more gentle taper from the cycle lane to mixed traffic and sharrows.

Responses:	
Designer	Recommendation accepted will be amended to extend taper.
Safety Engineer	Agree with CAT and Designer’s response.
Client decision	Agree with CAT and responses.
Action taken	The taper has been made more gentle in the designs.

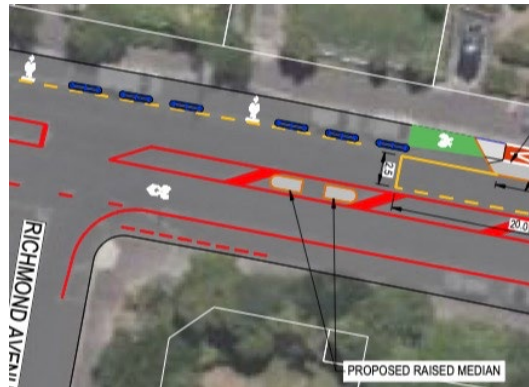
Figure 5-17: pedestrian refuge lacks accessibility details including kerb ramps

- broken yellow no stopping lines terminate downstream of the crossing point; motorists may park in the way of people trying to use the refuge
- there are no kerb ramps on either side of the road
- the cycleway separators are not spaced to enable pedestrians to cross the road

Probability of crash occurring	N/A
Expected crash severity	N/A
Primary treatment recommendations:	
5.13.1	Complete the design development to show kerb ramps and a clear path of pedestrian travel.

Responses:	
Designer	Noted, will be amended to add ramps on both sides.
Safety Engineer	Agree with CAT, the amended design should include the ramps, BYLs, and revising spacing of cycleway separators.
Client decision	Agree with CAT and responses.
Action taken	Kerb ramps have been added and a separator removed in the designs.

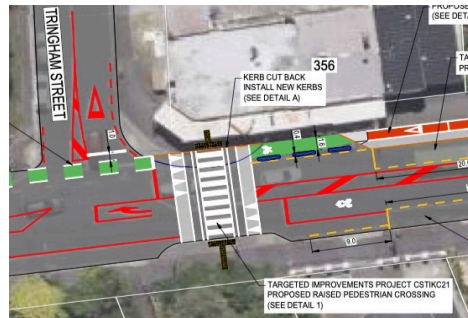
Figure 5-18: xxx

The risk factors are traffic volumes. The relevant standards are contained in the TCD Manual.

5.14.2 Complete the detailing for the Tringham Street pedestrian crossing.

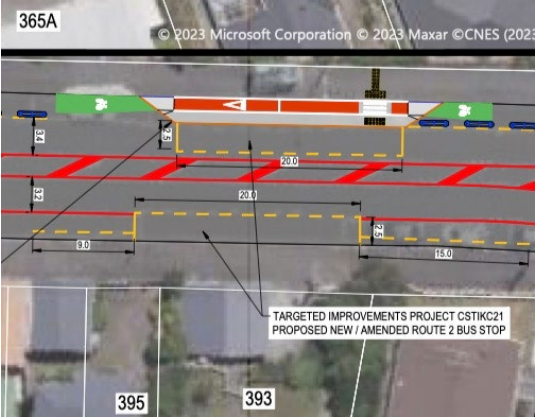
Figure 5-19: flush median adjacent to an inline bus stop

The crash types expected are sideswipe crashes between buses and overtaking motorists and head-on crashes if there is an oncoming motorist using the flush median at the same time. The risk factors are traffic volumes and low light conditions.

5.15.1	Install a raised median which can double as a pedestrian crossing facility
--------	--

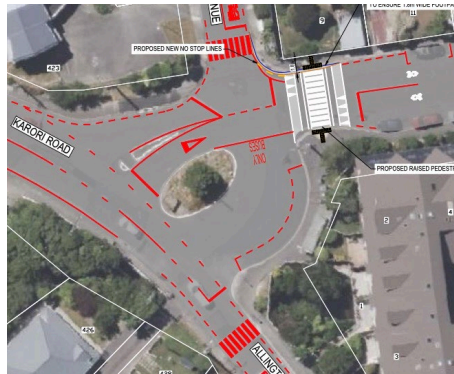
Figure 5-20: Karori / South Karori roundabout proposed markings

The safety issue is that motorists entering the roundabout look for other motorists and fail to see people on bikes. This is an unusual roundabout including a bus only element – motorists are already going to have a high workload. Adding more green backed sharrow markings may help remind motorists of the presence of people on bikes.
 The crash type/s expected right angle crashes due to the “looked but failed to see” issue.
 The risk factors are traffic volumes and speeds.
 The relevant standards are in the CNG.

5.16.2 Consider green backed sharrows on all approaches and in circulating lanes

Responses:	
Designer	Recommendation accepted as WCC indicated preference for sharrows with green back to be included in roundabout.
Safety Engineer	Agree with CAT and Designer’s response.
Client decision	Agree with all above.
Action taken	Green back sharrows added to design.
