# Wellington Transitional Cycleways Kilbirnie Connections cycleway audit – safety and accessibility

90% design audit

January 2023

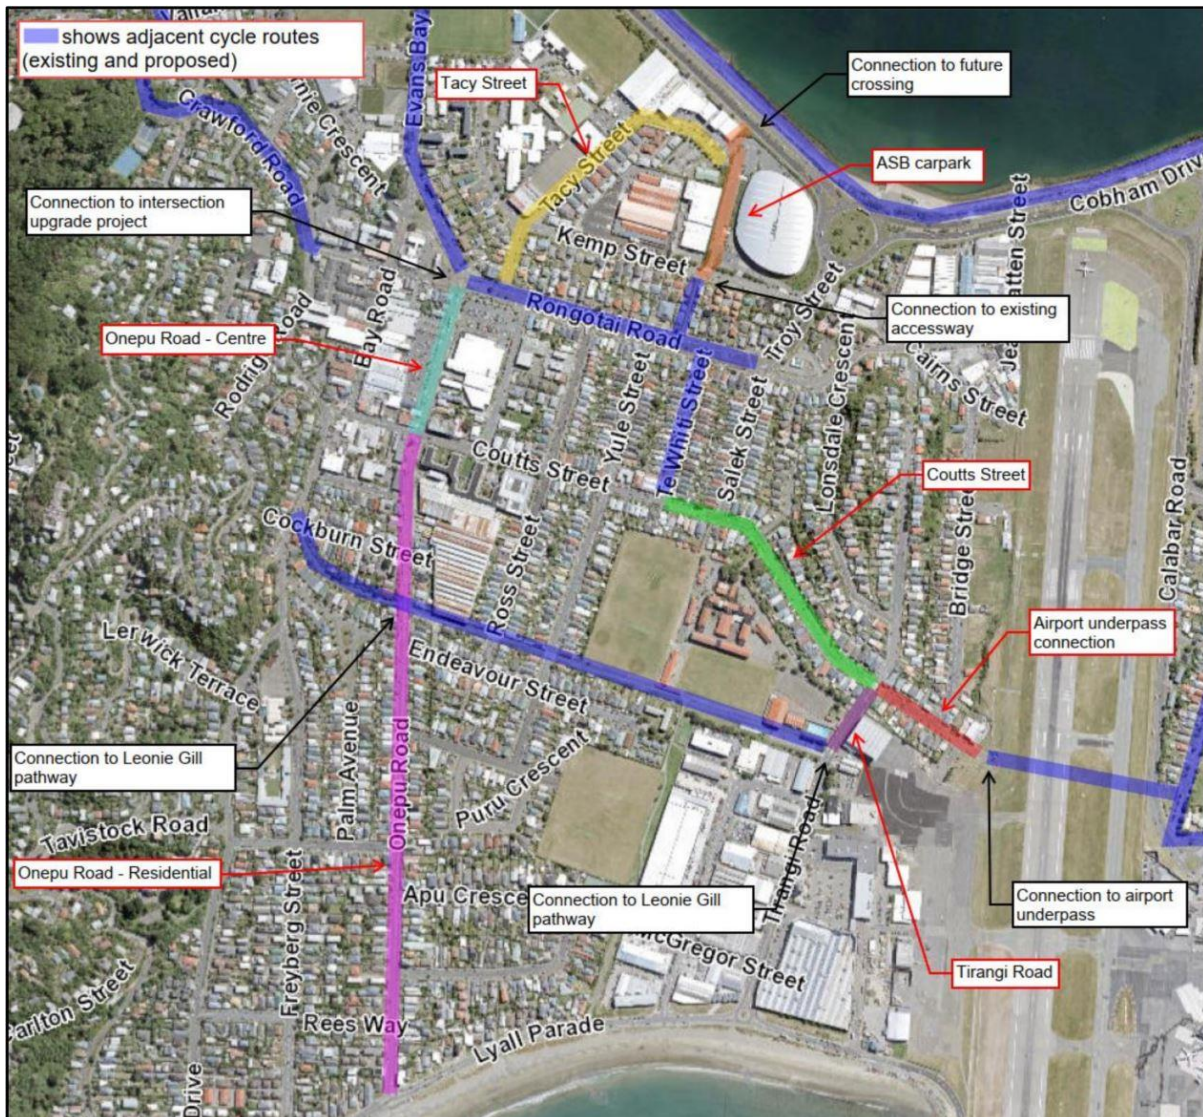
Figure 1-1: Extent of audit

This CASA is for the 90% stage of Kilbirnie connections as shown in Figure 1-1.

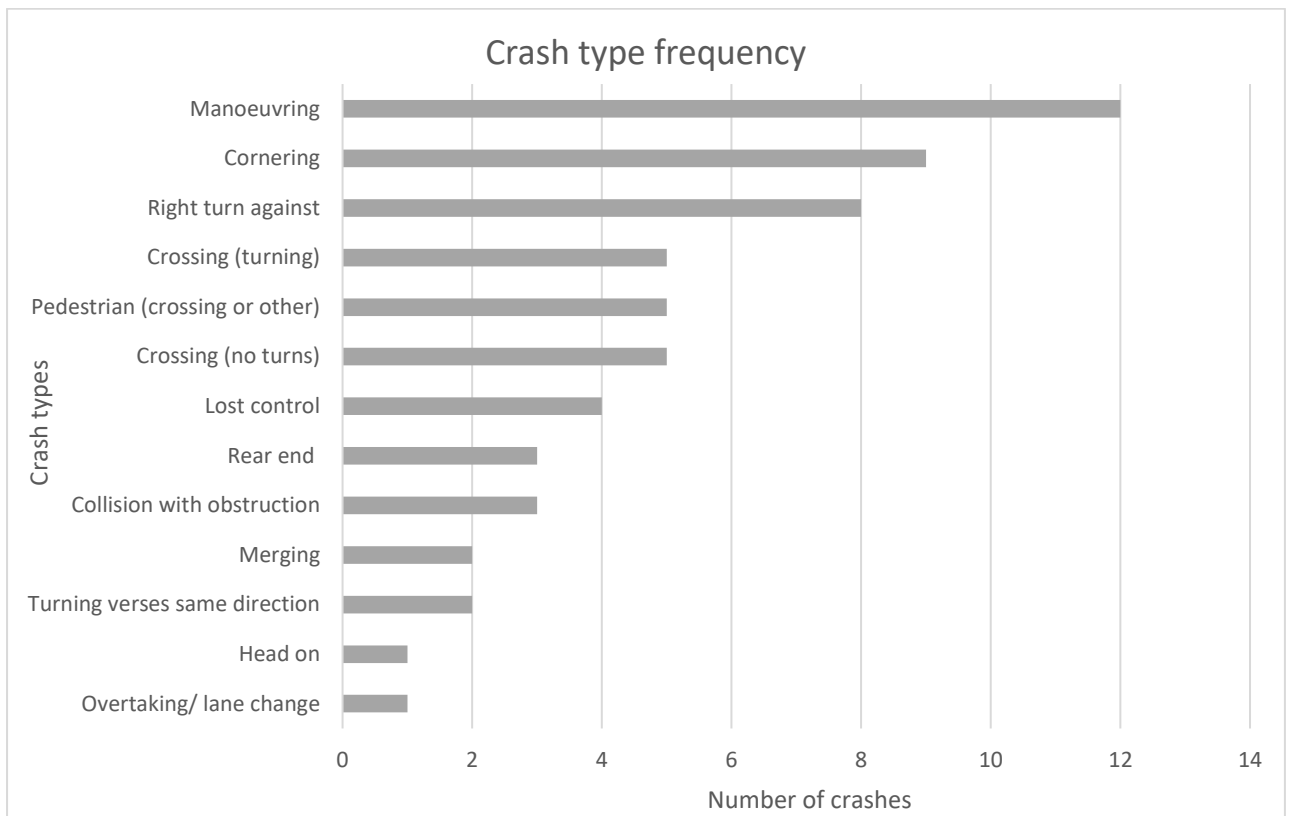
**Figure 1-3: Reported crash factors (grouped)**

The top four crash factors (manoeuvring, cornering, right turn against and crossing (turning and not turning) and pedestrians) all point to the constricting environment of the road and amount of traffic on the route. Given the lack of alternative options, lack of space and the busy nature of the corridor these are unavoidable risks that should be minimised through design.

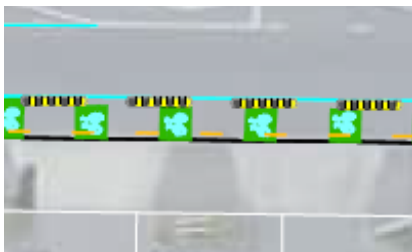
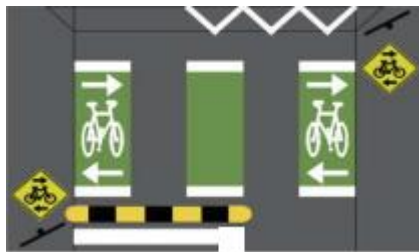
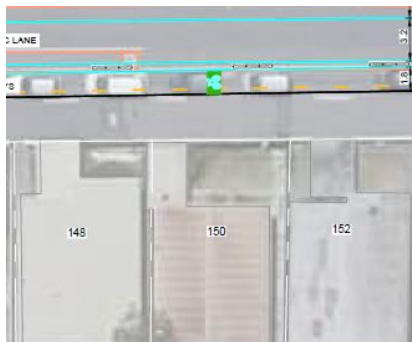
Figure 2-2 provides guidance of how to install speed humps leaving the private driveway and crossing into a separated cycleway. This provides vertical deflection with the speed hump on the private property side to reduce speeds of cars entering the separated cycleway.

Figure 2-3 shows driveways having no road marking or vertical elements with the separators. Road marking the cycle symbol at 100m exactly (indicative number) could be altered to provide the closest driveway with road marking. Depending on whether the separators are mountable or not, providing a vertical element for drivers leaving driveways will help to identify where the extents of the separators are.

Figure 2-1: Proposed commercial driveways

Figure 2-2: [Driveway treatment solution](#)

Figure 2-3: Coutts Street crossings with no markings

Probability of crash occurring		Unlikely
Expected crash severity		Minor injury
<b>Primary treatment recommendations:</b>		
2.1.1	Provide vertical elements to low separators	
<b>Supporting treatment recommendations:</b>		
2.1.2	Investigate use of speed humps on approach to separated cycleway

We agree with CAT on installing speed humps on commercial driveways. We recommend that the client engage in communication with business owners to determine if it is feasible to install the speed humps within the boundaries of their property. However, we believe that it is not an appropriate solution for residential properties given the lower vehicle volumes.

We also agree with the other recommendation regarding moving the proposed cycle symbols to align them with driveways.
<b>Safety Engineer</b>	Agree with CAT and Designer, noting that cycle symbols to align with all driveways.
<b>Proposed action</b>	Agree with CAT and designer – please note that there are some properties down Onepu Rd south at 154 175 and 192 that could be fairly high use – can we look into this treatment on those driveways too please.
<b>Client decision</b>	Agree with proposed action
<b>Action taken</b>

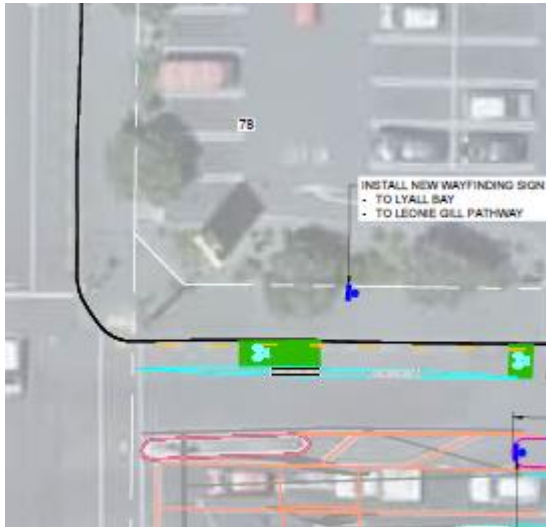
Figure 2-4: Location of way-finding sign

Several way-finding signs are indicated on the departure side of intersections (e.g. Figure 2-4). It is unclear if this is a repeater (confirmation) way-finding sign or not; providing the way-finding sign after the intersection will not help users determine their route initially.

Probability of crash occurring	N/A
Expected crash severity	N/A
<b>Primary treatment recommendations:</b>	
2.2.1	Designer to make sure way-finding is provided on approaches to intersections and the shown way-finding is only repeater confirmation.
<b>Supporting treatment recommendations:</b>	
2.2.2	N/a

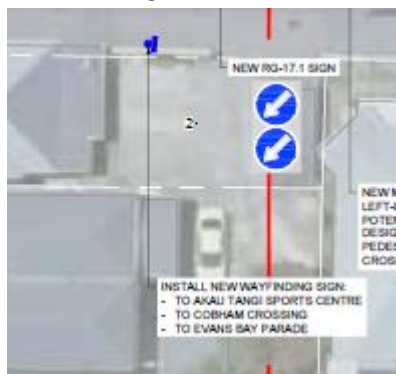
Figure 2-5: Way-finding signage with three locations

Some of the proposed way-finding signage lists up to three destinations (e.g. Figure 2-5). Draft guidance to Waka Kotahi on cycle way-finding for the CNG discusses the amount of information to be provided on a way-finding fingerboard sign to a maximum of two lines. Therefore, we assume that the signs in question will be in the form of an advance destination or confirmation destination sign.

Probability of crash occurring	N/A
Expected crash severity	N/A
<b>Primary treatment recommendations:</b>	
2.3.1	Investigate the use of appropriate destination signs for the three lines of information
<b>Supporting treatment recommendations:</b>	
2.3.2	N/a

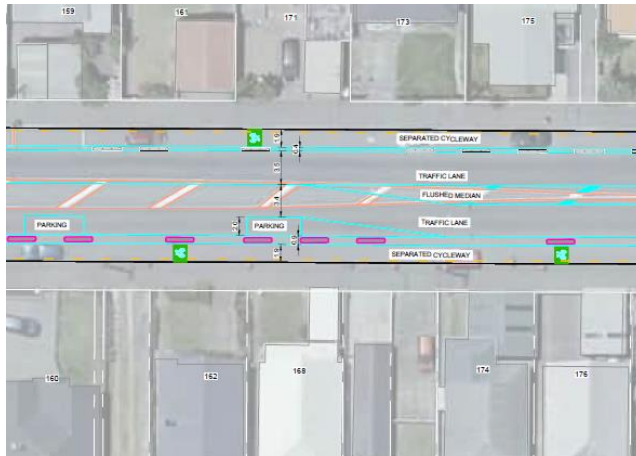
In the CNG – *Choice of separator or protection* provides guidance on the permeability of the separators with “The gap width in continuous separators should be limited to providing for the required design vehicle at a slow turning speed (typically **no more than 4-5 m gap** for single private accesses).”

Probability of crash occurring	Unlikely
Expected crash severity	Serious injury
<b>Primary treatment recommendations:</b>	
2.4.1	Reduce the of spacing of TCDs to <5m where applicable.
<b>Supporting treatment recommendations:</b>	
2.4.2	N/a

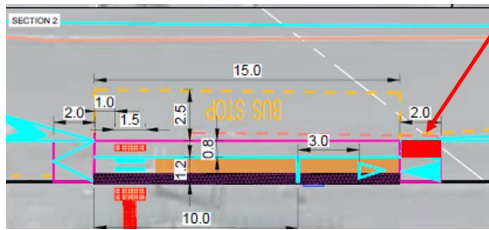
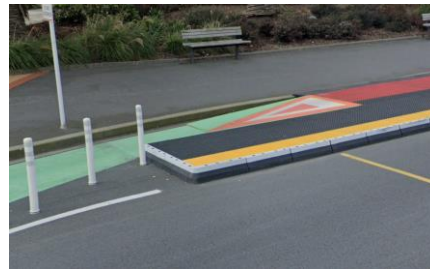
The crash type/s expected is cyclists striking pedestrians.

The risk factors are volume of cyclists, volume of bus users, cyclist understanding of the step-down space.

Figure 2-7: Diagram showing the removal of the ramp for the approach

Figure 2-8: Riddiford Street bus platform

Probability of crash occurring	Very unlikely
Expected crash severity	Minor injury
<b>Primary treatment recommendations:</b>	
2.5.1	Remove the ability for cyclists to enter the 0.8m area for bus users to step down into. (Similar to bollards in Figure 2-8)
<b>Supporting treatment recommendations:</b>	
2.5.2

<b>Responses:</b>	
<b>Designer</b>	We agree with CAT recommendation and will apply this to the bus stop platform designs.
<b>Safety Engineer</b>	Agree with CAT and Designer.
<b>Proposed action</b>	Agree with CAT and Designer.
<b>Client decision</b>	Agree with proposed action
<b>Action taken</b>

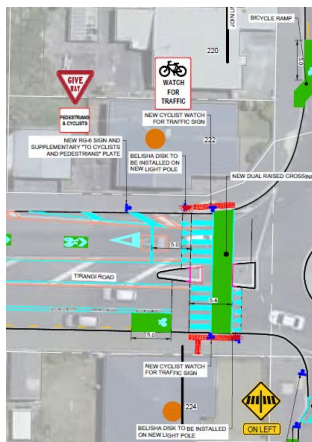
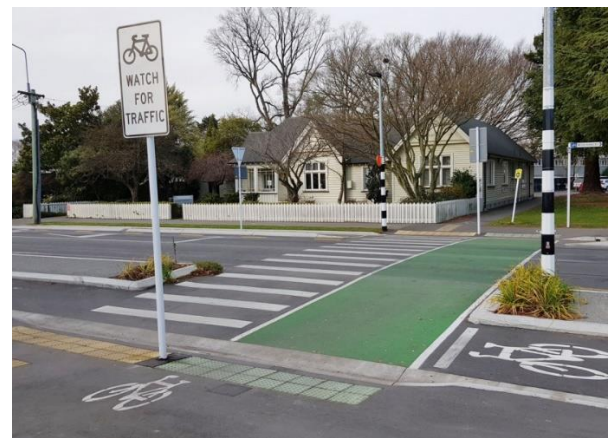
The [CNG](#) – *Unsignalised crossings* provides design considerations on the use of dual crossings.

Figure 2-9: Layout of dual crossings

Figure 2-10: Photo showing existing dual crossing as per CNG document.

Probability of crash occurring	N/A
Expected crash severity	N/A
<b>Primary treatment recommendations:</b>	
2.6.1	Provide green and yellow tactile ground surface indicators
2.6.2	Install signage in line with TCD part 4
<b>Supporting treatment recommendations:</b>	
2.6.3	N/a

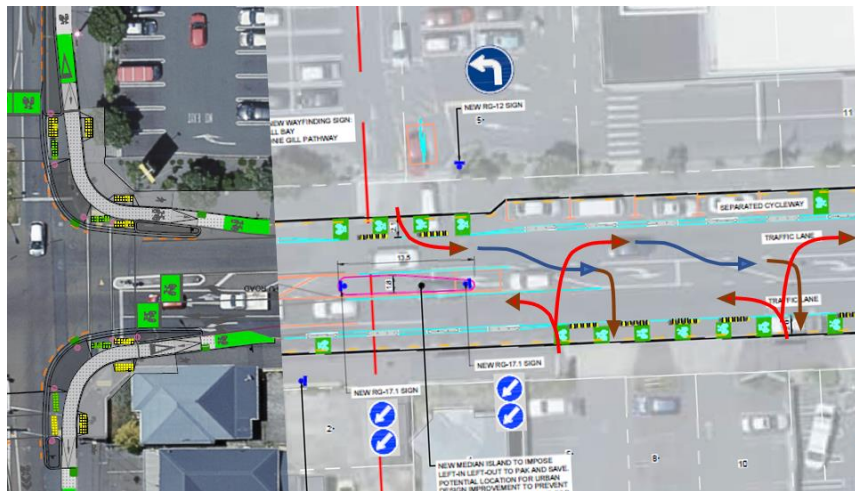
Figure 3-1: Merge of both plans to show proposed layout

The location of the proposed island out of Pak n Save driveway to supplement the left-in left-out (LILO) treatment is close to the proposed right-turning bay of the Rongotai Road intersection. The indicative plans for the proposed intersection treatment suggest that the island may limit the available room for turning traffic to queue (see Figure 3-1).

Probability of crash occurring	N/A
Expected crash severity	N/A
<b>Primary treatment recommendations:</b>	
3.1.1	Determine the length required for the right-turning bay
<b>Supporting treatment recommendations:</b>	
3.1.2

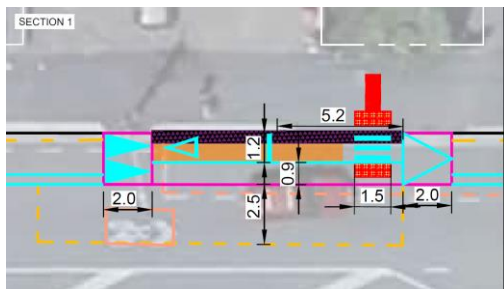
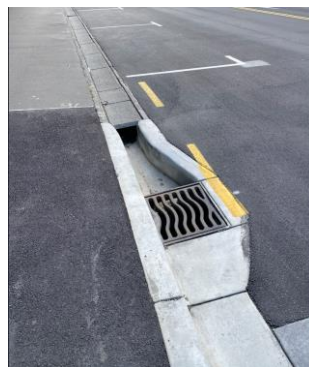
Allowing for vehicles to traffic over the platform could also lead to the metal grating being damaged / removed and become a bigger hazard.

Figure 3-2: Proposed bus platform layout

Figure 3-3: Gap left between steel plate for storm water

Probability of crash occurring	N/A
Expected crash severity	N/A
<b>Primary treatment recommendations:</b>	
3.2.1	Determine the right installation method of the metal grating to make sure no hazard is created.
<b>Supporting treatment recommendations:</b>	
3.2.2

<b>Designer</b>	We agree with CAT finding. We recommend the client considers the most appropriate way to address this issue.
<b>Safety Engineer</b>	Agree with CAT and Designer. Issue to be referred to Transport and Delivery – Maintenance for input.
<b>Proposed action</b>	Agree with CAT and Designer – will check in with T&I for input
<b>Client decision</b>	Agree with proposed action

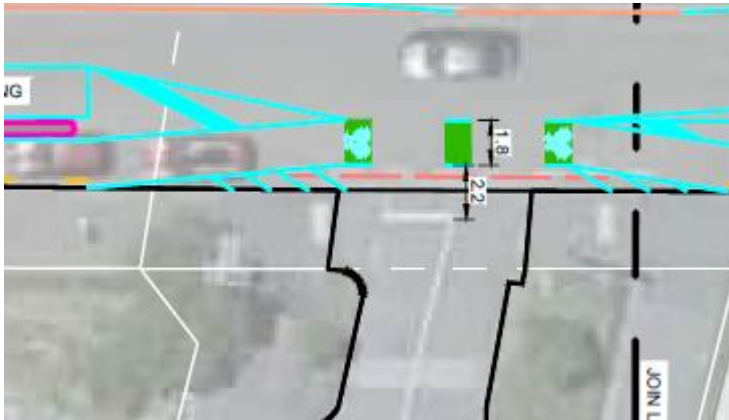
The cycle way has been moved laterally to allow for the give way limit lines to stay in the existing locations due to desktop study of required visibility intersection (see Figure 3-4).

**Figure 3-4: Separated cycleway moves laterally from minor road limit line**

The safety issue is that cyclists are likely to continue straight and not move laterally as the cycle lane shifts and vehicles will encroach into the setback distance.

Probability of crash occurring		Unlikely
Expected crash severity		Minor injury
<b>Primary treatment recommendations:</b>		
3.3.1	Determine if all intersections and driveways have enough visibility to push the limit lines back	
<b>Supporting treatment recommendations:</b>		
3.3.2

<b>Designer</b>	We agree with CAT finding that some cyclists will not obey the proposed line marking. In the worst-case scenario, these cyclists may be riding adjacent to the channel lip line, which provides a relatively safe gap between car bumper and the edge of the cycleway. It should be noted that pushing the limit line further back, which would move vehicles further away from the edge of the traffic lane, results in an increase in travel time for turning vehicles in conflict areas. The required setbacks will be implemented in accordance with CNG-TN002, however, due to existing constraints in certain areas slightly shorter setbacks have been applied in some locations with consideration of the safety risk.
<b>Safety Engineer</b>	Agree with Designer. Behaviour at this location to be monitored and further mitigation considered if necessary.
<b>Proposed action</b>	Agree with designer and safety engineer

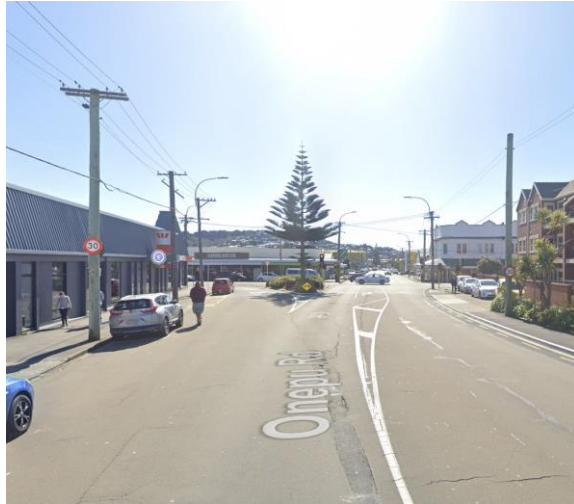
Figure 3-6: Approach to 30km/h speed zone in Kilbirnie

Probability of crash occurring	Unlikely
Expected crash severity	Serious injury
<b>Primary treatment recommendations:</b>

The risk factors are speed of motor vehicles, volumes of turning vehicles and volumes of cyclists.

3.4.1	Provide threshold road marking on Onepu Road
3.4.2	Install larger 30km/h speed signs, not the minimum sizing
<b>Supporting treatment recommendations:</b>	
3.4.3	Install “Kilbirnie Village – 30km/h” signage, to provide better threshold

<b>Responses:</b>	
<b>Designer</b>	We agree with CAT treatment recommendations 3.4.1 and 3.4.2.
<b>Safety Engineer</b>	Agree with CAT and Designer.
<b>Proposed action</b>	Agree with CAT and Designer.
<b>Client decision</b>	Agree with proposed action
<b>Action taken</b>

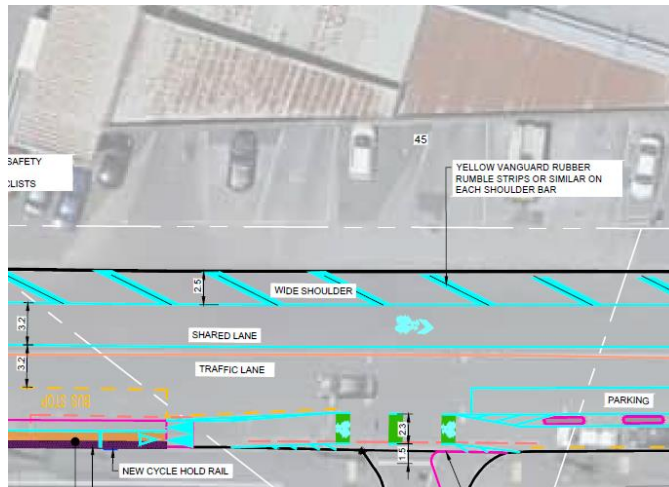
Figure 3-7: Rumble strips proposed along wide shoulder

The crash type/s expected is motor vehicle and cyclist rear-end and side-swipe crashes. The risk factors are lane width, volume of motor vehicles and cyclists, speed of motor vehicles and volume of buses.

Probability of crash occurring	Likely
Expected crash severity	Serious injury
<b>Primary treatment recommendations:</b>	
3.5.1	Remove proposed rumble strips
3.5.2	Provide cyclist head start movement at Onepu Road and Coutts Street
<b>Supporting treatment recommendations:</b>	
3.5.3	Provide a gap in the rumble strips to allow cyclists to traffic through while buses are not stationary in the wide shoulder
3.5.4	Provide the minimum lane width for mixed traffic lane and per CNG of 4.2m

<b>Designer</b>	We agree with CAT finding. We also agree with CAT recommendation 3.5.1 and suggest this is implemented for the TR designs. The investigation of cyclist head start movement at the intersection of Onepu Road and Coutts Street, as outlined in recommendation 3.5.2, is considered as a part of the design and needs to be confirmed by the WCC signals team. It also must be noted that it is not feasible to increase the width of the shared lane, as the proposed 2.5m shoulder is intended to be utilised by stationary buses.
<b>Safety Engineer</b>	Agree with CAT and Designer. Confirm adequacy of cyclist head start time with WCC signals team.
<b>Proposed action</b>	Advance cycle light ahead of the Barnes Dance phase will give cyclists plenty of time to get ahead of traffic. Design being updated to remove rumble strips and hatching and replace it with a cycle lane and then a shared bus bike lane – TR drawings are being updated

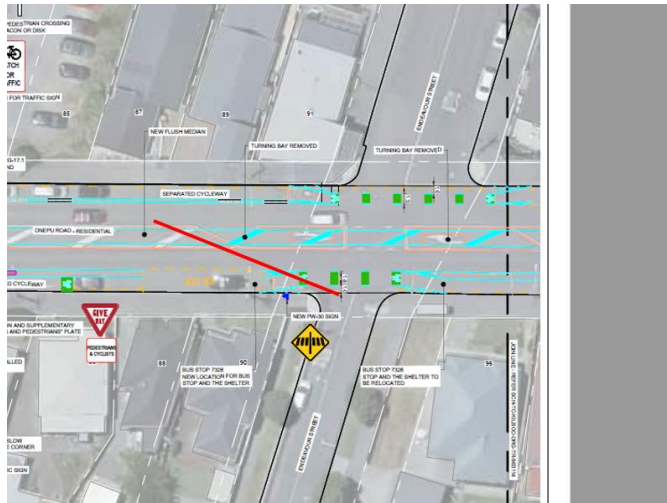
Probability of crash occurring	Very unlikely
Expected crash severity	Minor injury
<b>Primary treatment recommendations:</b>

Figure 3-8: Extract showing visibility for right-turning traffic if bus stop is occupied.

3.7.1	Determine if adequate visibility is provided. Relocate bus stop if necessary
<b>Supporting treatment recommendations:</b>	
3.7.2	N/a

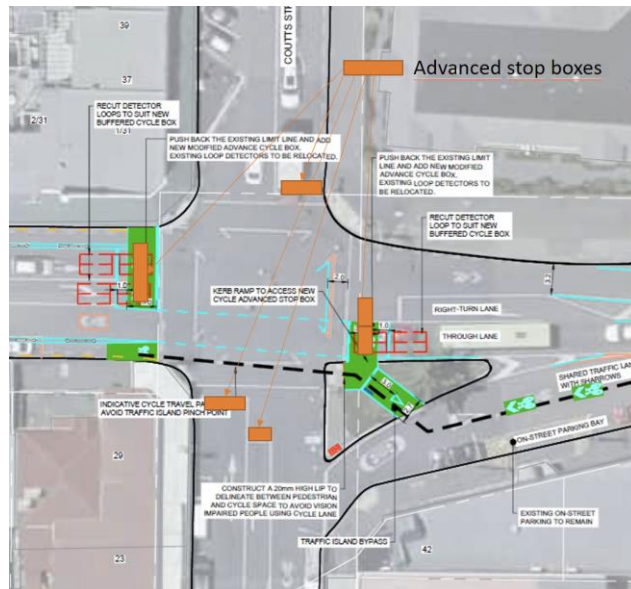
Figure 3-9: Diagram showing potential advanced stop box locations

The relevant guidance is [Cycling network guidance – Cyclist waiting facilities at intersections](#) and [Design Guidance Note – Buffered Advance stop box](#)

Probability of crash occurring	Unlikely
Expected crash severity	Minor injury
<b>Primary treatment recommendations:</b>	
3.8.1	Provide advanced stop boxes for all legs to provide cyclists the opportunity to turn outside of the Barnes dance phase (see Figure 3-9).
<b>Supporting treatment recommendations:</b>	
3.8.2	N/a

<b>Responses:</b>	
<b>Designer</b>	<p>We agree with the CAT recommendation. ASBs on the side road are out of our current scope.</p> <p>We also note that that installing ASBs on staggered right turn lanes impact traffic signal timing, resulting in increased delay, and capacity of the lane. According to Austroads Part 4A, it is recommended to consider the sight distance requirement on signalised intersections, as signals may not always function due to power outages or damage to the controller. Therefore, it is imperative to verify the sight distance requirement prior to implementing ASBs.</p>
<b>Safety Engineer</b>	<p>Agree with CAT and Designer. However, the current scope should be reconsidered to include ASBs on side road. Verify the sight distance requirements prior to implementing the ASBs.</p>
<b>Proposed action</b>	<p>Agree – expanding scope to include ASBs on side road</p>
<b>Client decision</b>	<p>Agree with proposed action</p>

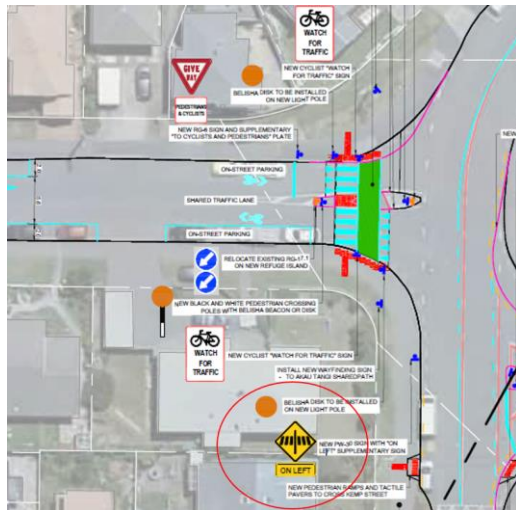
Figure 4-1: “On Left” sign

The draft consultation document for [TCD manual part 4 – in between intersections](#) provides guidance on the colours to provide the additional signs for cycle path crossings (see Figure 4-2).

<b>Designer</b>	We agree with CAT that “On Left” supplementary sign is not included in TCD manual. However, it should be noted that none of the regulatory signs in TCD manual, Part 4 (Table 8-1), effectively convey the proposed condition. Considering that installing W16-2 is mandatory we still recommend retaining “On Left” supplementary sign in the design for better communication and clarity.
-----------------	---

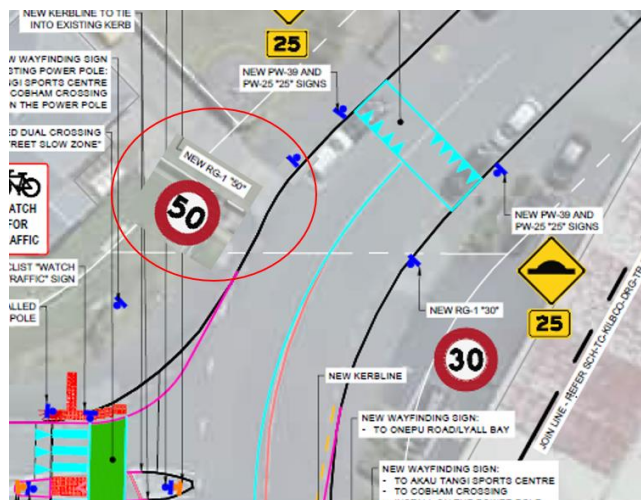
A 50 km/h speed limit sign is missing from the western leg of Kemp St (see Figure 4-3). The safety issue is some drivers will be unaware they are driving reasonably slower than the posted speed limit.

The risk factors are volumes of motor vehicles and speed of motor vehicles.

Figure 4-3: Circled 50km/h sign missing within drawing

Probability of crash occurring	Very unlikely
Expected crash severity	Minor injury
<b>Primary treatment recommendations:</b>	
4.2.1	Install missing speed limit sign
<b>Supporting treatment recommendations:</b>	
4.2.2	N/a

<b>Responses:</b>	
<b>Designer</b>	We agree with CAT recommendation and will include the missing sign.
<b>Safety Engineer</b>	Agree with CAT and Designer.
<b>Proposed action</b>	Agree with CAT and Designer.
<b>Client decision</b>	Agree with proposed action
<b>Action taken</b>

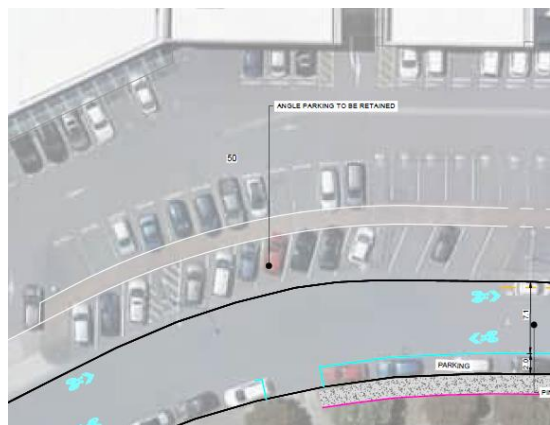
The risk factors are angle of parks, volume of cyclists, time restriction of parking areas and speed of cyclists.

**Figure 4-4: Angled parking being retained without buffer to the road**

Probability of crash occurring		Unlikely
Expected crash severity		Minor injury
<b>Primary treatment recommendations:</b>		
4.3.1	Provide buffer between parking and shared lane	
<b>Supporting treatment recommendations:</b>		
4.3.2	Install sharrow further away from the edge of the shared lane to advise cyclists to not travel along the edge

Responses:	
<b>Designer</b>	We agree with CAT recommendation. A buffer will be implemented between the 60-degree parking spaces and the shared lane, however, due to the road width, it will still not comply with the standards outlined in the CNG table. Sharrow marking will be placed according to new edge line marking.
<b>Safety Engineer</b>	Agree with CAT and Designer.
<b>Proposed action</b>	Agree with CAT and Designer
<b>Client decision</b>	Agree with proposed action
<b>Action taken</b>

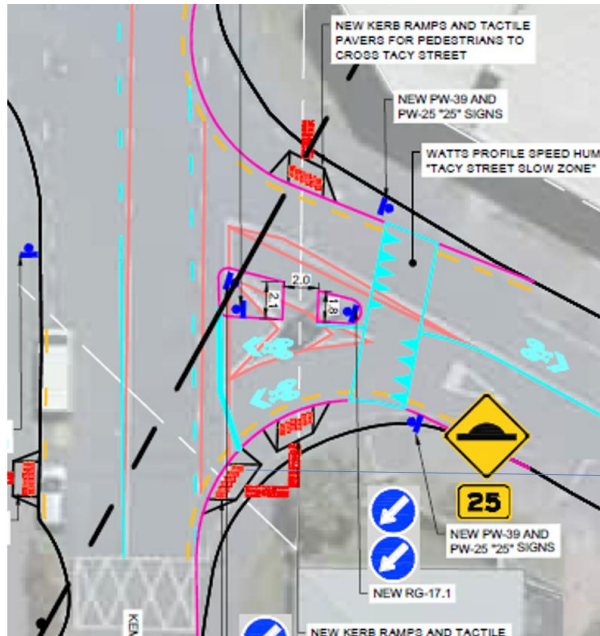
Figure 4-6: Kemp Street crossing point

The pedestrians using the crossing across Kemp Street (Figure 4-6) only have a crossing point whereas all the other crossings in the area are prioritised pedestrian crossing points.

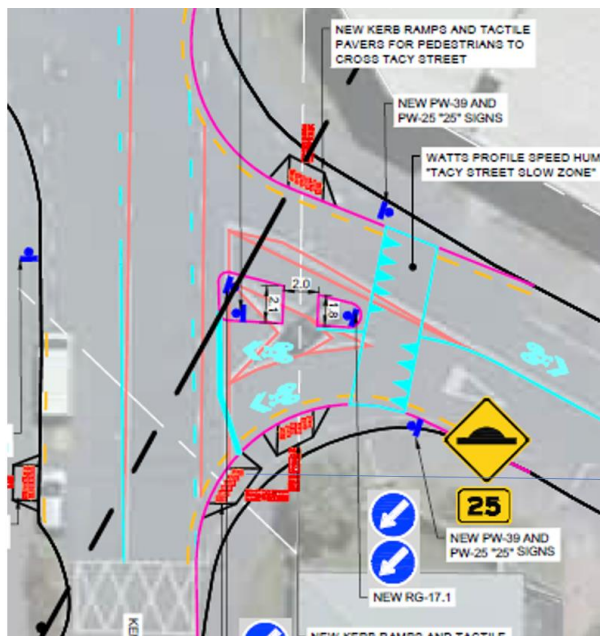
Figure 4-7: Kemp Street Intersection

Installation of dual Sharrows within one lane so close to the limit line is confusing. At a roundabout approach only one Sharrow is installed even though cyclists can turn in any direction.

**Designer** We agree with CAT recommendation and will implement 4.5.1.

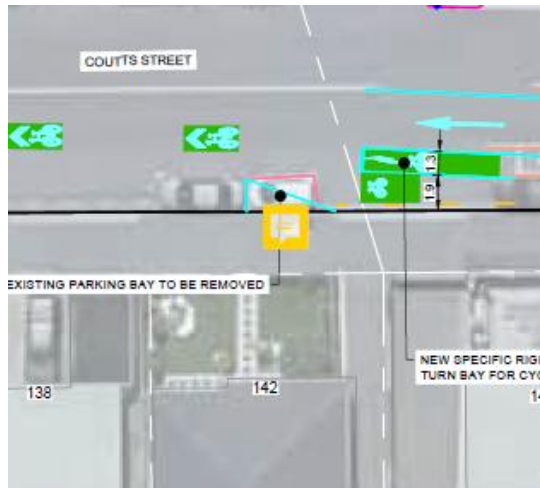
A parking space near Te Whiti Street is proposed for removal (Figure 5-1). Like other locations where existing parks are to be removed, installation of broken yellow lines (BYL) highlights the removal of parking.

Figure 5-1: 142 Coutts Street parking removed

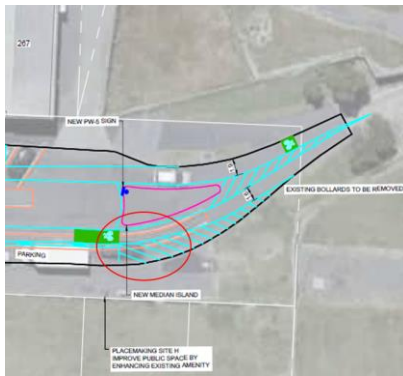
Figure 5-2: Proposed median island treatment with gap >2m circled

Figure 5-3: Christchurch pop-up example of closing road to vehicles only

5.2.2	Provide signage informing vehicles that road has ended.
5.2.3	Install flexi posts to deter users from driving through.

<b>Responses:</b>	
<b>Designer</b>	We agree with this finding. Following discussion with WCC we have agreed to use planter boxes in order to restrict vehicular access to the area. Furthermore, two chevron board signs will be installed to clearly indicate the termination of the roadway for vehicles. This will be updated on the TR design.
<b>Safety Engineer</b>	Agree with CAT and Designer response.
<b>Proposed action</b>	Agree and planter boxes to be used.
<b>Client decision</b>	Agree with proposed action
<b>Action taken</b>

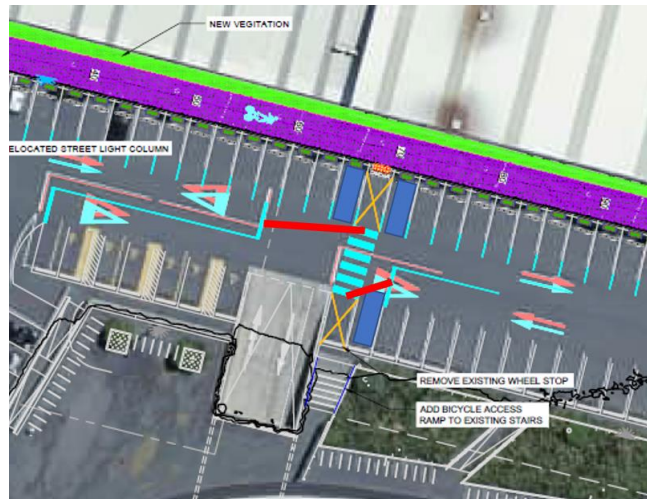
Relevant standards are [TCD manual – Pedestrian crossings \(Zebra\)](#) and [Pedestrian network guidance – Zebra crossing](#). Both help to discuss all the design requirements of a pedestrian crossing.

Figure 6-3: Diagram showing parked cars blocking visibility of pedestrians

Probability of crash occurring	Very likely
Expected crash severity	Serious injury
<b>Primary treatment recommendations:</b>	
6.2.1	Remove crossing point
6.2.2	Provide all required accompanying infrastructure for pedestrian crossings.
<b>Supporting treatment recommendations:</b>	
6.2.3	Reduce speed of carpark and turn into shared zone
6.2.4	Install the crossing on a raised safety platform

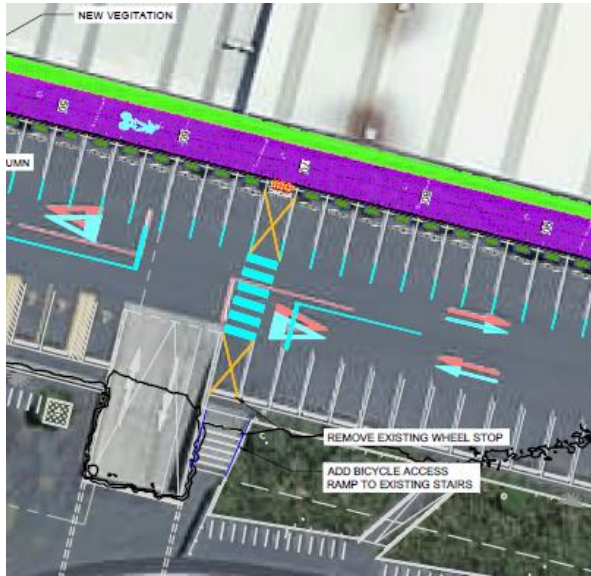
Figure 6-4: Crossing facility in car park

[Waka Kotahi Cycling network guidance](#) provides guidance on minimum widths required for dual cycle / zebra crossing markings.

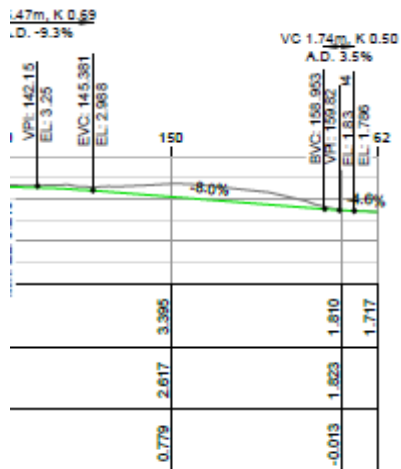
Figure 6-5: Indicative elevation along Tacy Street

The relevant guidance is CNG draft guidance, which states maximum gradients (up to 10m) and downhill gradients for interested but concerned riders is 8%. With a note stating “the maximum downhill gradient is applicable only if cycleway is to be ridden in the downhill direction only.

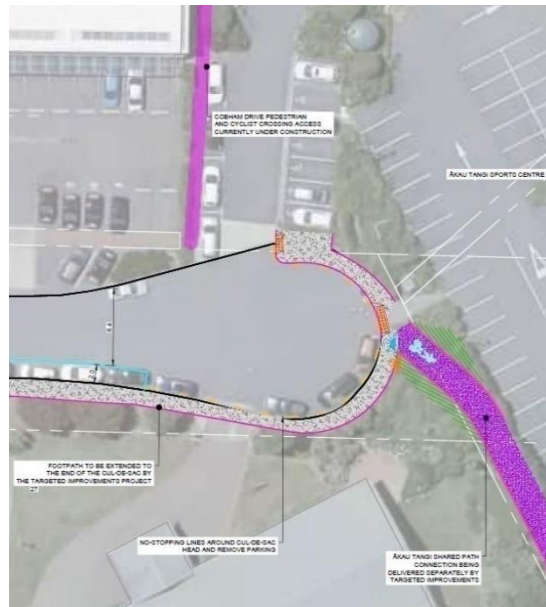
Figure 6-6: Diagram showing proposed footpath

Probability of crash occurring	Unlikely
Expected crash severity	Minor injury
<b>Primary treatment recommendations:</b>	
6.5.1	Install a compliant footpath width
<b>Supporting treatment recommendations:</b>	
6.5.2	N/a

<b>Responses:</b>	
<b>Designer</b>	Footpath will be 1.5m as far as possible. Narrower sections will only be used if existing services or trees cannot be moved.
<b>Safety Engineer</b>	Agree with Designer. The extent of less than 1.5m should be reported back in the final design for confirmation by the Safety Engineer and Client.
<b>Proposed action</b>	Agree with Designer and Safety Engineer responses. The extent of less than 1.5m should be reported back in the final design for confirmation by the Safety Engineer and Client.
<b>Client decision</b>	Agree with proposed action
<b>Action taken</b>
