Memorandum

To:	Claire Pascoe, Renee Corlett	Of:	Wellington City Council
From:	Lukas Adam	Date:	5 October 2022
Copies:	Bridget Doran		
Project:	NZ3257		
Subject:	Riddiford Street bus stop bypasses - accessibility audit

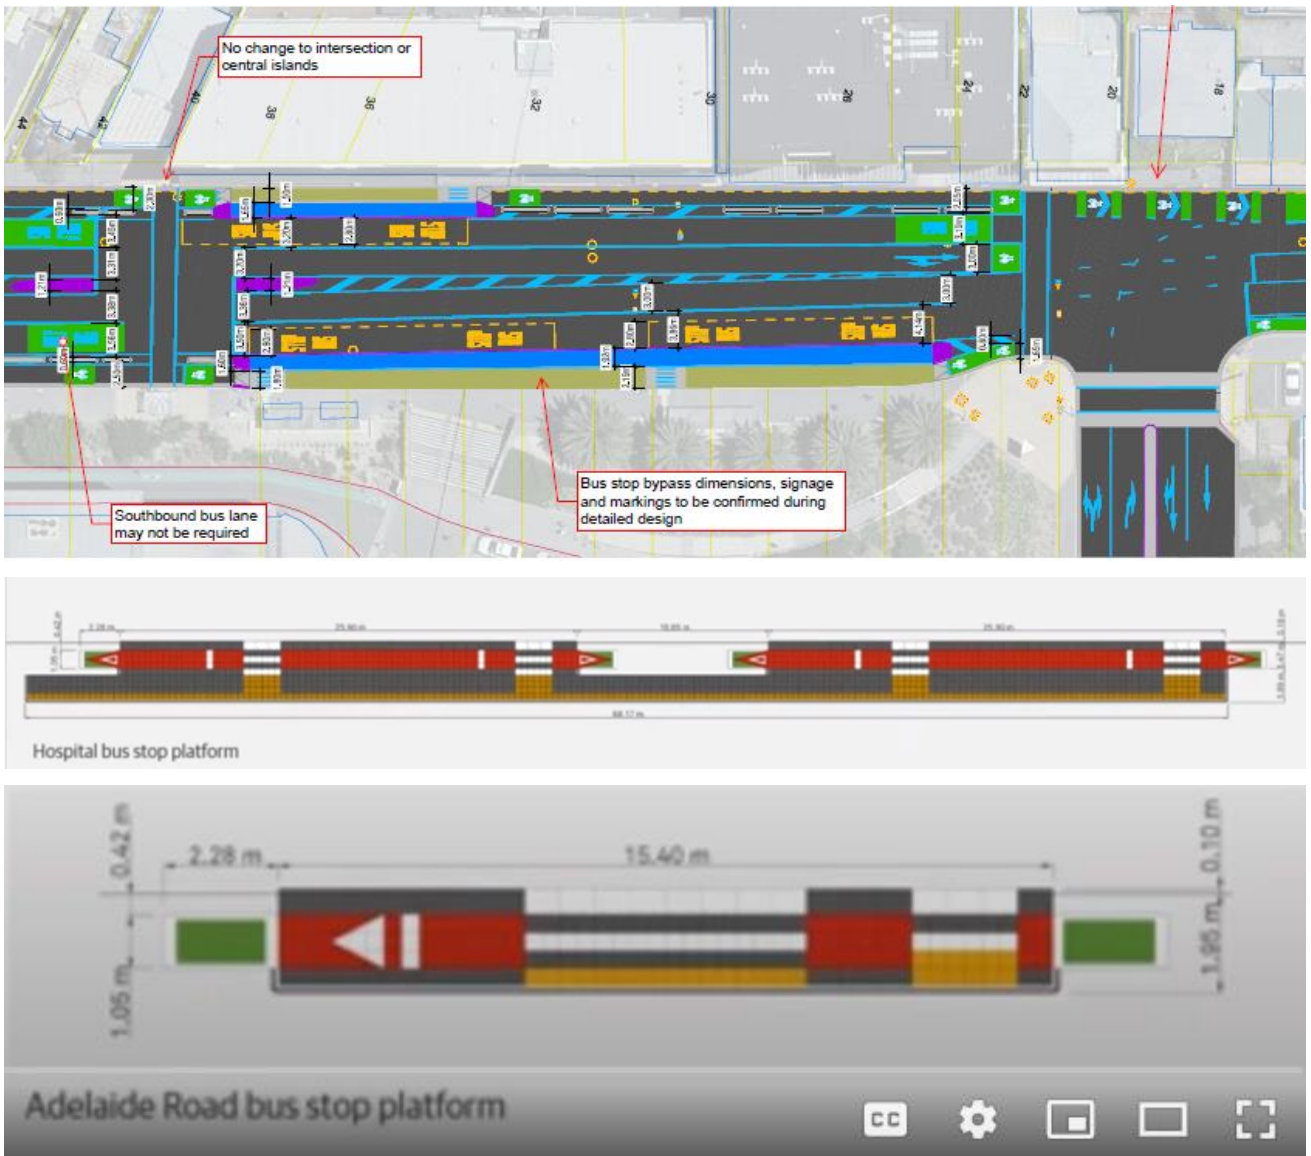
Figure 1: Bus stop bypass design - 30% concept design (October 2021)

The designs are shown in **Figure 1** and site photos are included in Figure 2. Note that we have not confirmed dimensions on-site. We have assumed that dimensions shown on drawings are the same as what has been constructed.

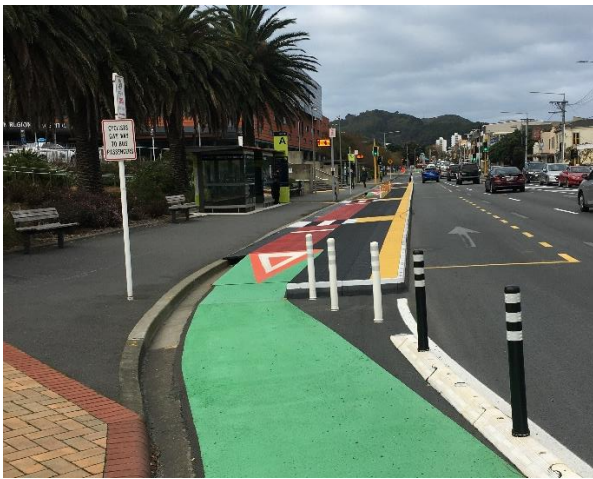
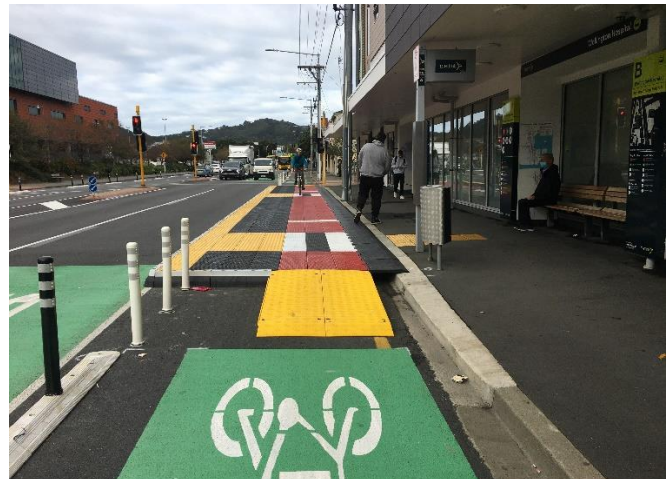
Figure 2: Riddiford Street bus stop bypass (southbound left, northbound right)

The cycleways narrow from 2300-2500mm to 1050mm (three red bus stop platform units) at the bus stop, as shown in Figure 2. Two types of ramp between the carriageway and kerb levels are used: a steel plate approximately 1400mm wide and plastic ramps are approximately 1200mm wide. It was observed that the taper of the horizontal change in direction required to access the first ramp in the southbound direction is

relatively steep, which in addition to the crossfall of the carriageway could cause some cyclists to lose their balance.

It is recommended that all ramps are widened to a minimum of 1500mm. If feasible, the following changes should also be made:

- a) The cycleways on the bus stop platforms should also be widened by one unit width to 1400mm. This will be more easily achieved at the southbound bus stops, which are one unit wider in total.
- b) Changes should be made to the layout of the approach to the first ramp on the southbound bus stop to make the deviation to align to the ramp less pronounced.

Cycleway and ramp widths	
Access principle(s):	Safe
Overall Rating	Minor
Designer response	<p>Temporary plastic ramps have already been replaced with steel plate so comment a has already been addressed.</p> <p>For comment b the approach turn complies with the guidance of 10m radii. Straightening the approach angle further would require civil works which is outside of scope of transitional cycleways programme. Would be cautious of realigning the ramp because then cyclists would need to turn on the bus stop platform which provides less friction than the road surface</p>
Client decision	Agree with designer. We will aim to ensure the ramps on the bus platforms are 1500mm where feasible. Note road width constraints may result in a less than desired outcome in some instances.
Action taken	Use 1500mm ramps where possible. Investigate replacing ramps if on-going issues

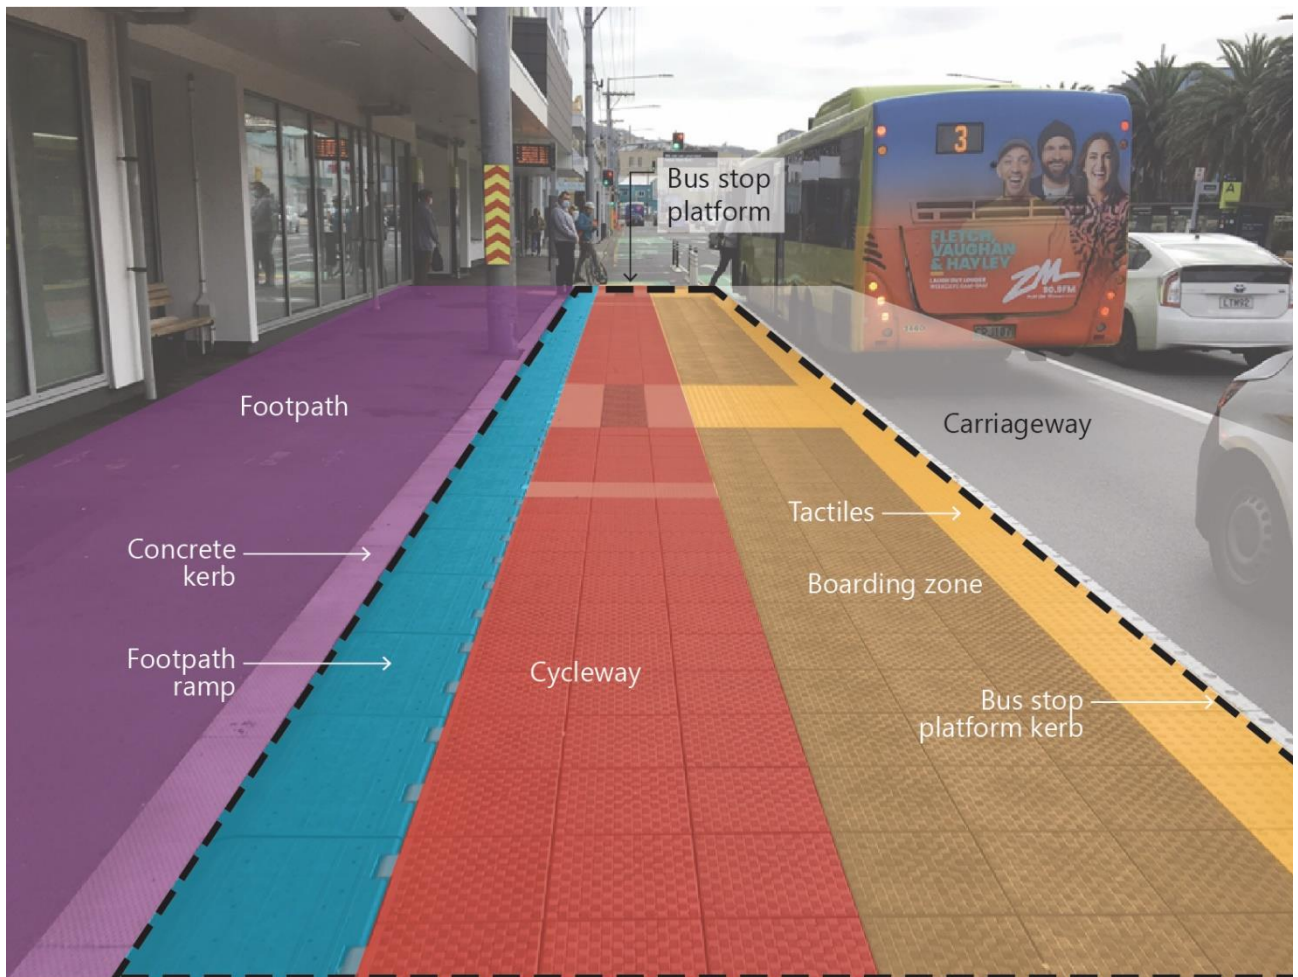
Figure 3: Bus stop bypass terminology

Figure 3 sets out the terminology used in this document regarding bus stop bypass elements.

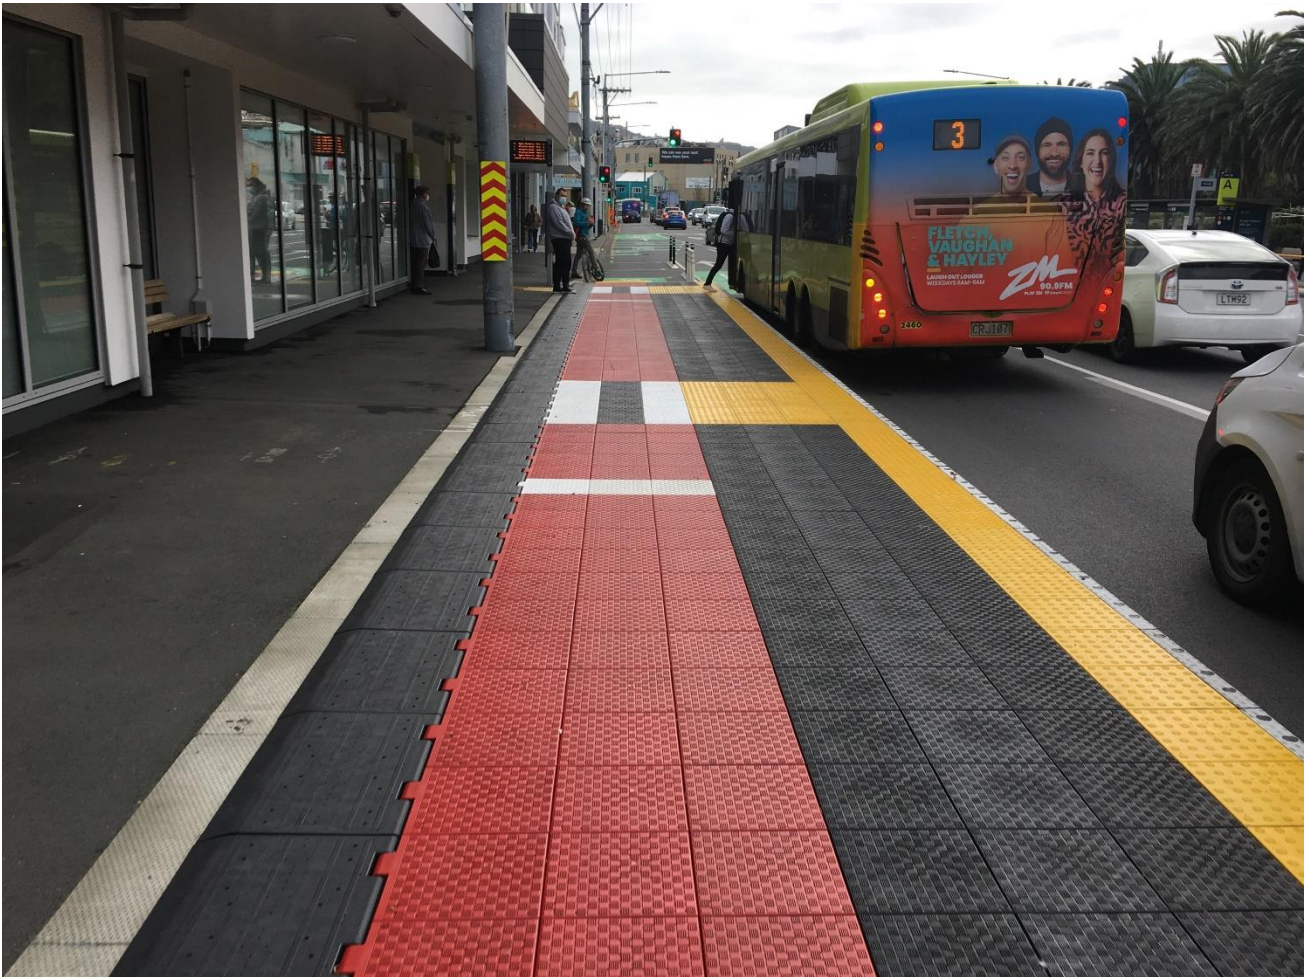
Figure 4: Northbound bus stop platform

Tactiles along the length of the bus stop platform kerb highlight the change in level down to the carriageway (a function which is also performed by the kerb itself), as shown in Figure 4. When approaching from the footpath side, there is no tactile warning of the potential hazard presented conflict with cyclists using the bus stop bypass cycleway aside from the footpath ramp between the concrete kerb and bus stop platform. A row of tactiles should, therefore, be added along the length of the bus stop platform between the concrete kerb and cycleway, particularly at the zebra crossings. The existing tactiles along the bus stop platform kerbside should be retained.

It should be noted, however, that design changes to accommodate additional tactiles should consider the use of the boarding zone. Narrowing the boarding zone will compromise its use for bus access ramps and, for example, for passengers to harness a guide dog or put a child into a pram.

Tactiles and bus stop platform geometry	
Access principle(s):	Safe
Overall Rating	Minor
Designer response	Am cautious of putting tactiles on the ramp over the gutter as this would make it harder for people in wheel chairs and people with prams to access the bus stop platform. Preference would be tactiles along the kerbline instead because this would create less of a lip for wheel chairs. Stick on tactiles could potentially be used to test tactiles along the kerbline
Client decision	Investigate additional stick on tactiles along the kerb to test improved accessibility.
Action taken	Investigate additional tactiles along the kerb.

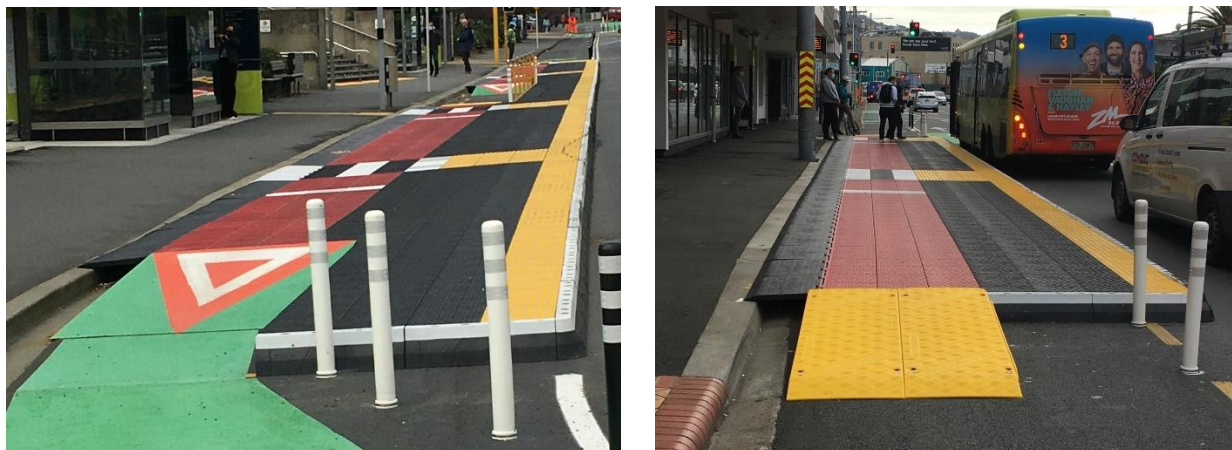
Figure 5: Different markings at the two bus stops (southbound left, northbound right)

Inconsistent markings are used to communicate the need for cyclists to give way to bus passengers at the bus stop platform zebra crossings, as shown in Figure 5. The two 'up' ramps in the southbound direction feature the same green colour as the cycleways and white give way triangles on a red background, while this is missing from the equivalent plastic ramp in the northbound direction. Furthermore, the zebra markings on the northbound bus stop platform do not extend to the concrete kerb as they do in the southbound direction. All zebra markings could also be one unit wider to improve legibility. The short length and width of the zebra markings makes them difficult to recognise readily.

These inconsistencies reduce the clarity of the design and could lead to confusion and collisions. It is recommended that for the northbound bus stop platform: a) the triangle markings are added to the ramp, and b) the zebra markings are extended to the concrete kerb. For both sides of the street, it is recommended that

the zebra crossings are widened by two units to enhance the legibility of where pedestrians should cross the cycleway to board a waiting bus.

Inconsistent markings	
Access principle(s):	Safe, Obvious
Overall Rating	Minor
Designer response	Comment a is already addressed by change in ramps. Comment b agree that for consistency the white tiles should be used to the kerb. Comment c the width of the zebra in the bus stop designs is 6 tiles or 2.3m wide and a bus front door is 2m wide so the existing width is sufficient
Client decision	Changes to ramp markings made. Agree with designer
Action taken	No additional action required.

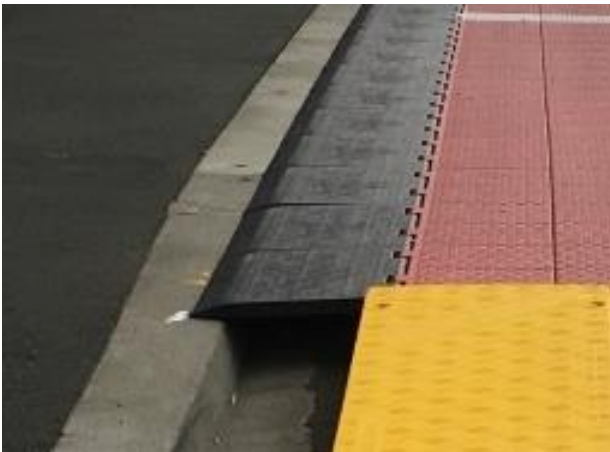
Figure 6: Footpath ramp lacking slip resistance (black units)

The slip resistance of the footpath ramp units (shown in Figure 6) was observed to be lower than the main bus stop platform units. It is recommended that these are tested for slip resistance and a treatment to increase grip applied if a deficiency is identified.

Slip resistance and surface textures	
Access principle(s):	Safe, Obvious
Overall Rating	Minor
Designer response	To consider applying slip resistant tape or similar product
Client decision	Agree with designer
Action taken	Look to add slip resistant tape along this section.
