**Shelly Bay Road Upgrades**  
**Options Assessment Report**

Prepared for  
Wellington City Council

Prepared by  
Tonkin & Taylor Ltd

Date  
June 2022

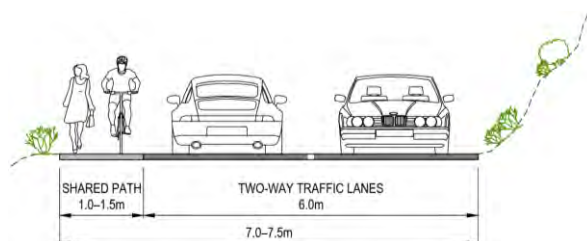
Figure 3.2: Indicative cross section of the minimum consented road works for the development

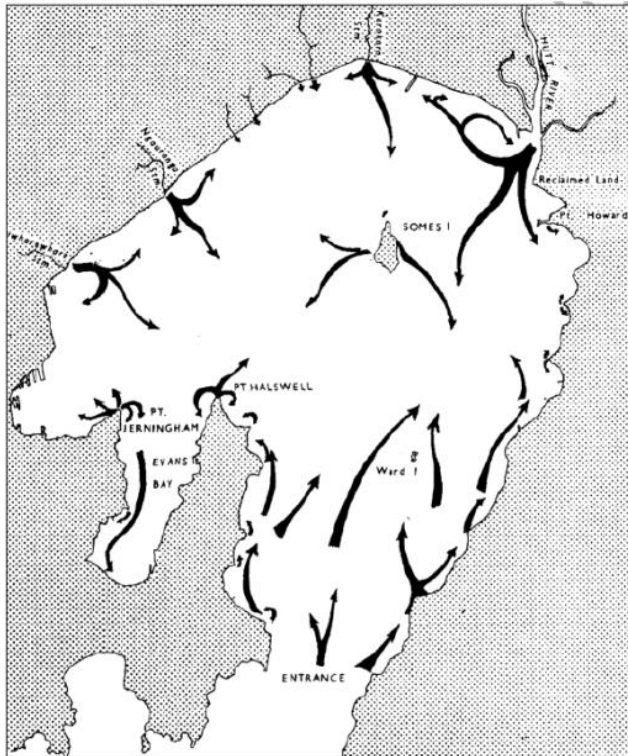
Figure 3-5: Sediment transport processes within Wellington Harbour [Source: Van der Linden (1967)].

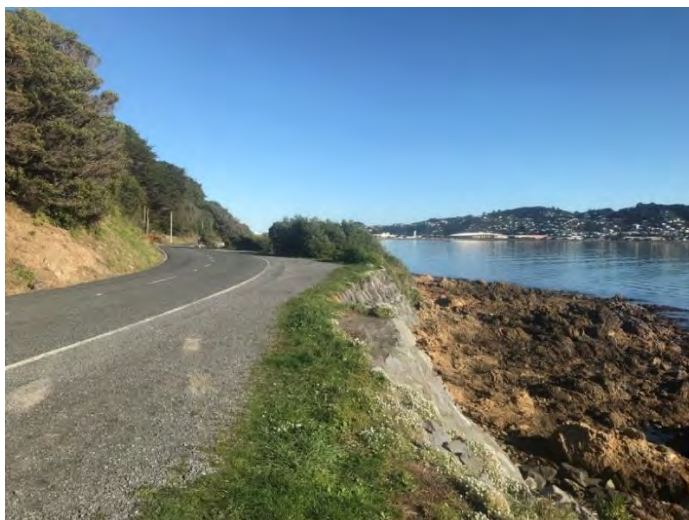
Figure 4-2: Shows the coast proximately of Shelly Bay Road to the coastline

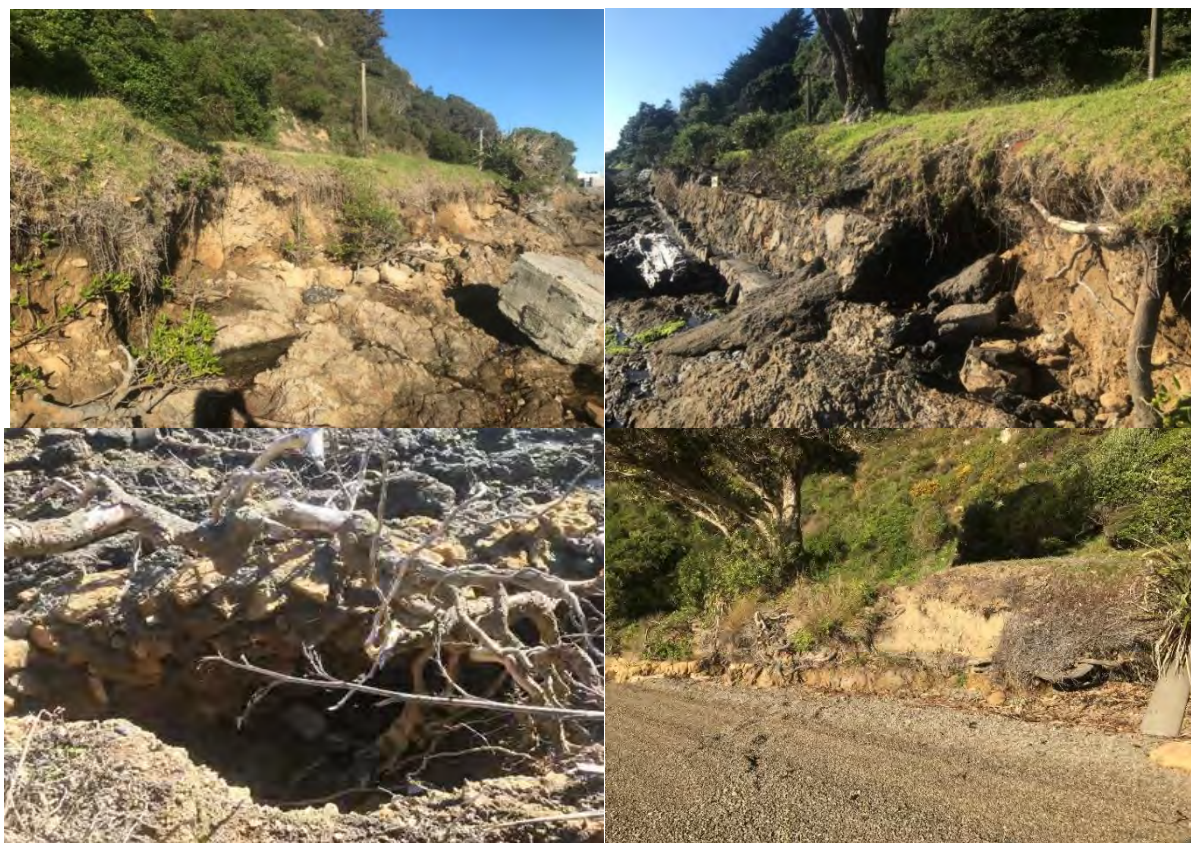
There is evidence along the length of the project site that this area is subject to ongoing erosion due to wave attack. The presence of significant lengths of seawall along Shelly Bay Road indicates vulnerable areas that have been repaired over the lifetime of the road. There are also areas of recent erosion and during the site walkover evidence of damage to the backshore and some seawalls was observed reflecting this ongoing erosional trend (refer **Figure 4-3**).

Figure 4-3: Erosion trends along the coastal line of Shelly Bay Road

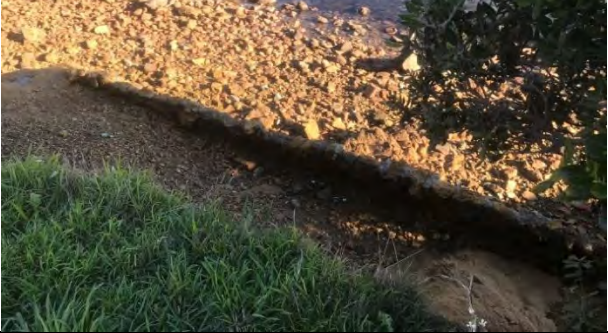
Asset ID	Changes noted since 2016 condition assessment and image
<p>14555 Vertical wall Mortared rock</p>	<p>2016 condition: Poor Present Day condition: Very poor</p> <ul style="list-style-type: none"> <li>• Overtopping and undermining of wall</li> <li>• Scour of crest</li> <li>• Damage to face</li> </ul>

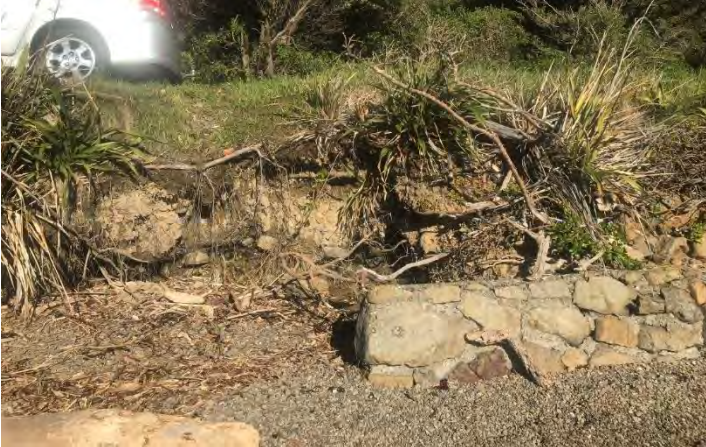
<p>14740 Vertical wall Mortared rock</p>	<p>2016 condition: Poor Present Day condition: Very poor</p> <ul style="list-style-type: none"> <li>• Overtopping and undermining of wall</li> <li>• Scour of crest</li> <li>• The seawall isn't protecting the bank behind</li> <li>• Damage to face</li> <li>• End-scour of wall</li> <li>• Higher seawall likely needed such as the one adjacent</li> </ul>

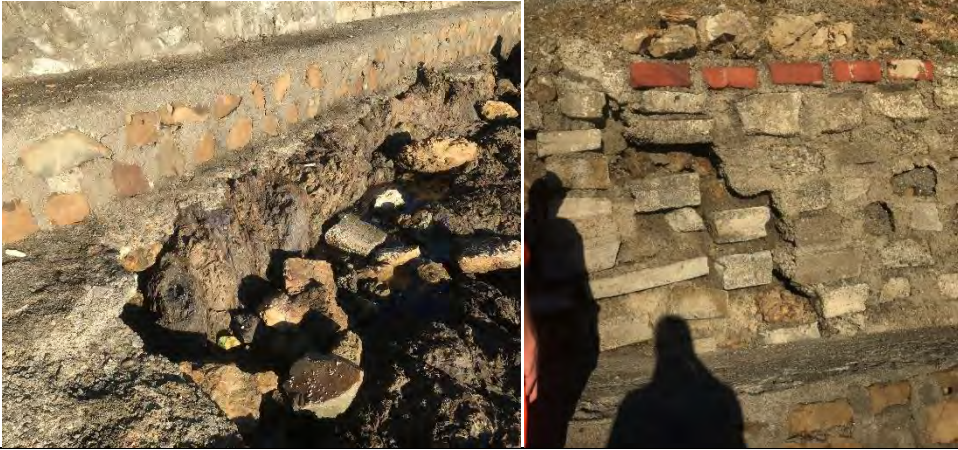
<p>11205 Stepped vertical wall Mortared rock</p>	<p>2016 condition: Average Present Day condition: Poor</p> <ul style="list-style-type: none"> <li>• Localised undermining of wall</li> <li>• Localised significant damage to face</li> </ul>

<ul style="list-style-type: none"> <li>• End-scour of wall (particularly at the southern end)</li> </ul>

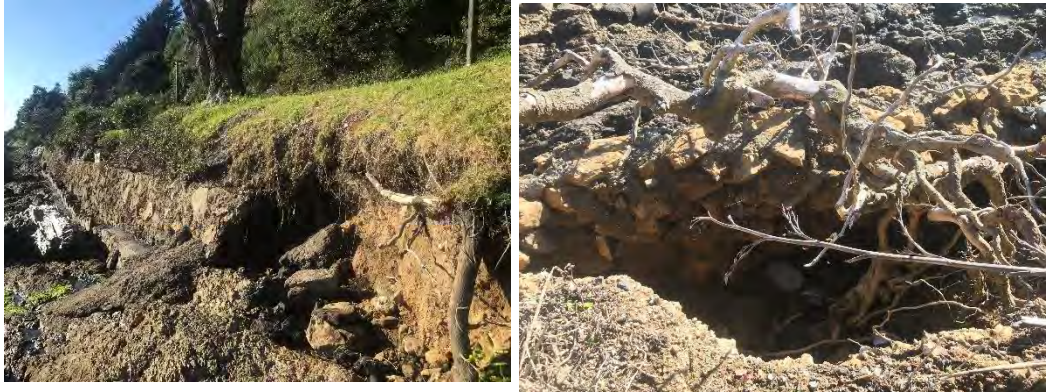
<p>14581 Vertical wall Mortared rock</p>	<p>2016 condition: Average Present Day condition: Poor</p> <ul style="list-style-type: none"> <li>• Localised undermining of wall</li> <li>• Damage to face</li> <li>• End/outflanking scour (more significant at the southern end)</li> <li>• At the end of a wall there are large concrete blocks that may have been put there to prevent erosion, but they have since been displaced</li> </ul>

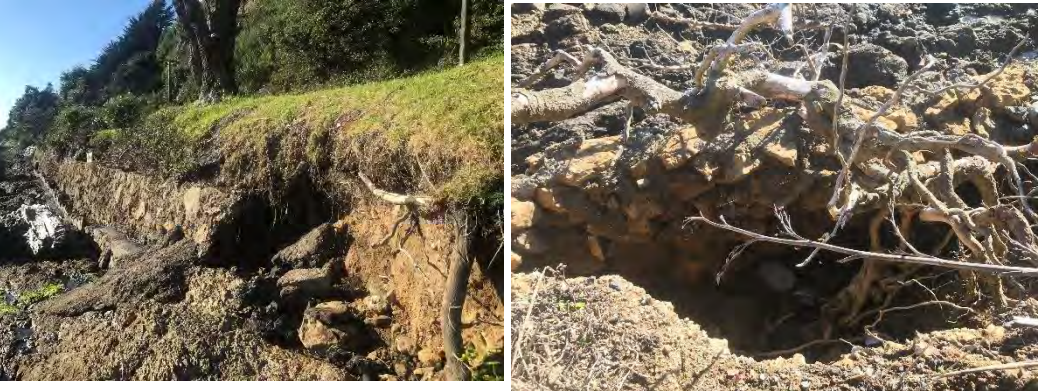
<p>14584 Vertical Wall Mortared rock</p>	<p>2016 condition: Average Present Day condition: Very poor</p> <ul style="list-style-type: none"> <li>• Void behind wall caused by undermining failure</li> <li>• Damage to face</li> <li>• End-scour of wall</li> </ul>

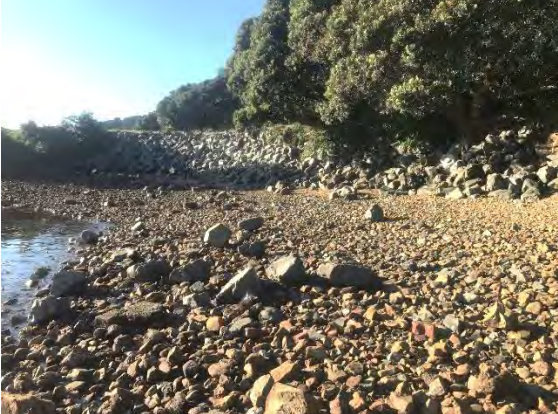
<p>NW04</p>	<p>This wall was not included in the 2016 assessment and has likely been installed post-2016.</p>

<p>Revetment Rip rap rock</p>	<p>Present Day condition: Poor-Average</p> <ul style="list-style-type: none"><li>• It can be seen in the image that several rocks have been plucked from this revetment and are located on the beach. This is likely due to the revetment being constructed too steep for the size of rock used. It is anticipated this plucking will continue to occur in future storm events.</li></ul>

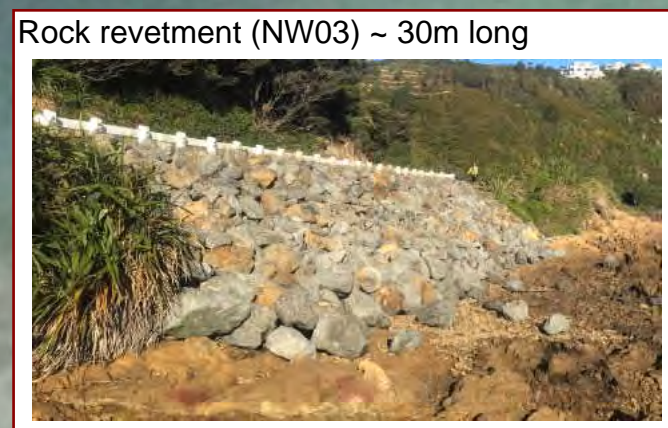
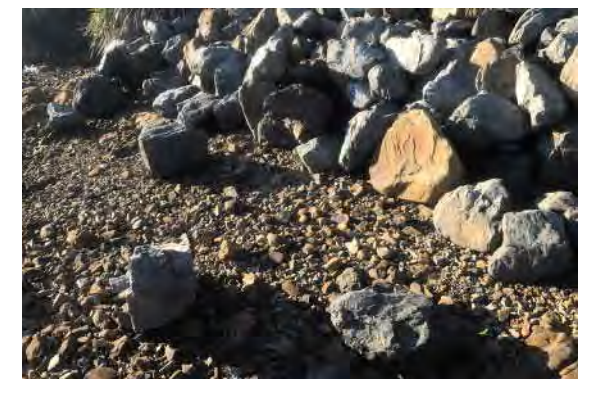
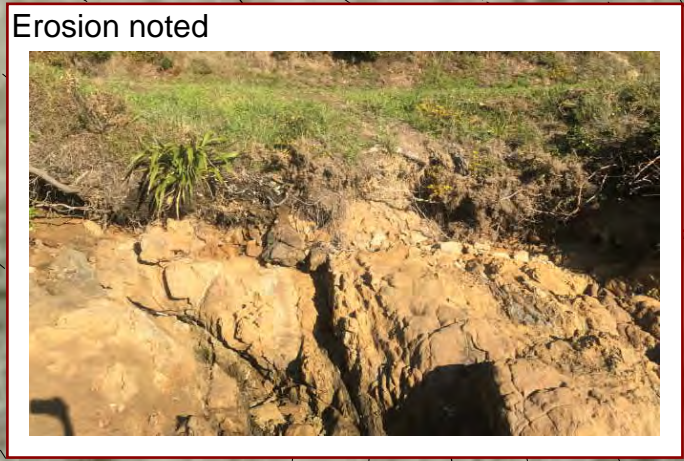
No toe key, rock over steep, plucking and movement of toe rock noted

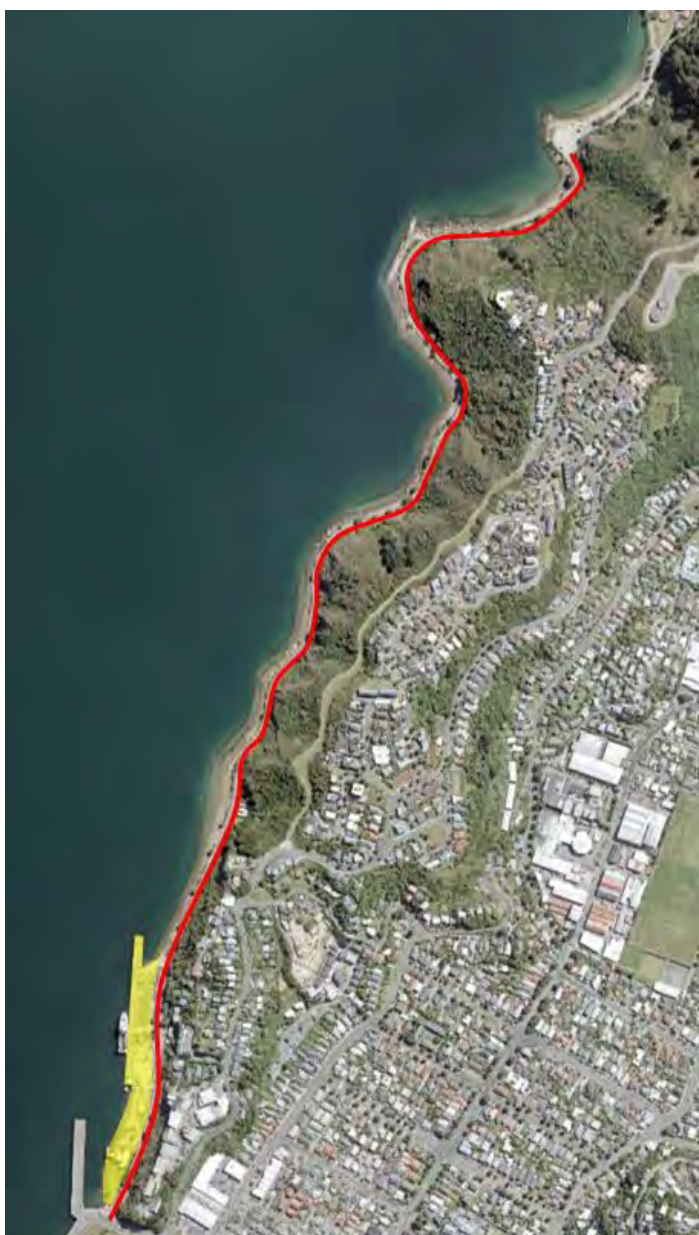
*Figure 1: Physical scope of work (extent of the project scope (study area) shown in red; coastal areas outside of scope highlighted in yellow)*

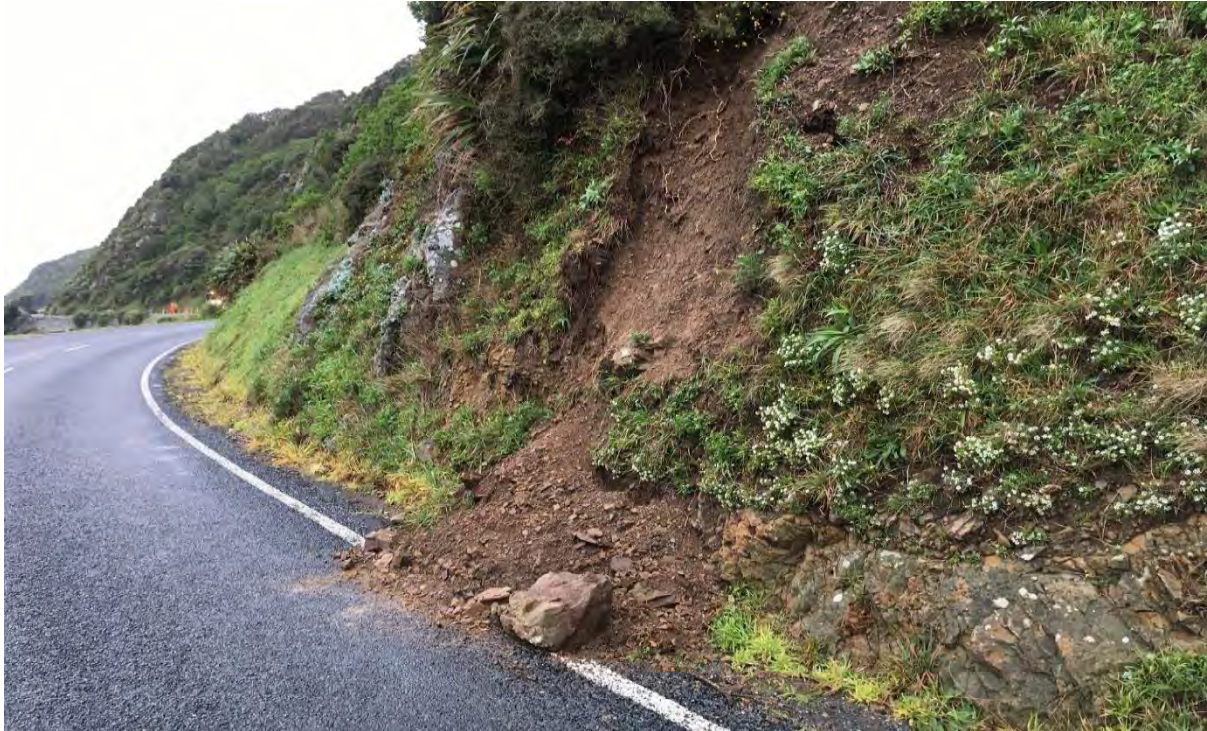
*Figure 5: Shallow slide of loose surficial soils and rock observed on 19 June 2020. Approximately 1 m<sup>3</sup> debris inundating road shoulder*
