# Preliminary Slope Hazard Assessment

## Shelly Bay Road Upgrades

Prepared for  
Wellington City Council

Prepared by  
Tonkin & Taylor Ltd

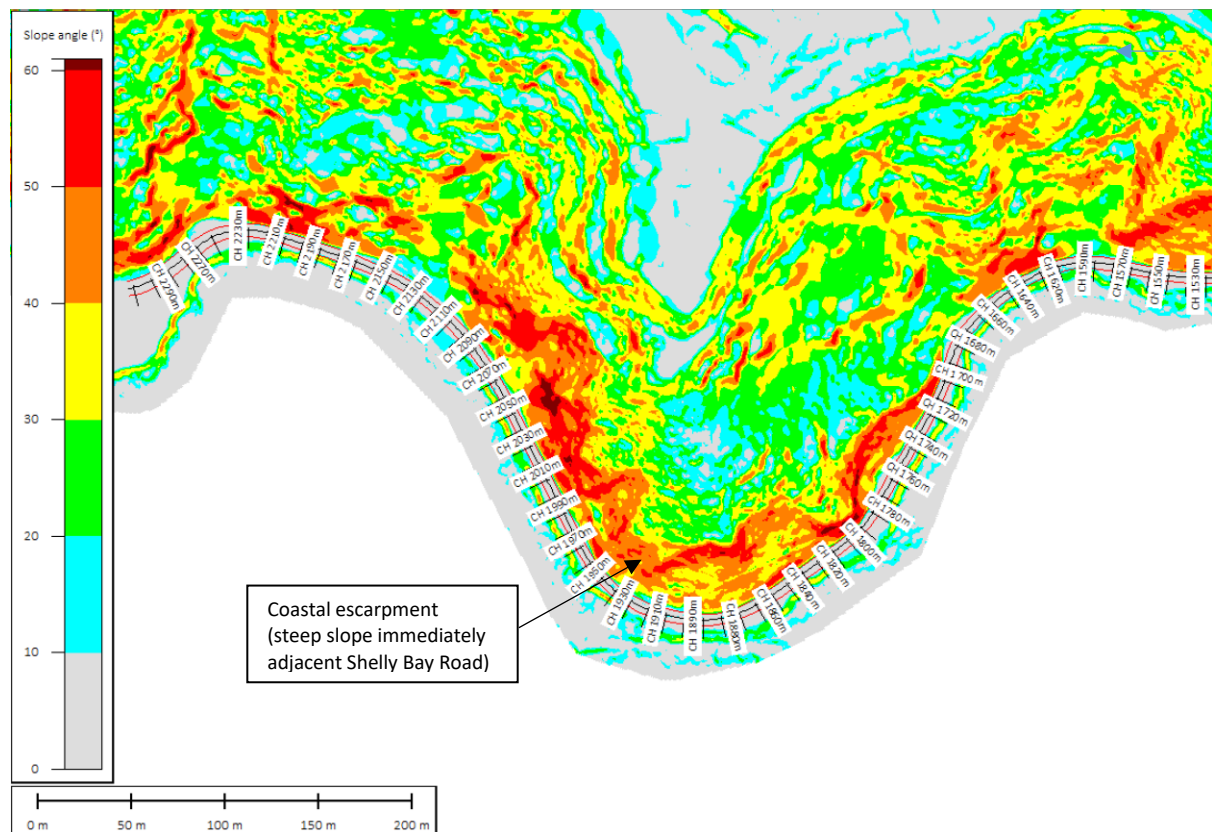
Figure 2: Extract from GIS software presenting slope angles as colours

The site topography has been assessed using Blue Marble Geographics Global Mapper (v21.0.2). This software was used to identify locations of prior instability, and slopes with an elevated risk due to their slope angle, height, and distance from Shelly Bay Road. **Figure 2** presents the general slope angles between Chainage 1530 and 2290 m. In summary:

- There are some localised areas of rock outcrop on the escarpment that exceeds 60 degrees;
- The existing road shoulder width is limited. The road generally less than 1 m from the base of the escarpment; and

- The crest of the escarpment is undulating, which is inferred to be the result of pre-historic retrogressive land sliding. The remnant features on the escarpment are narrow and wide gullies.

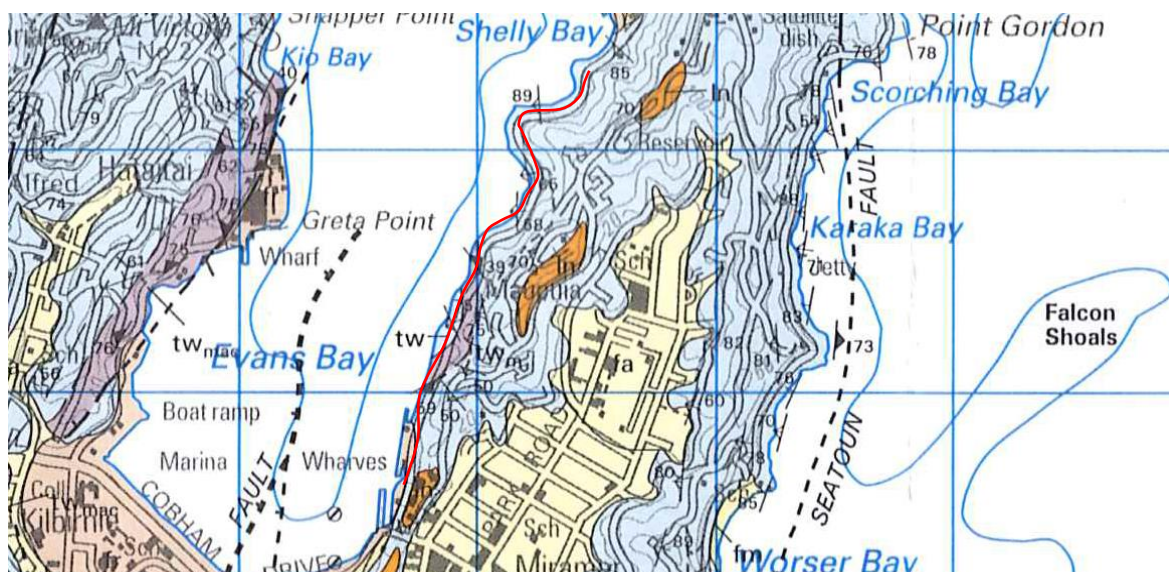
Figure 3: Geological setting and extent of study (red line). Note that this map only describes the general geology of the area and does not provide site-specific detail

Shelly Bay Road in the context of the regional geology is presented in **Figure 3** below. The geological map<sup>1</sup> indicates that the slopes are comprised of very steeply bedded, alternating sandstone/mudstone (known commonly as “Greywacke” rock) of the Rakaia Terrane (Late Triassic). A discrete block mapped separately as ‘melange and broken’ is located between approximately Chainage 660 and 810, and 980 and 1100 m. Greywacke rock is extensively fractured in multiple directions which is attributed to the rockfalls that are commonly observed on road cuts and natural rock slopes in the Wellington region, including Shelly Bay Road.

Although not mapped, a layer of colluvium soil overlies the rock in some areas across the slopes. The thickness of colluvium will likely be variable and predominantly thin or non-existent on steep slopes and ridges, and thicker in shallow slopes and gullies.

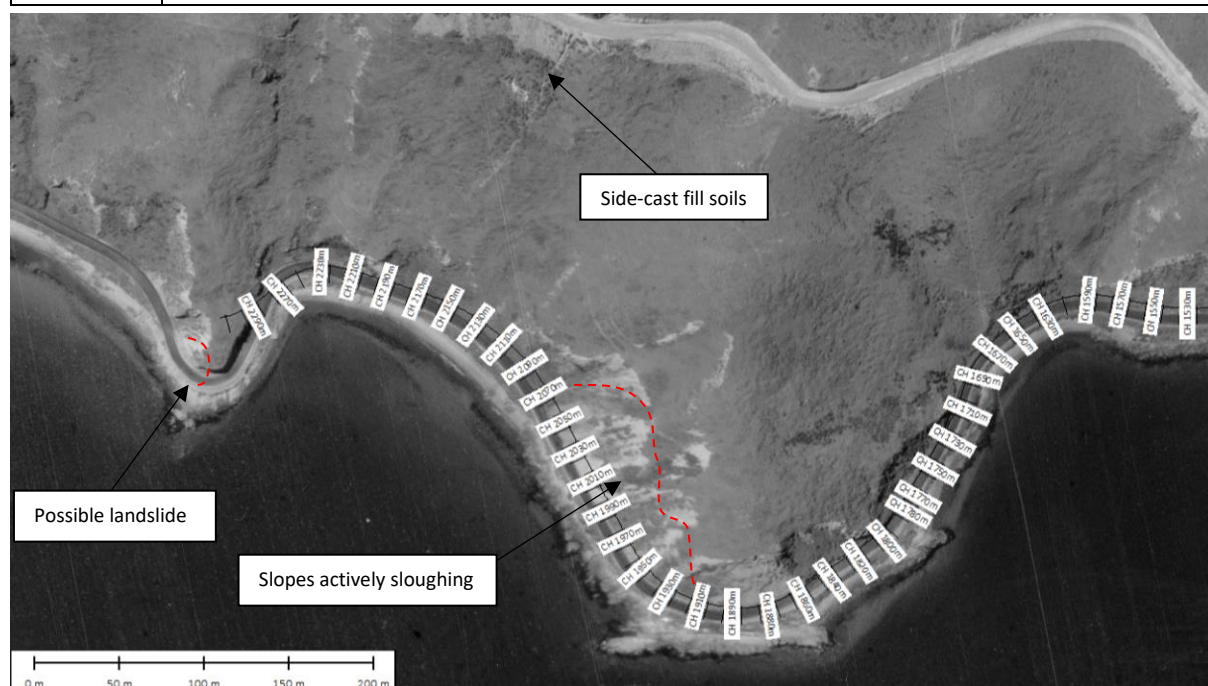
**Figure 4: Historic aerial photograph c.1939**

Year	Observations
1939	<ul style="list-style-type: none"> <li>Numerous small to intermediate-scale landslides on slopes above the escarpment.</li> <li>Slopes are grass-covered and free from vegetation. Terracettes (shallow soil slumping) are common.</li> <li>Some side-cast fill is present on the side of the road (likely during construction) at the top of the slope – now Main Road, Akaroa Drive, Prison Road, and Maupuia Walkway.</li> <li>Most of the escarpment is exposed and appears to be actively sloughing in some areas, particularly between Chainage 1930 to 2090 m.</li> <li>Significant retrogressive landslide features in gully upslope from Chainage 2240 and 2260m (headscarp fully regressed).</li> <li>A 20 m wide landslide appears to have occurred at approximately Chainage 2320 m (note that this has been removed by subsequent earthworks cutting).</li> <li>Some local quarrying of rock may have occurred between Chainage 280 and 400. A dwelling is now located on the flat land in this area.</li> </ul>
